INDIAN ARCHAEOLOGY 2009-10

- A REVIEW

**PUBLISHED BY THE DIRECTOR GENERAL
ARCHAEOLOGICAL SURVEY OF INDIA
JANPATH, NEW DELHI
2016**

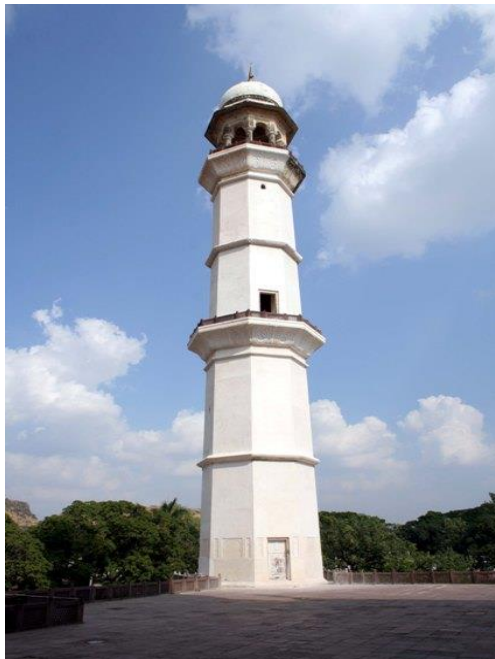
B

Bibi-ka-Maqbara: A, before and B, after repairing of the minaret

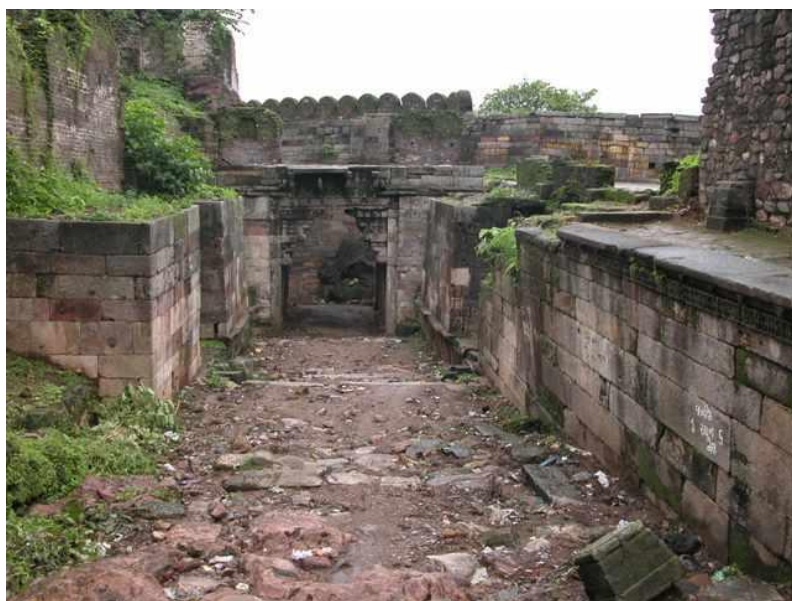
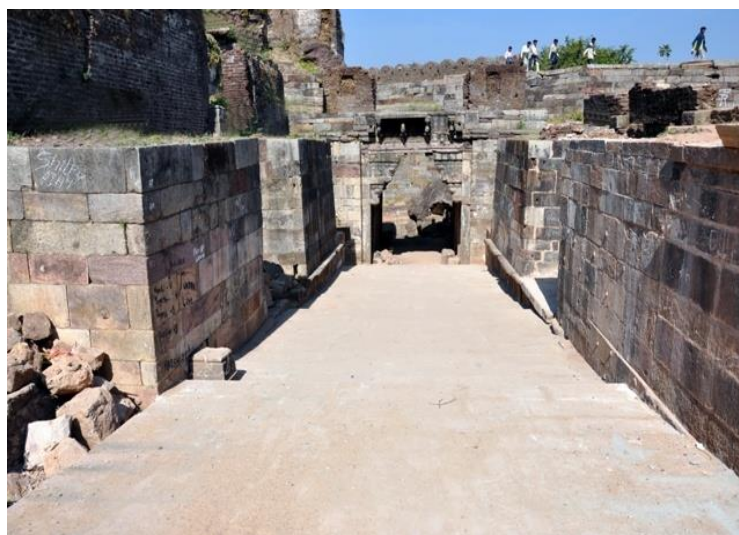
Plate: 142

Sadan Shah Gate, Champaner: A, before and B, after repairs to the damaged and worn-out pathway

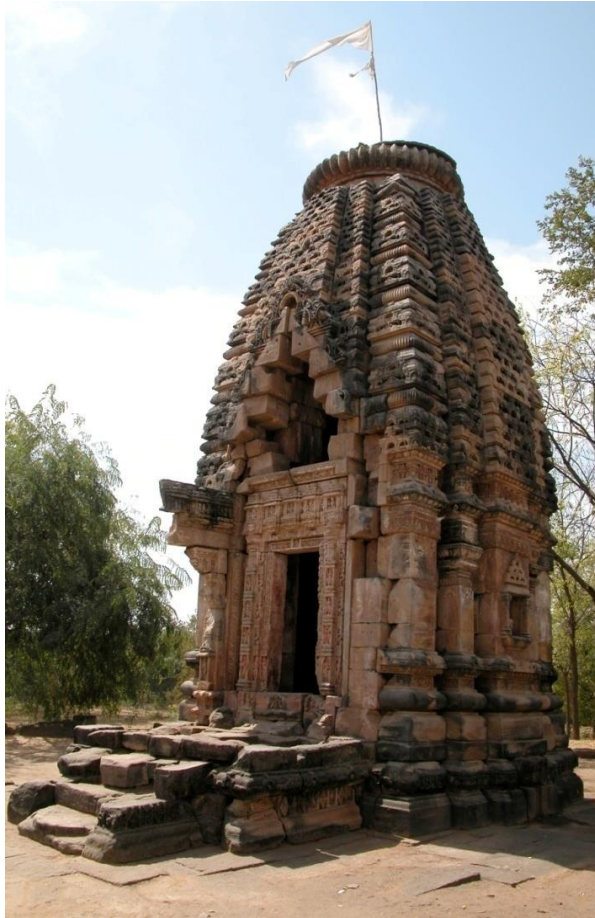
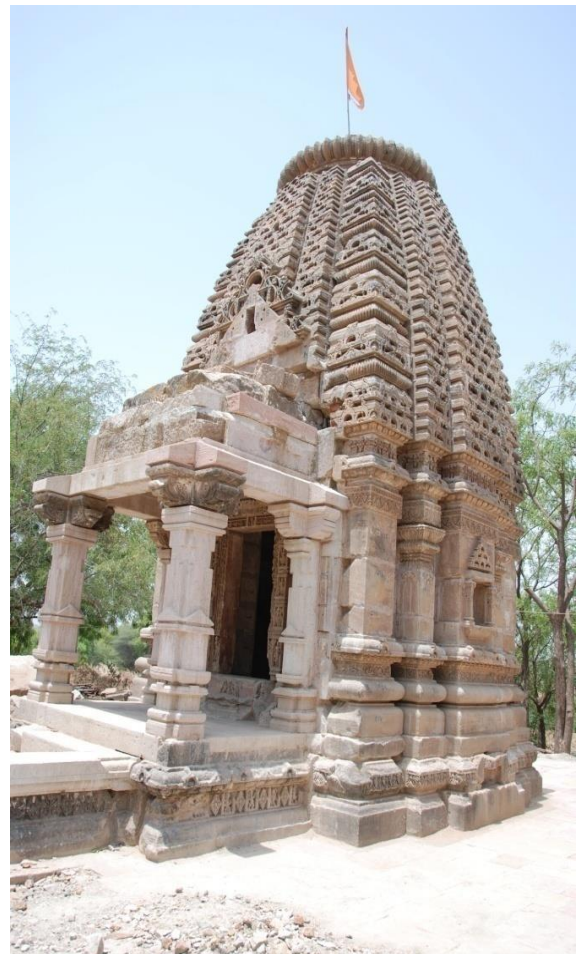
Group of Temples, Khed-Roda: A, before and B, after repairs to the temple

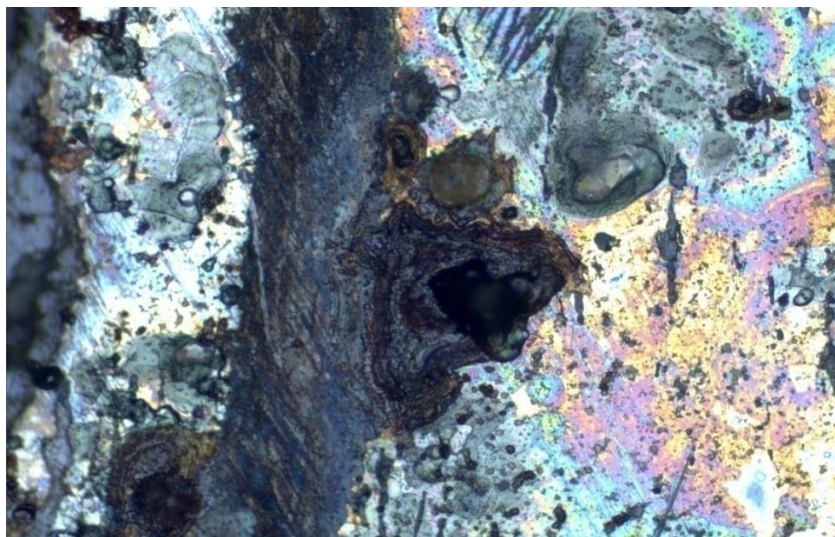
- Sample drawn from sword handle showing the metallographic details such as big cavities with a thick separate layer of one of the components formed during the cooling process due to difference in its freezing point. Cavity might have been formed due to faster rate of corrosion of localized material. Different component phases perhaps did not fuse properly during the working.

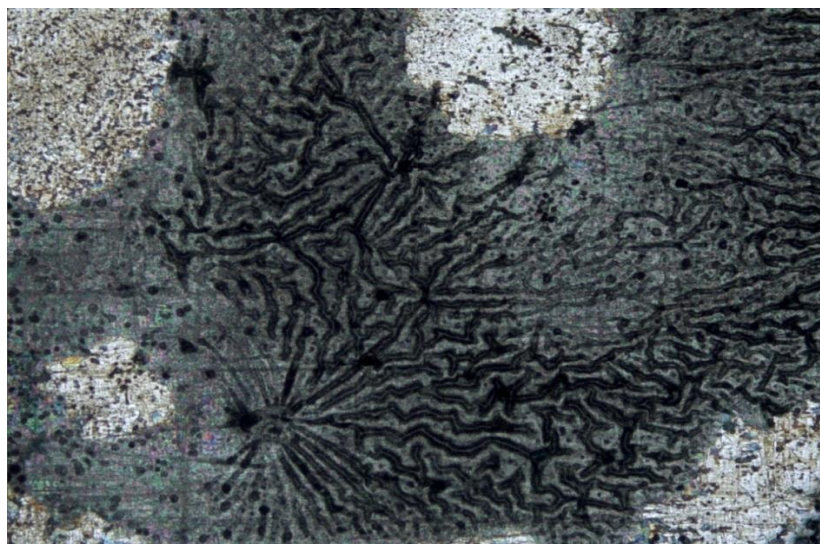
- Sample drawn from sword handle showing the metallographic details such as big patches surrounded by dendrites with slag inclusions. The image is showing the distinct phases of component materials which are indicating the cast process of working.

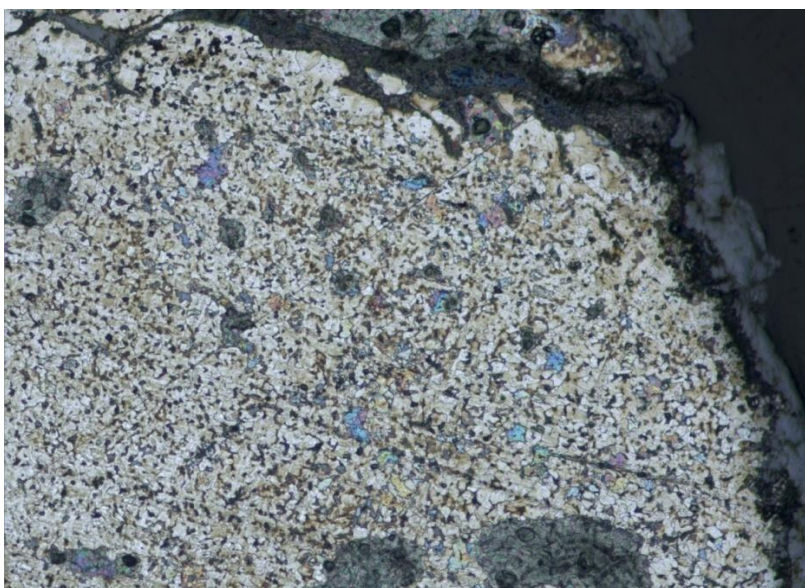
- Sample drawn from sword handle showing the metallographic details such as grains of different shape and size representatives of different components which are closely knitted. The outer boundaries showing the corrosion products formed on the outer surface of the object.
