INDIAN ARCHAEOLOGY 2013-14

– A REVIEW

**PUBLISHED BY THE DIRECTOR GENERAL
ARCHAEOLOGICAL SURVEY OF INDIA
JANPATH, NEW DELHI
2016**

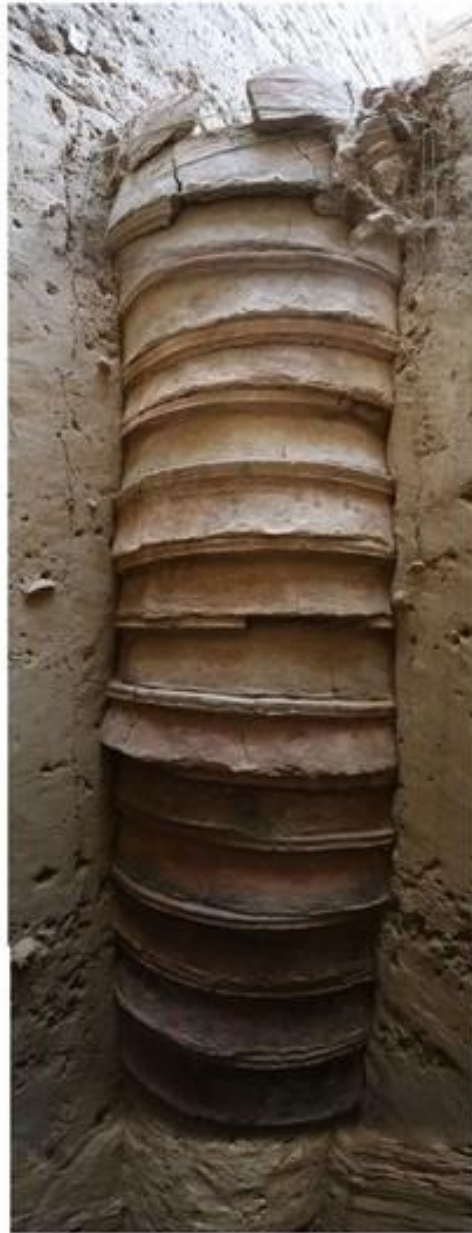
Plate 14

Purana Qila: Ring well, Mauryan Period.

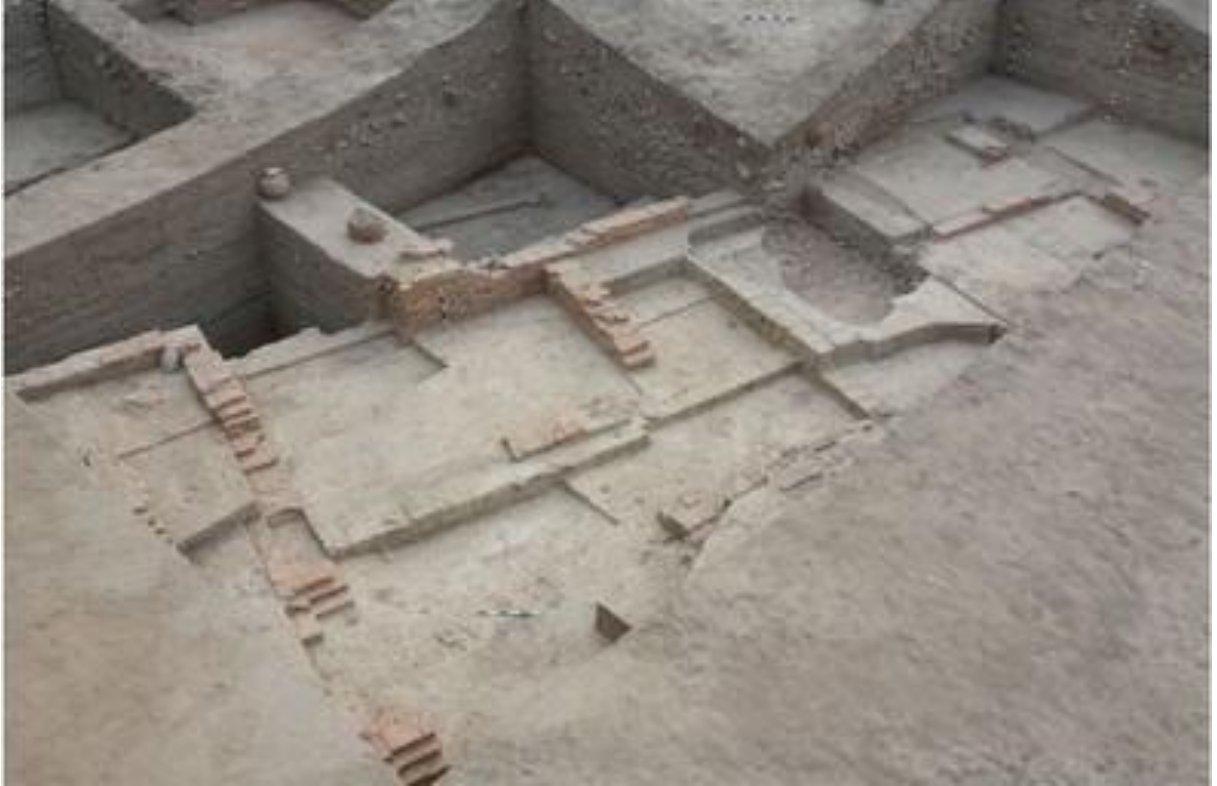
Period III: In this level a house consists of three rooms was exposed (Pl. 17). The walls are constructed with burnt bricks. Mud bricks have also been used for partition of rooms and for laying out the floor. The brick sizes varies from 39 x 27 x 6cm to 37 x 22 x 5.5cm and 33 x 22 x 5cm. Bricks are placed either header or stretcher wise. In one case, one row of header and other row of stretcher

Purana Qila: House, Kushana Period.

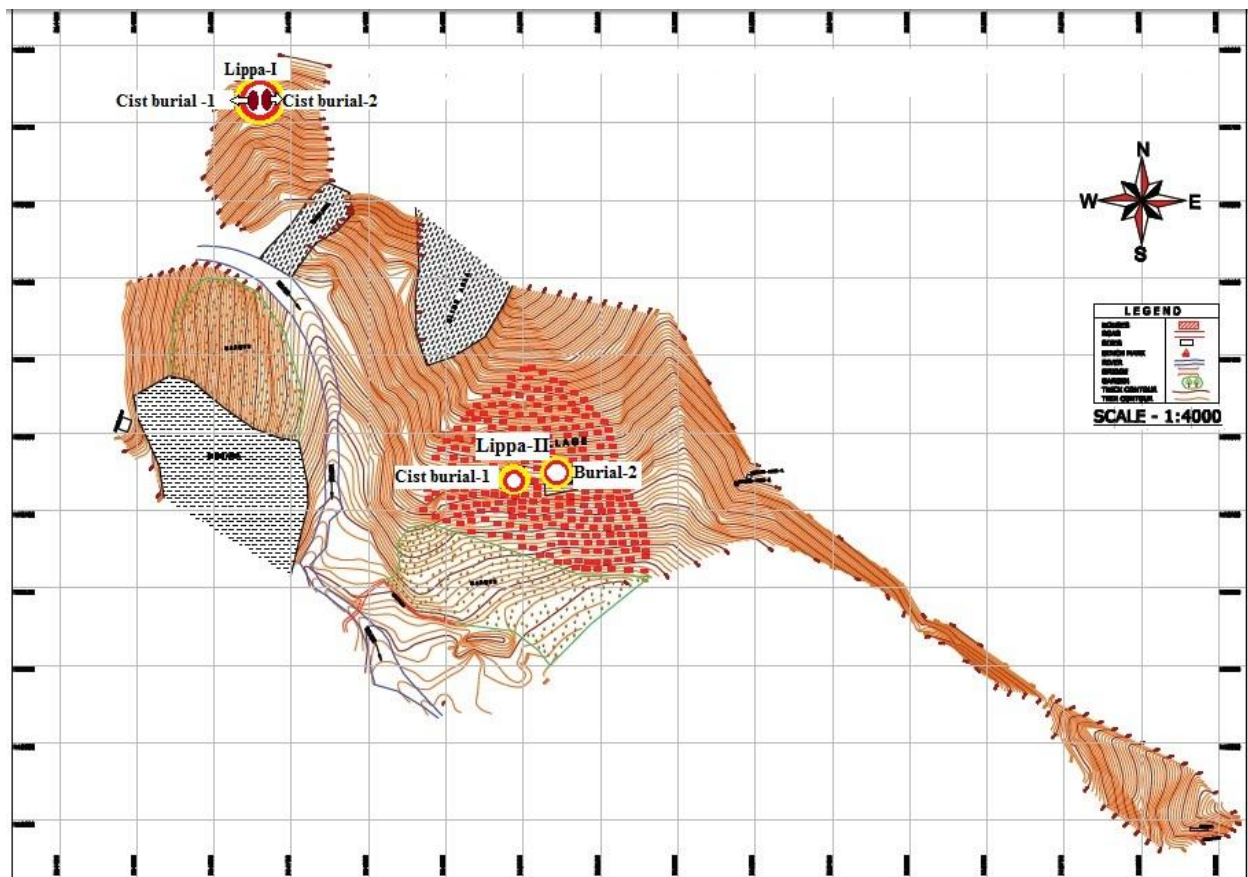
Fig. 6

Kinnaur: Contour map of the area, Lipka.

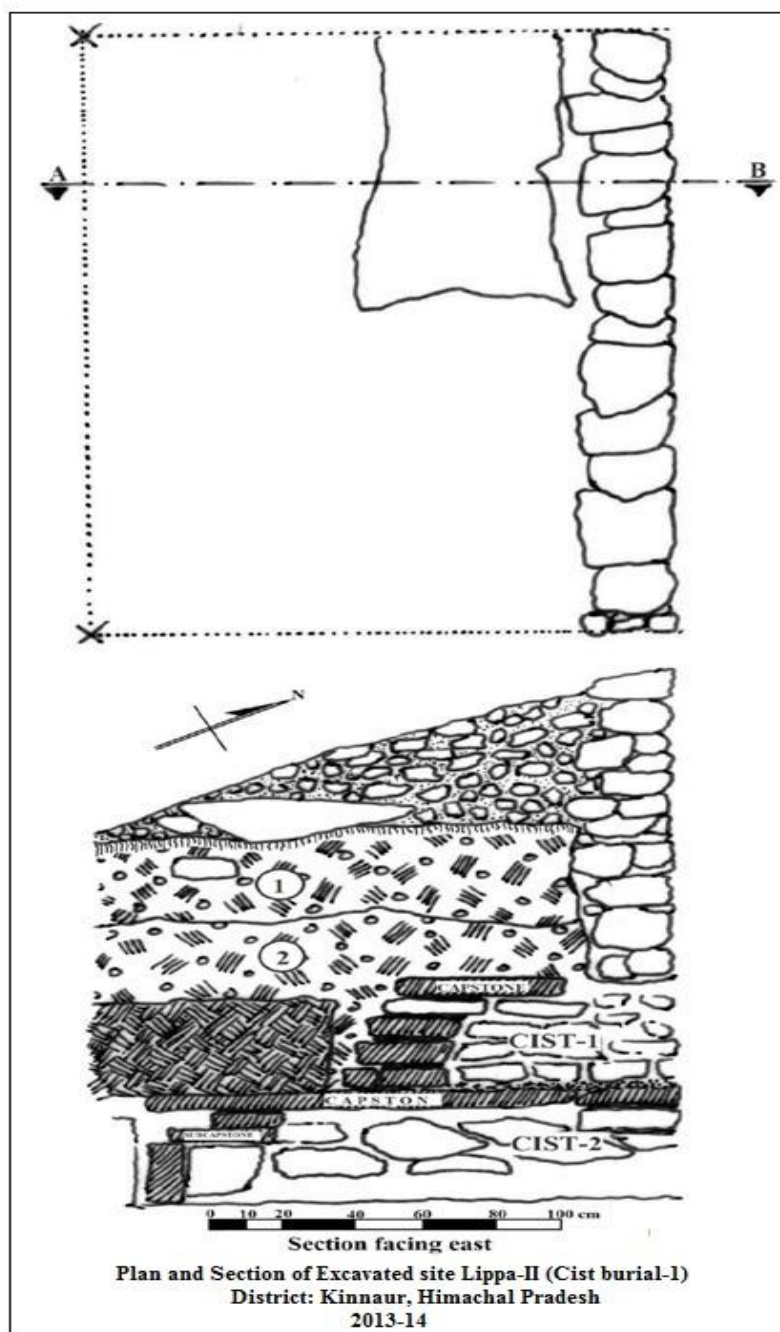
Fig. 7

Kinnaur: Exposed section of burial site, Lippa.

A thick deposits measuring 2.44m overlying the Cist was a distinct stratigraphy which was divided into five different layers of deposition based upon their texture and colour. The most interesting feature of the deposition is a 46cm thick, hard dark greyish band of slate deposit (layer 3) separating the compact yellowish clay and silt deposit (layer 2) and cobble rich silt and mud deposit (layer 4 and 5). This is the only burial site on the steep slopes at Lippa which has been found at such a depth. Efforts are underway to study the erosional pattern of the slope and their effect on the archaeological sites, particularly the burial sites in Kinnaur which are prone to landslides and glacial actions.

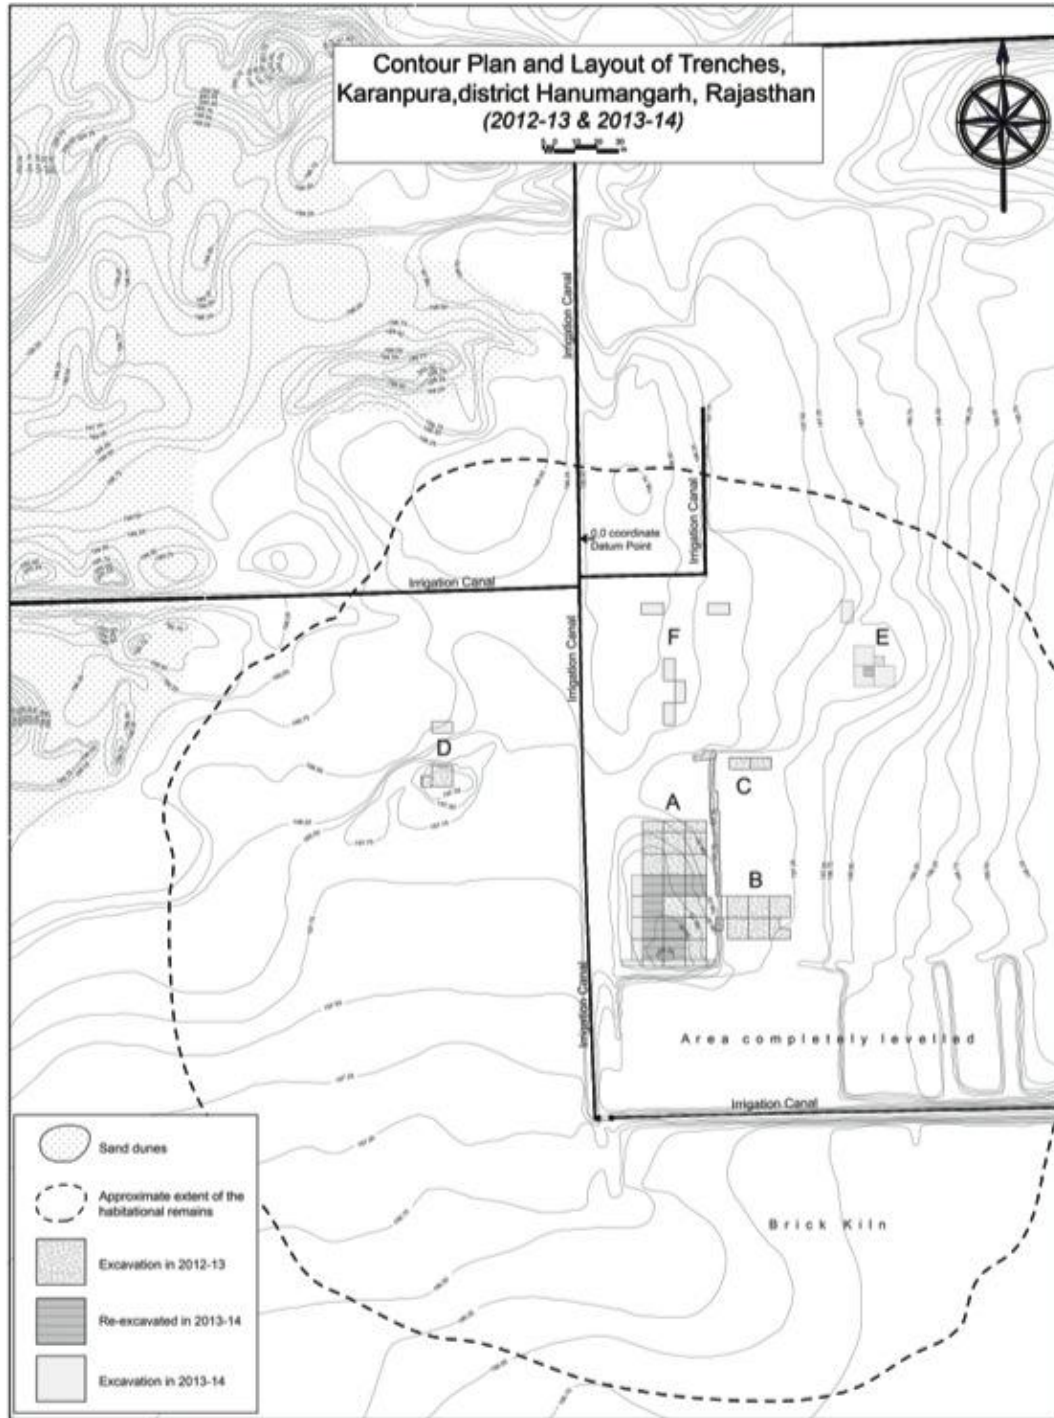
Fig. 10

Karanpura: Contour plan and layout of trenches.

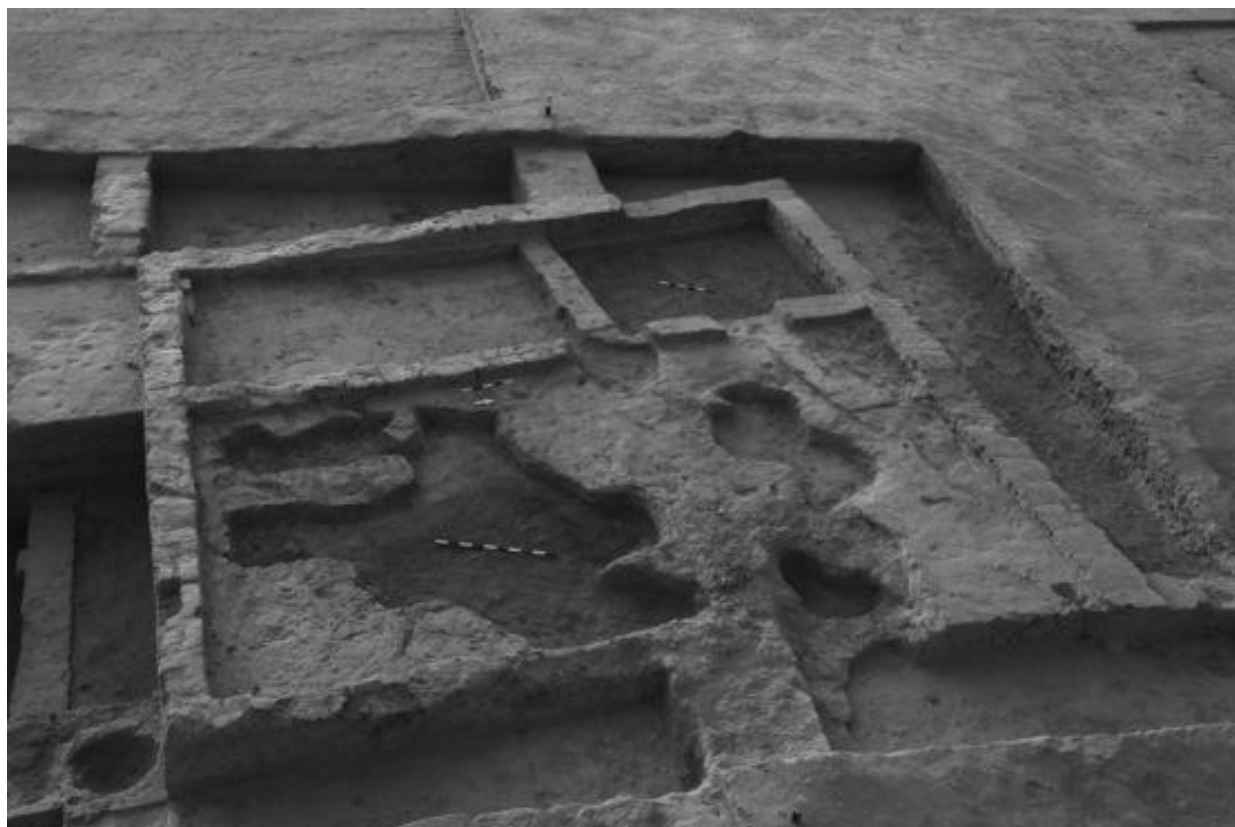
Plate 38

Karanpura: Complete house plan in trench.

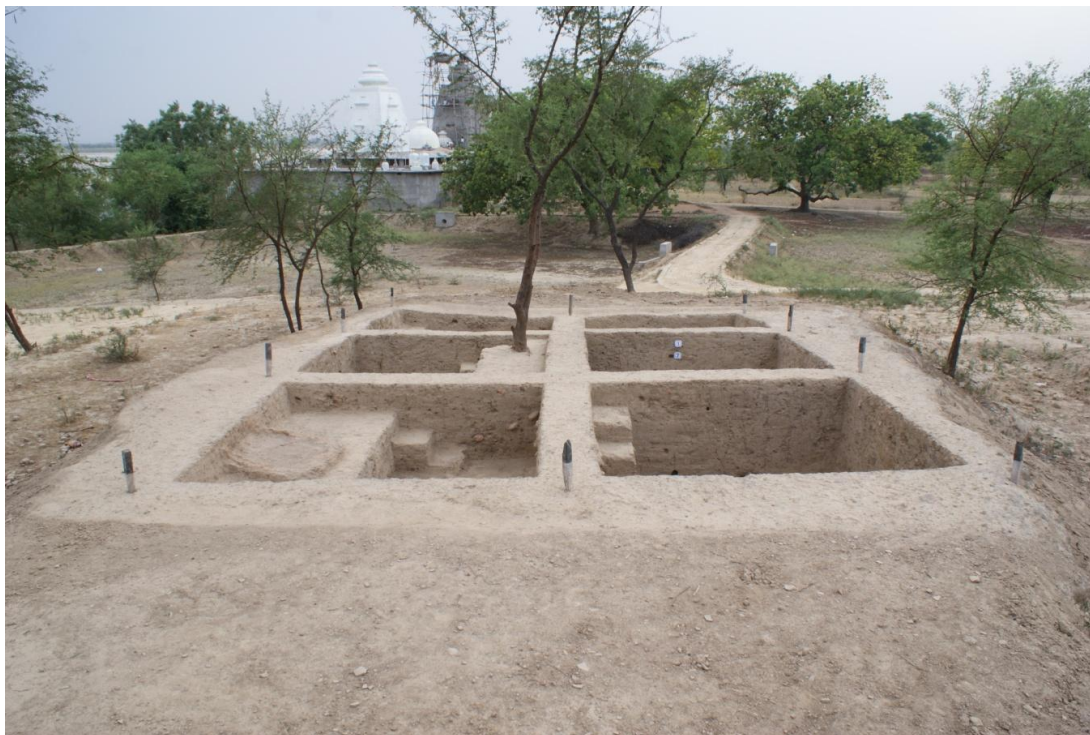
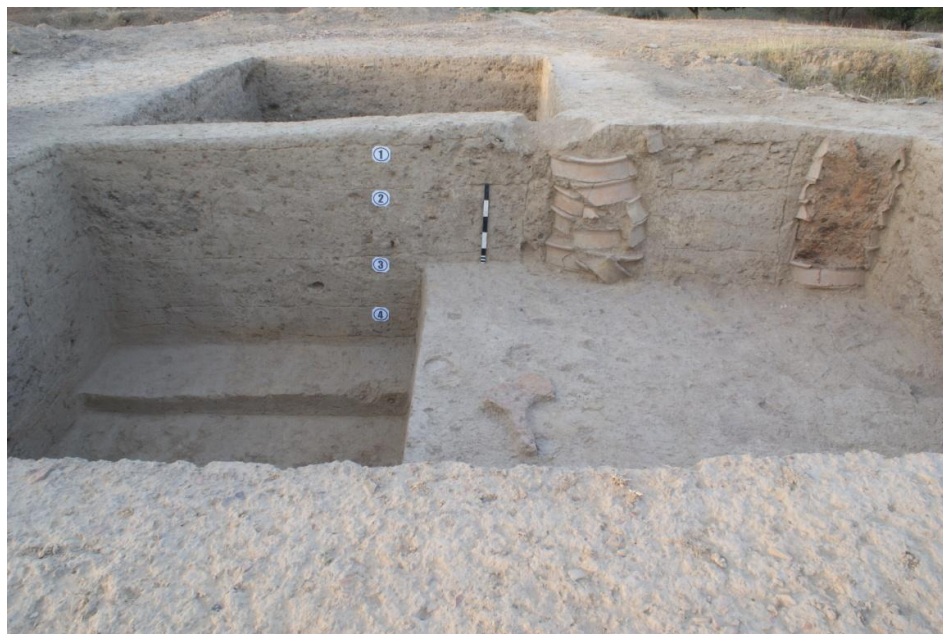
Dwarkapur: a; General View of the excavated trenches and b; Rammed floor made of burnt clay and potsherds of Period I.

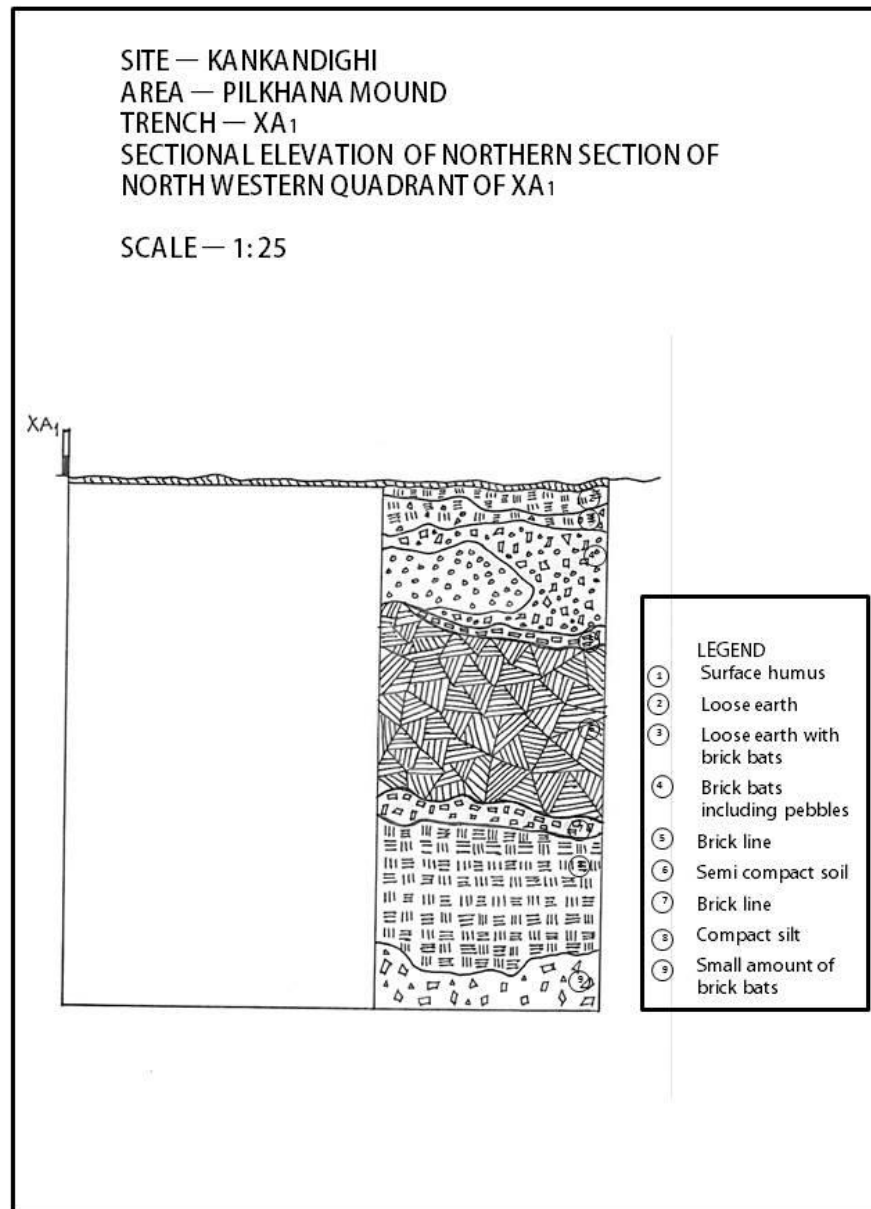
Fig. 24

Kankandighi: Stratigraphy of trench XA₁ of Pilkhana mound.

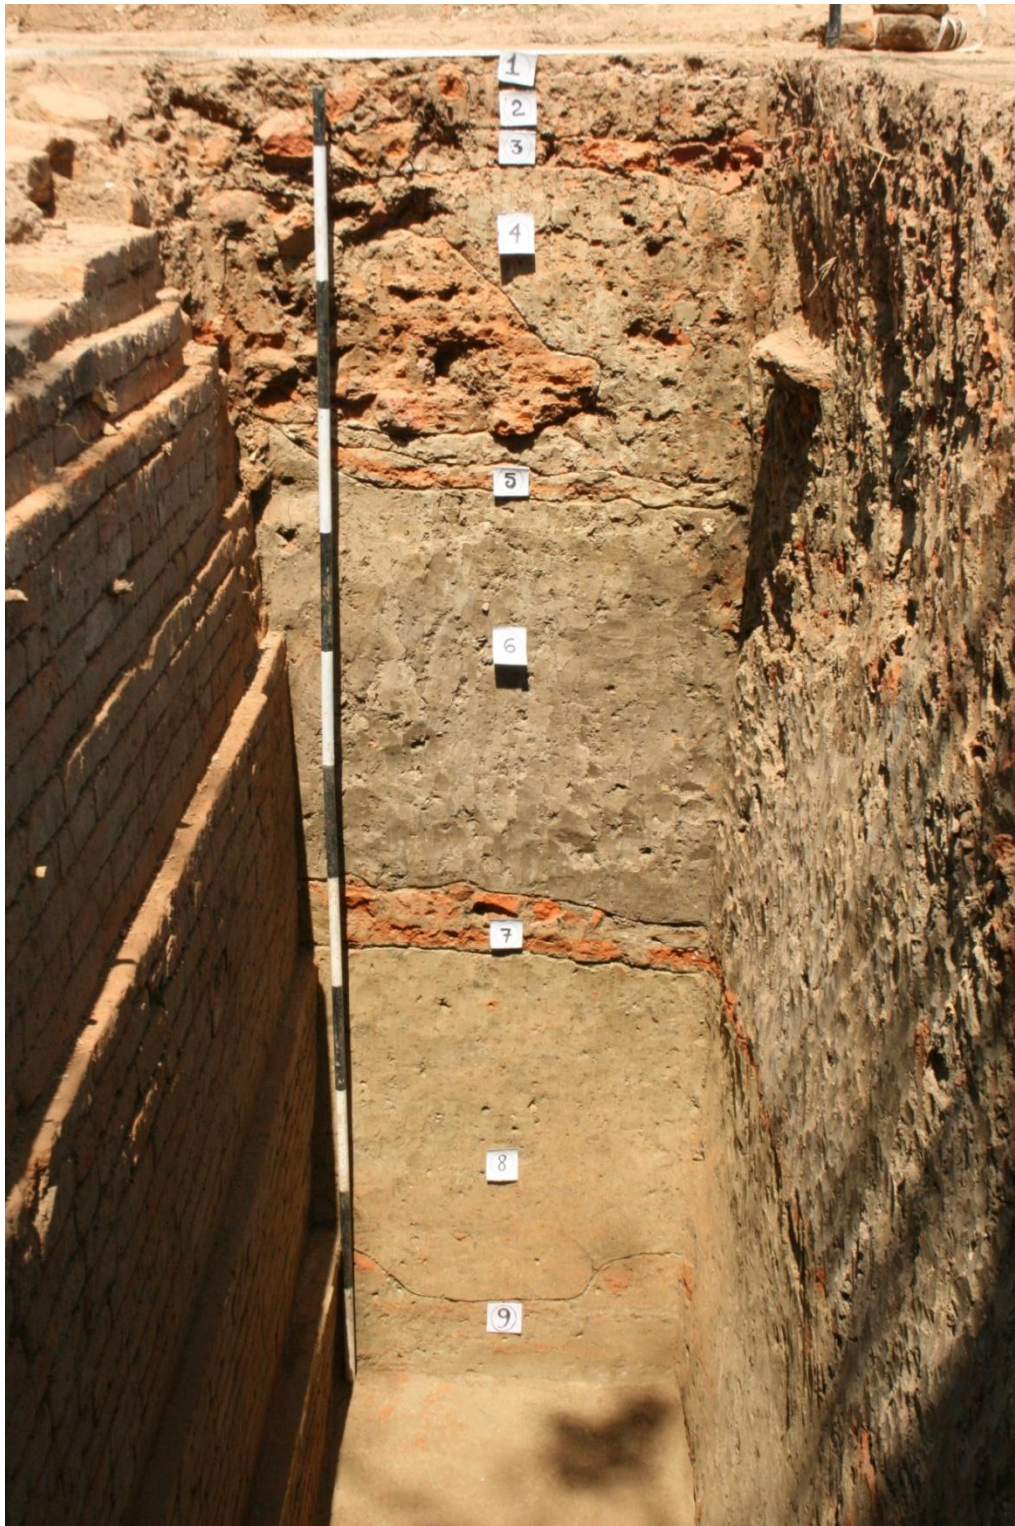
Kankandighi: Stratigraphy of index trench XA₁ of Pilkhana mound.

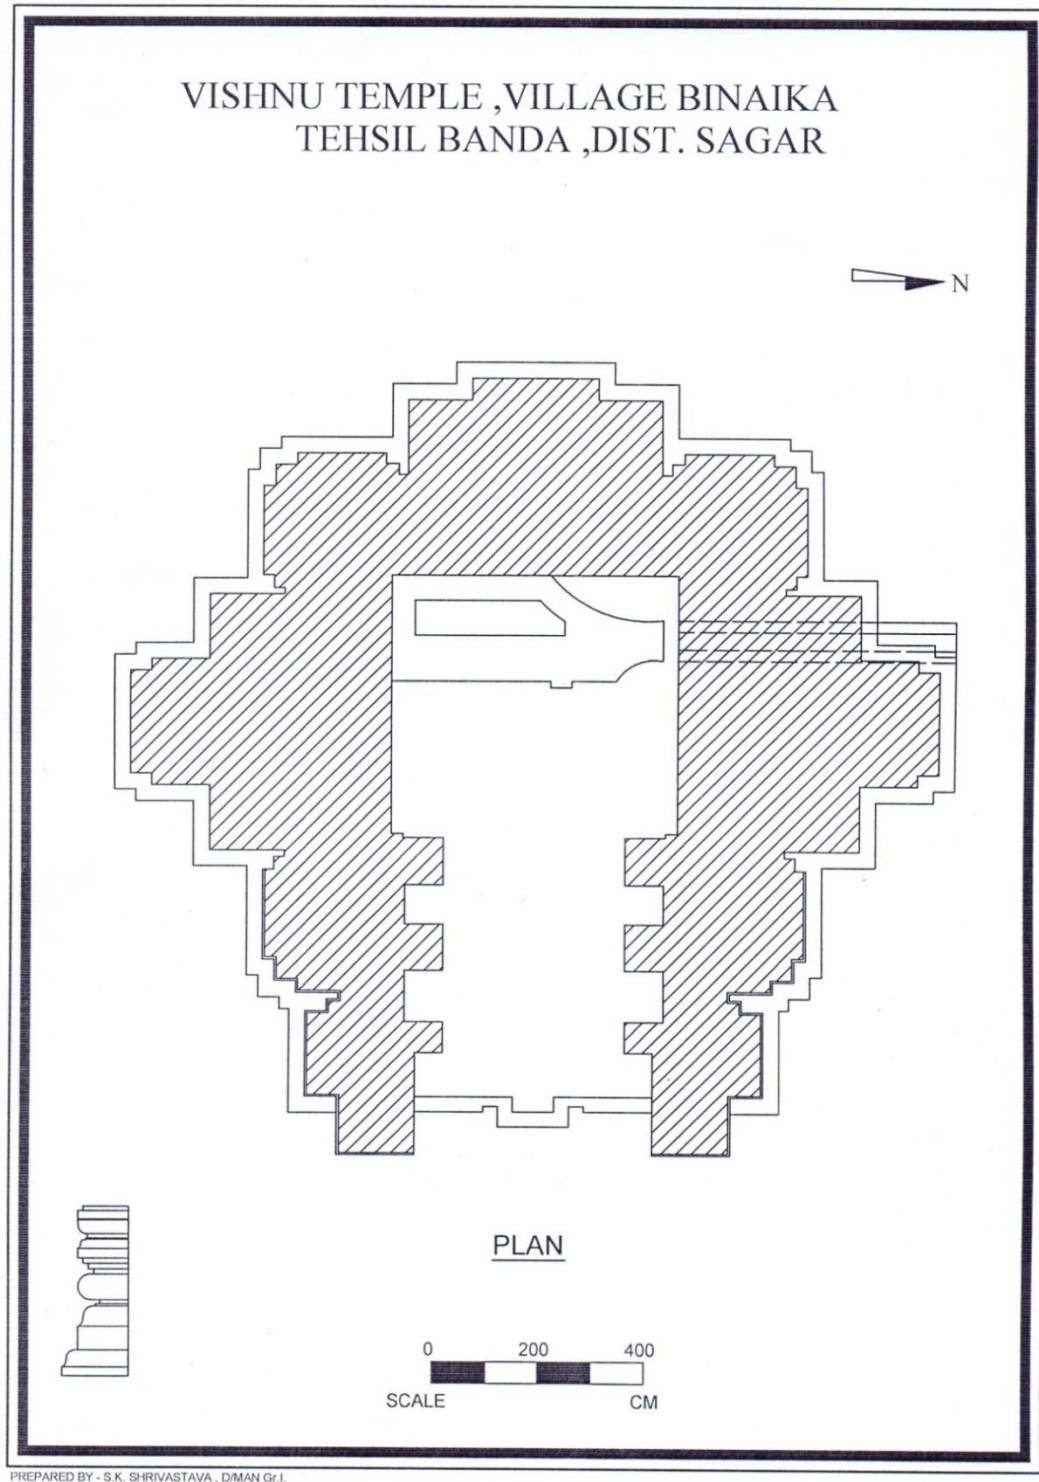
Fig. 25

Binaika: Plan of temple.

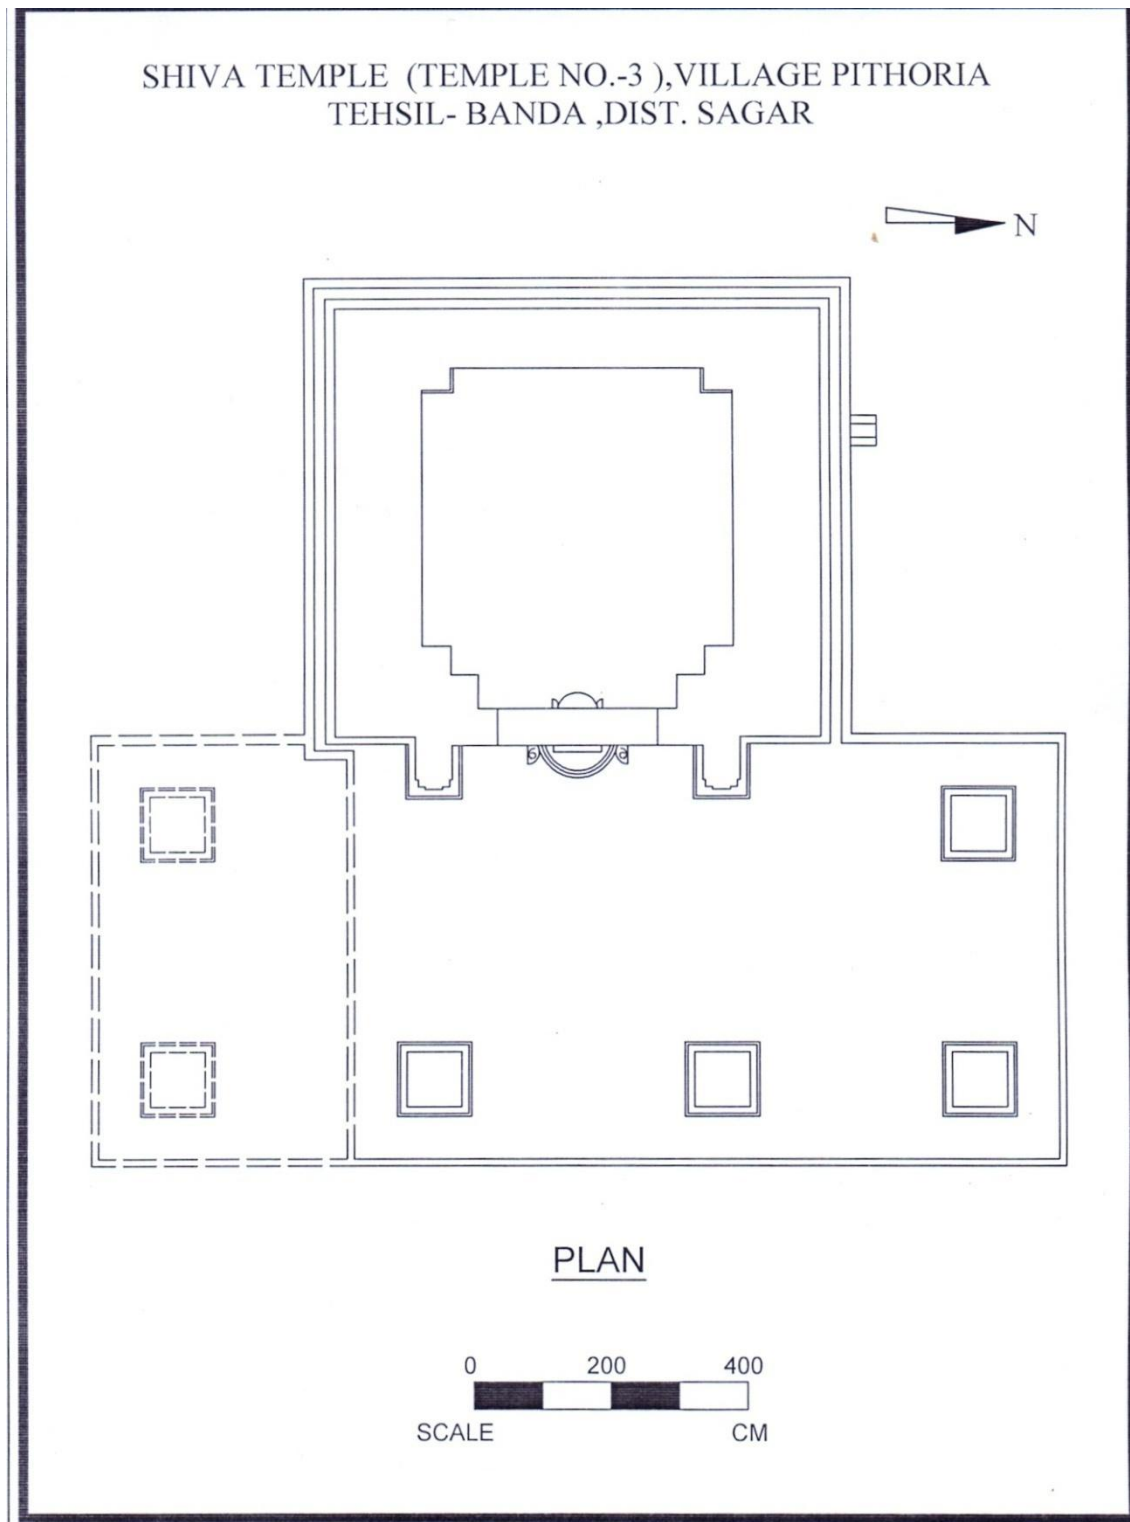
Fig. 26

Pithoria: Plan of temple No. 3.

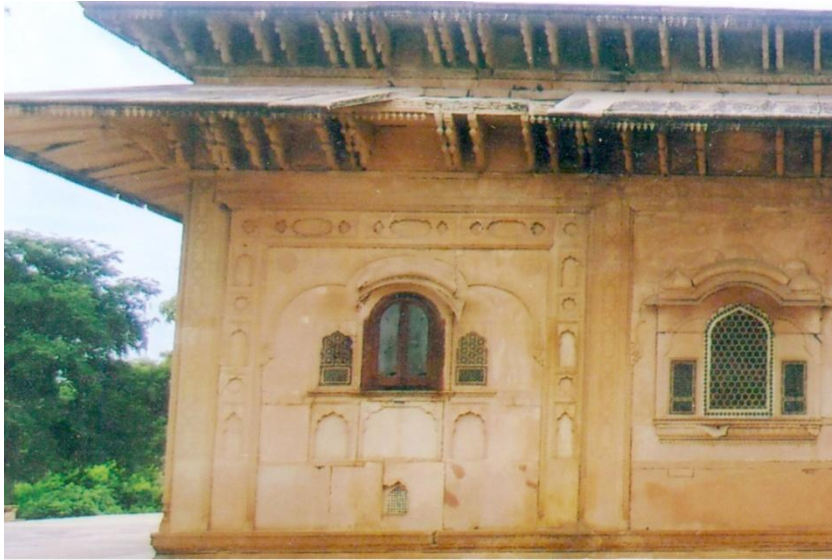
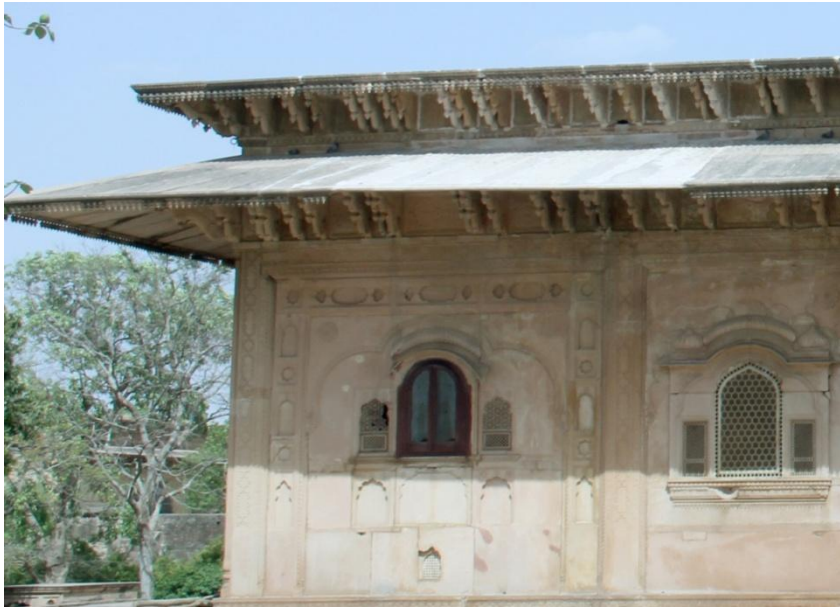
Plate 140

Deeg: a; before and b; during conservation of broken chajja, Nand Bhawan.

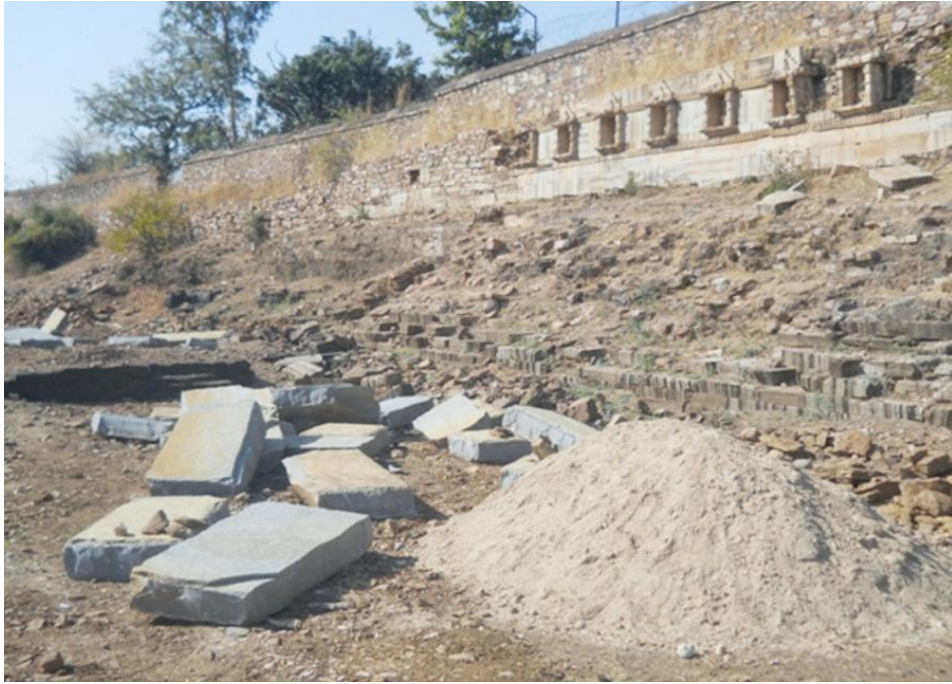
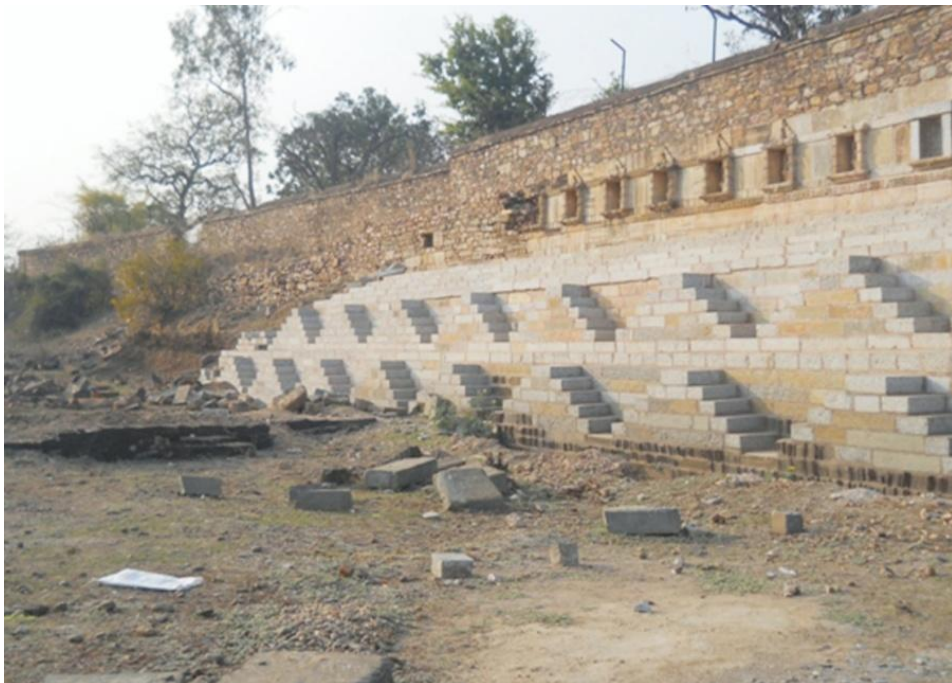
Chittaur: a; before and b; after conservation of dilapidated/missing ghats of Sukhadia tank, Fort of Chittaur.
