Indian Archaeology

1989-90—A REVIEW

INDIAN ARCHAEOLOGY 1989-90 - A REVIEW

EDITED BY **S. K.
MAHAPATRA**
*Secretary
Department of Culture
&
Director General
Archaeological Survey of India*

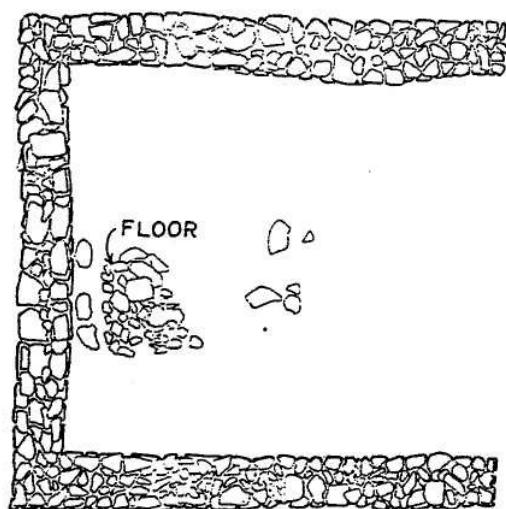
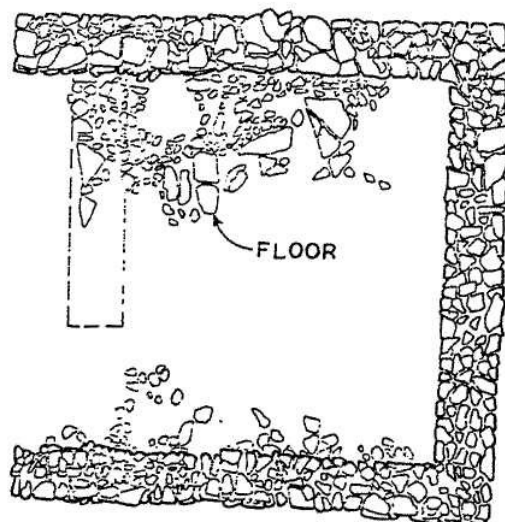
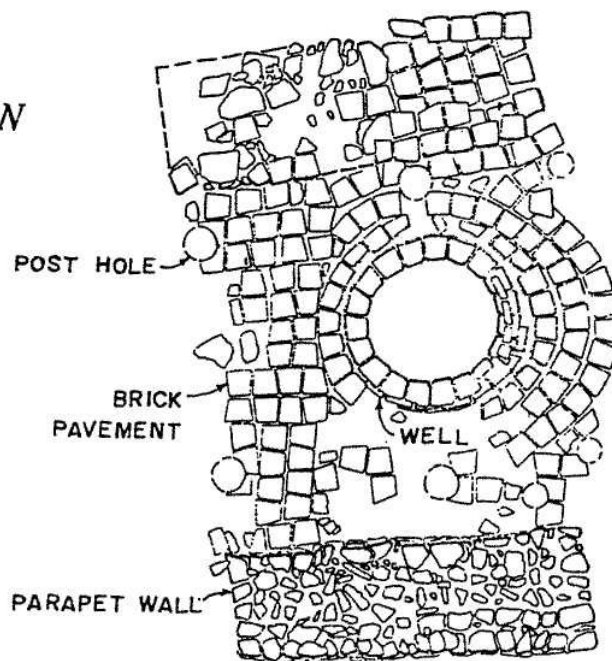
FIG. 5

PLAN

ADAM-89-90
NAGPUR DISTRICT
STRUCTURES OF PERIOD-V

SCALE 40 0 40 80 120 160 200 CM

Structures of the period were devised either of burnt brick or stone with *murrum* lining at the base. Of the two structural phases, phase I is represented by a two coursed shale stone wall in mud mortar; the base of it had *murrum* lining. The exposed portion of the single coursed wall was semi-circular on plan while its thickness was 25 cm. The inner portion had mud floor. Of the phase 2 a

well of burnt brick (dia. 1.10 m) having fifty-four courses was noticed cut into the natural soil (pl. XVII A). Another brick wall of eighteen courses was exposed which was aligned to a lane. The either ends of the wall seem to have been robbed; however, the wall appears to have been used as retaining wall in the succeeding period in which an outlet for a private drain was envisaged (pl. XVII B).

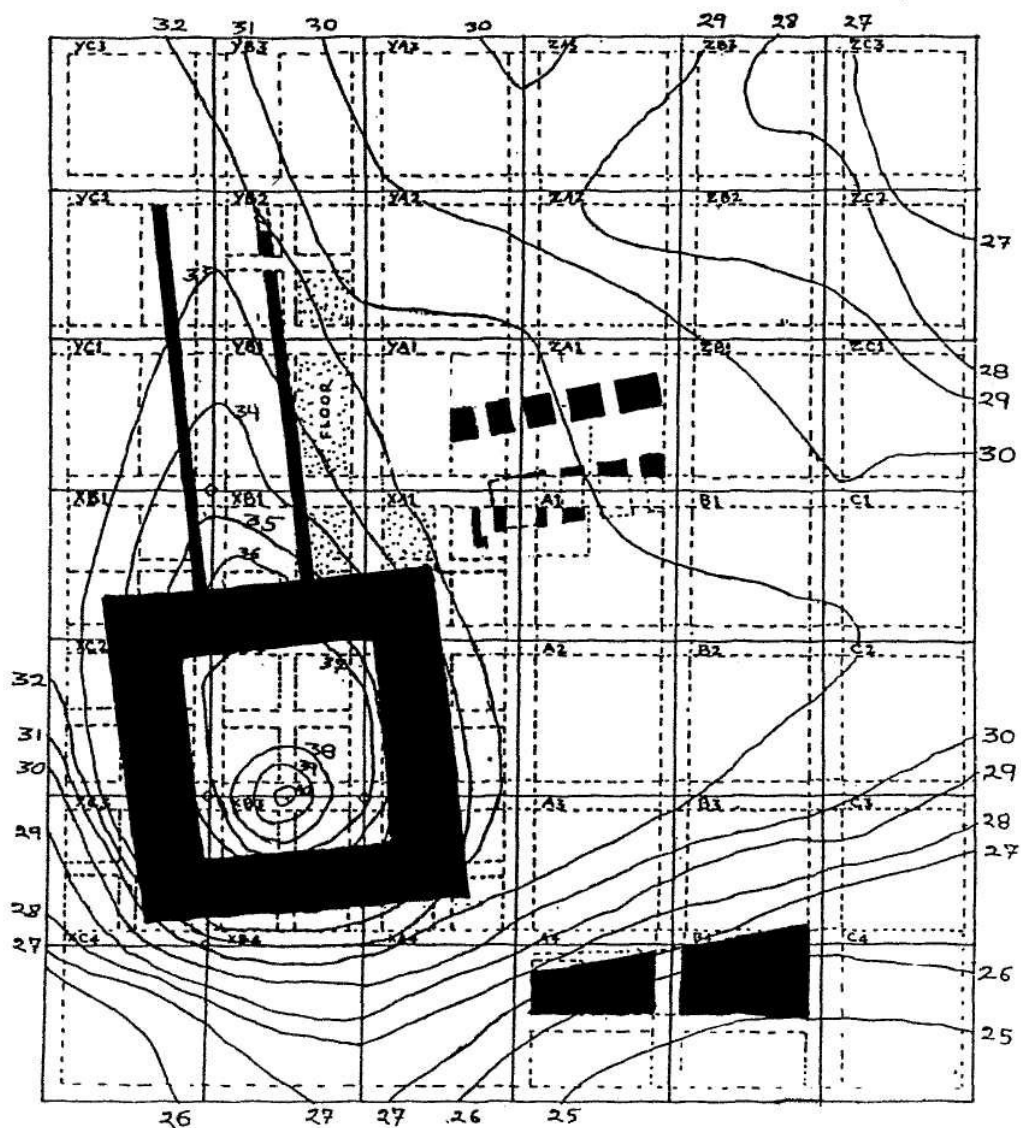
FIG. 6

BARABATI FORT, CUTTACK, ORISSA
PLAN OF EXCAVATED REMAINS
SCALE: 1 Cm = 4 Mts

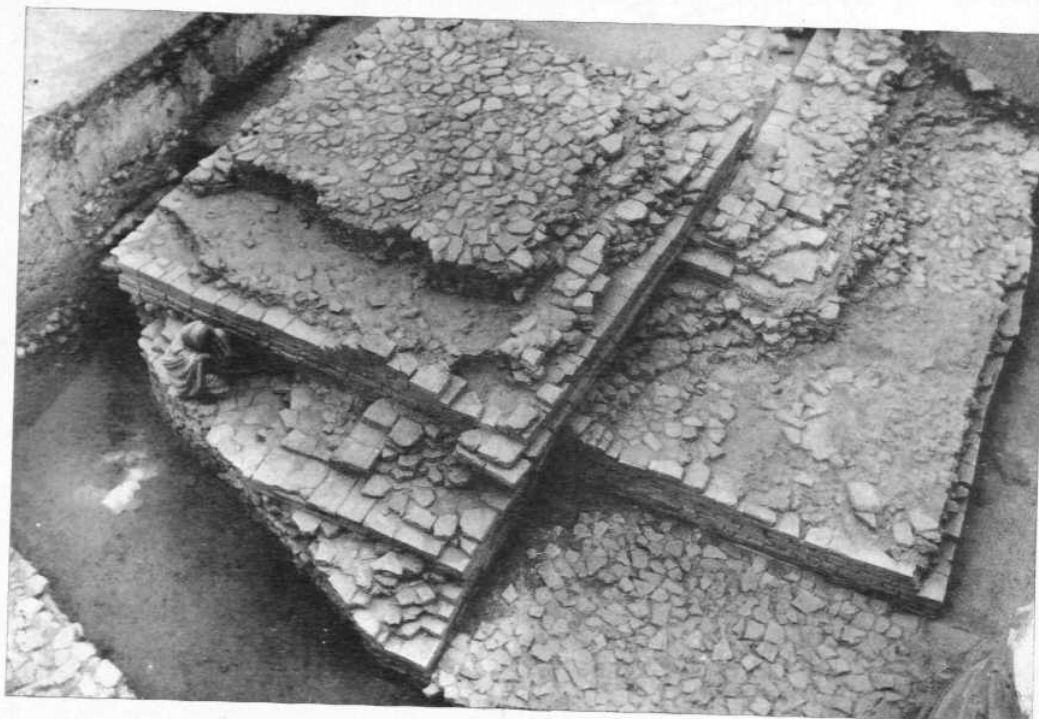
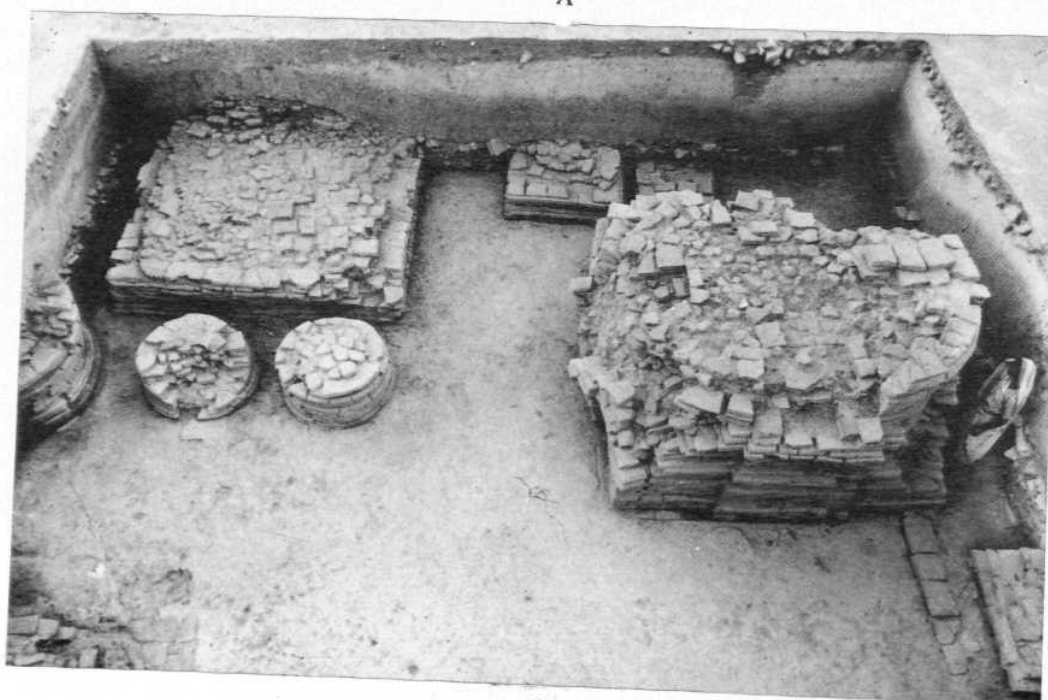
Kolhua : exposed structures. See p. 12

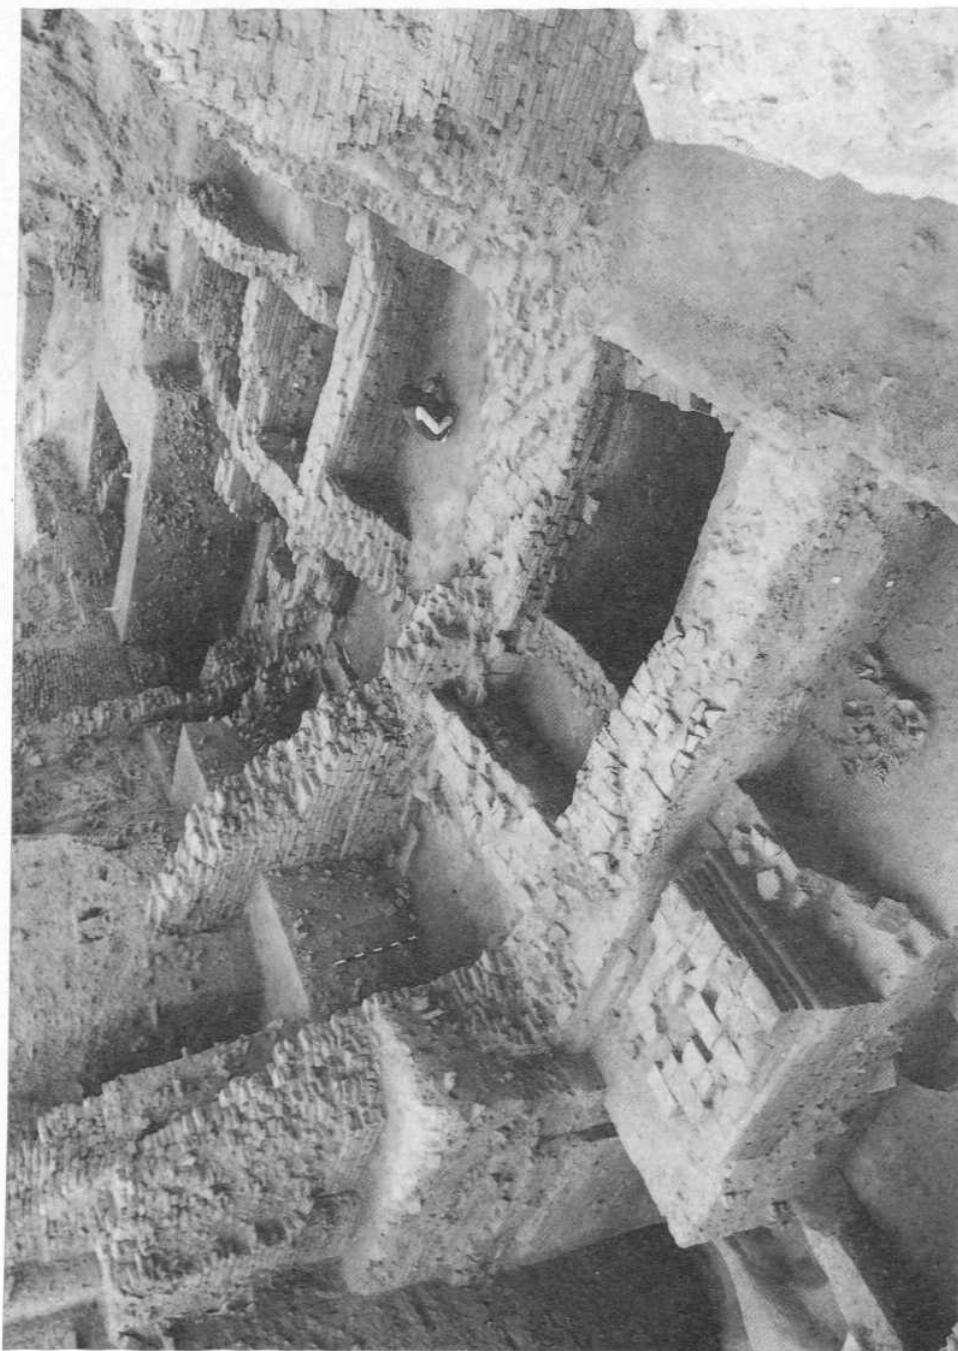
Harsh-ka-Tila (Thanesar) : view of excavated structures of different periods in the rain gully. See p. 28

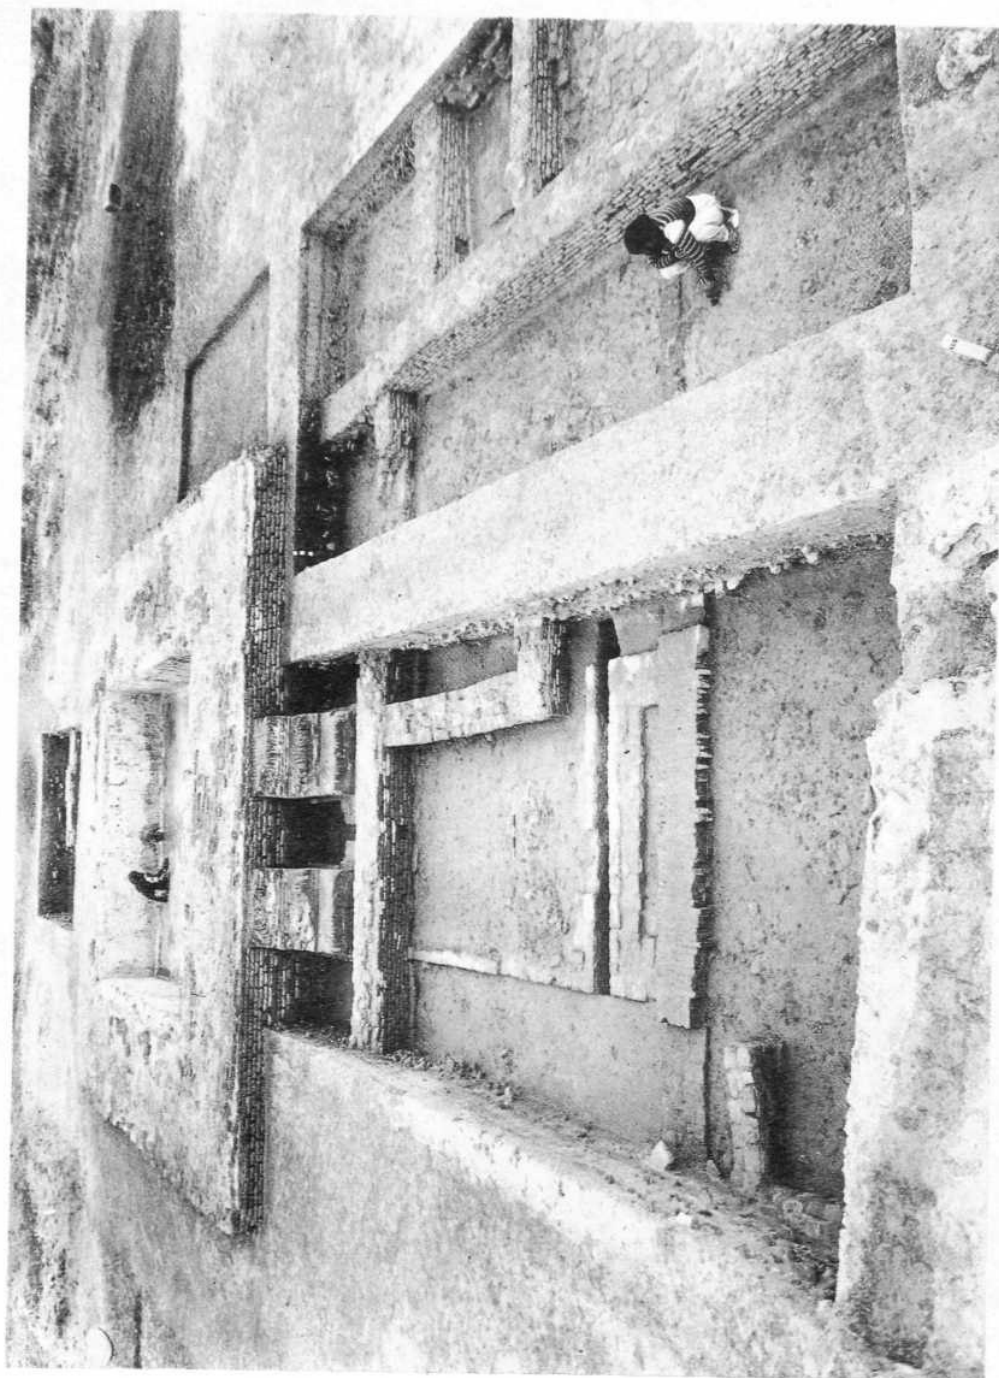
Harsh-ka-Tila (Thanesar): garden-complex, Mughal period. See p. 31

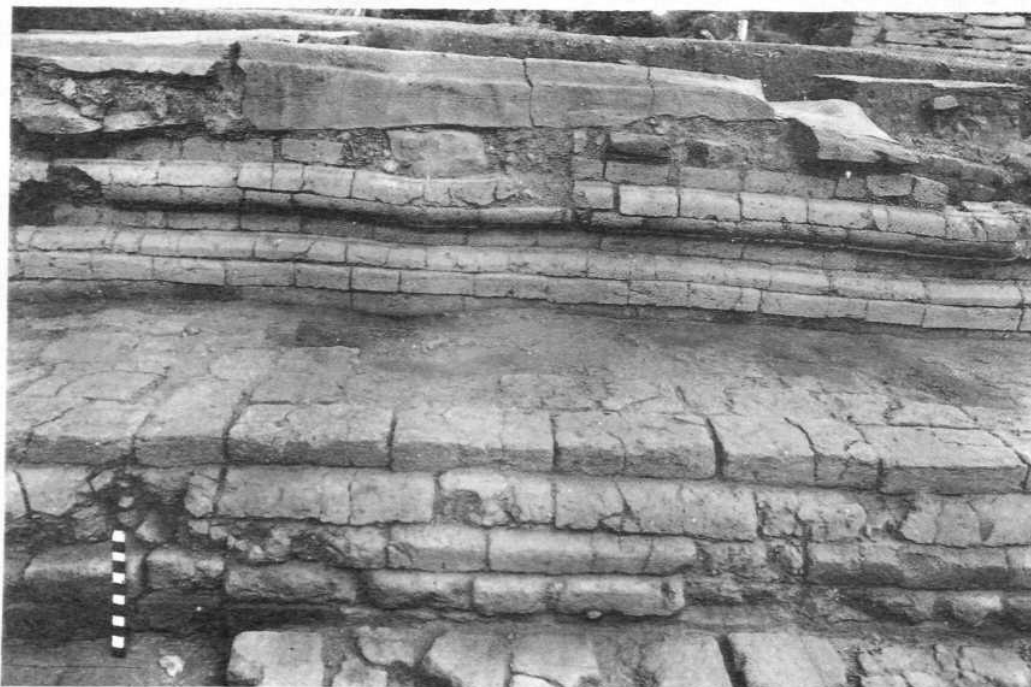
Gudnapur : exposed structures. See p. 43

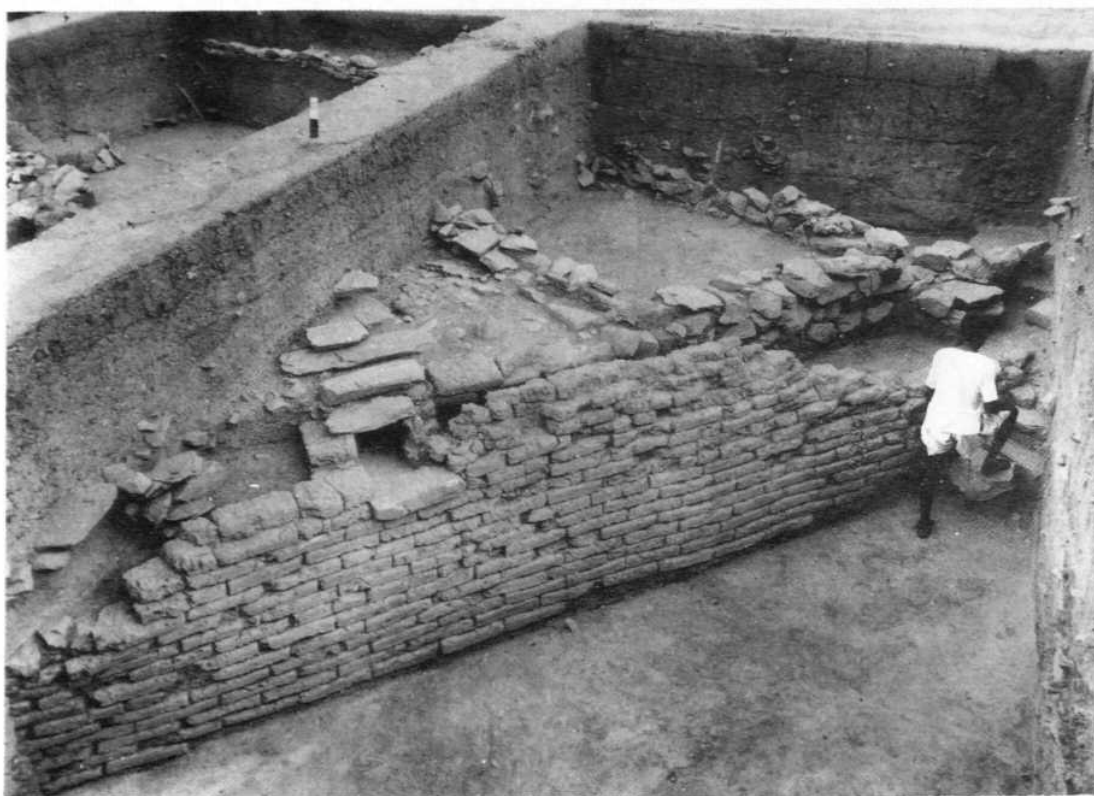
Adam : A, trenches inside the rampart and B, exposed structures, Period IV. See pp. 61 and 64

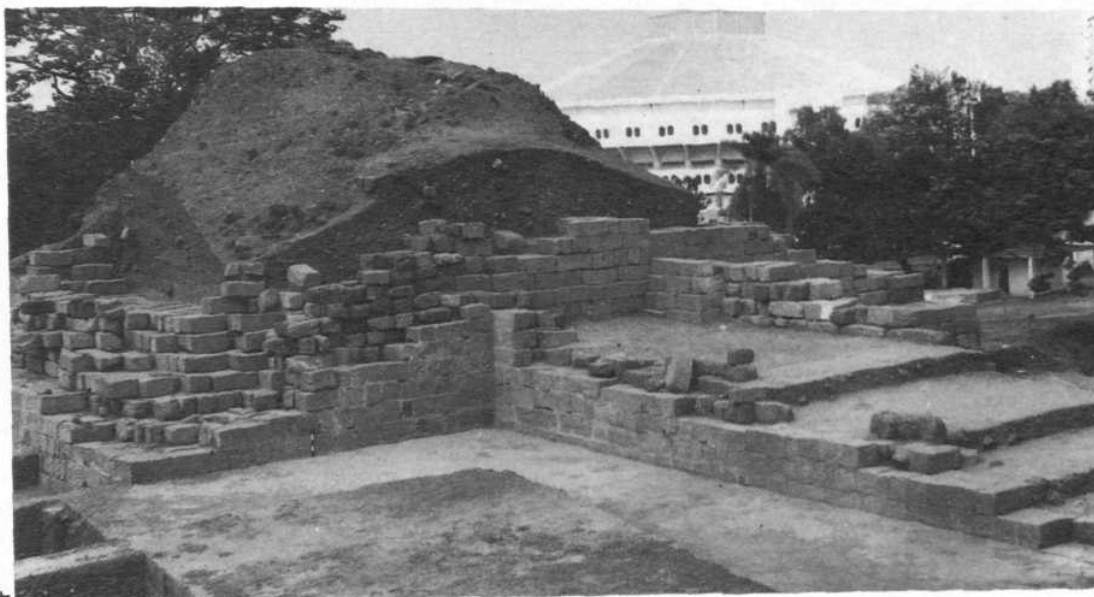
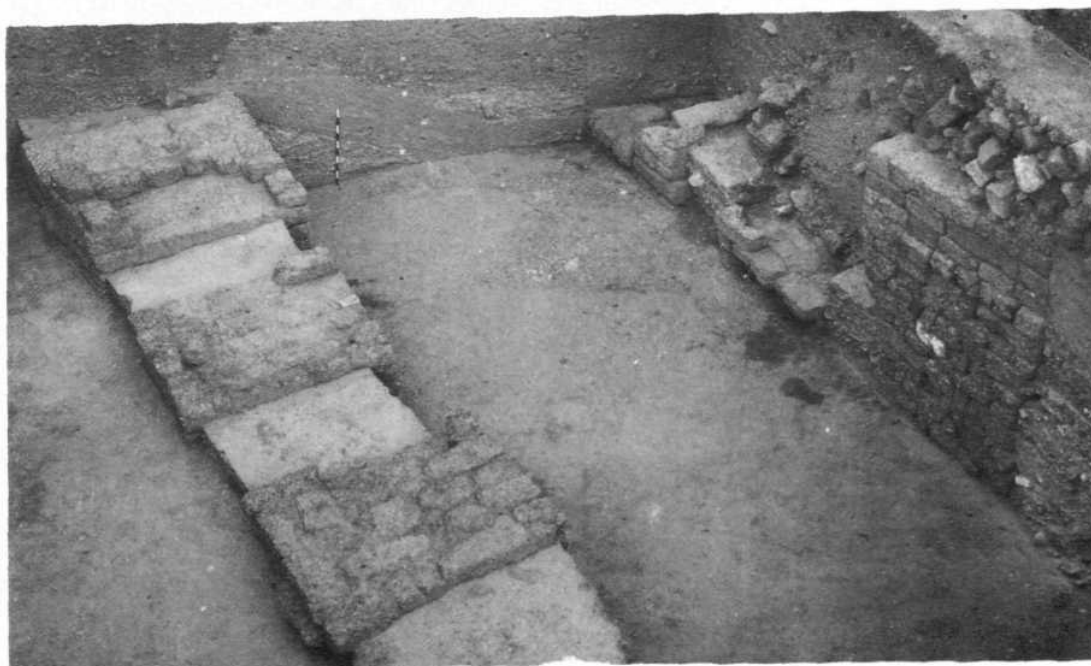
*Barabati fort, Cuttack : A, view of structure, approach ramp and lime concrete flooring;
B, view showing rows of pillars of laterite blocks. See p. 76*

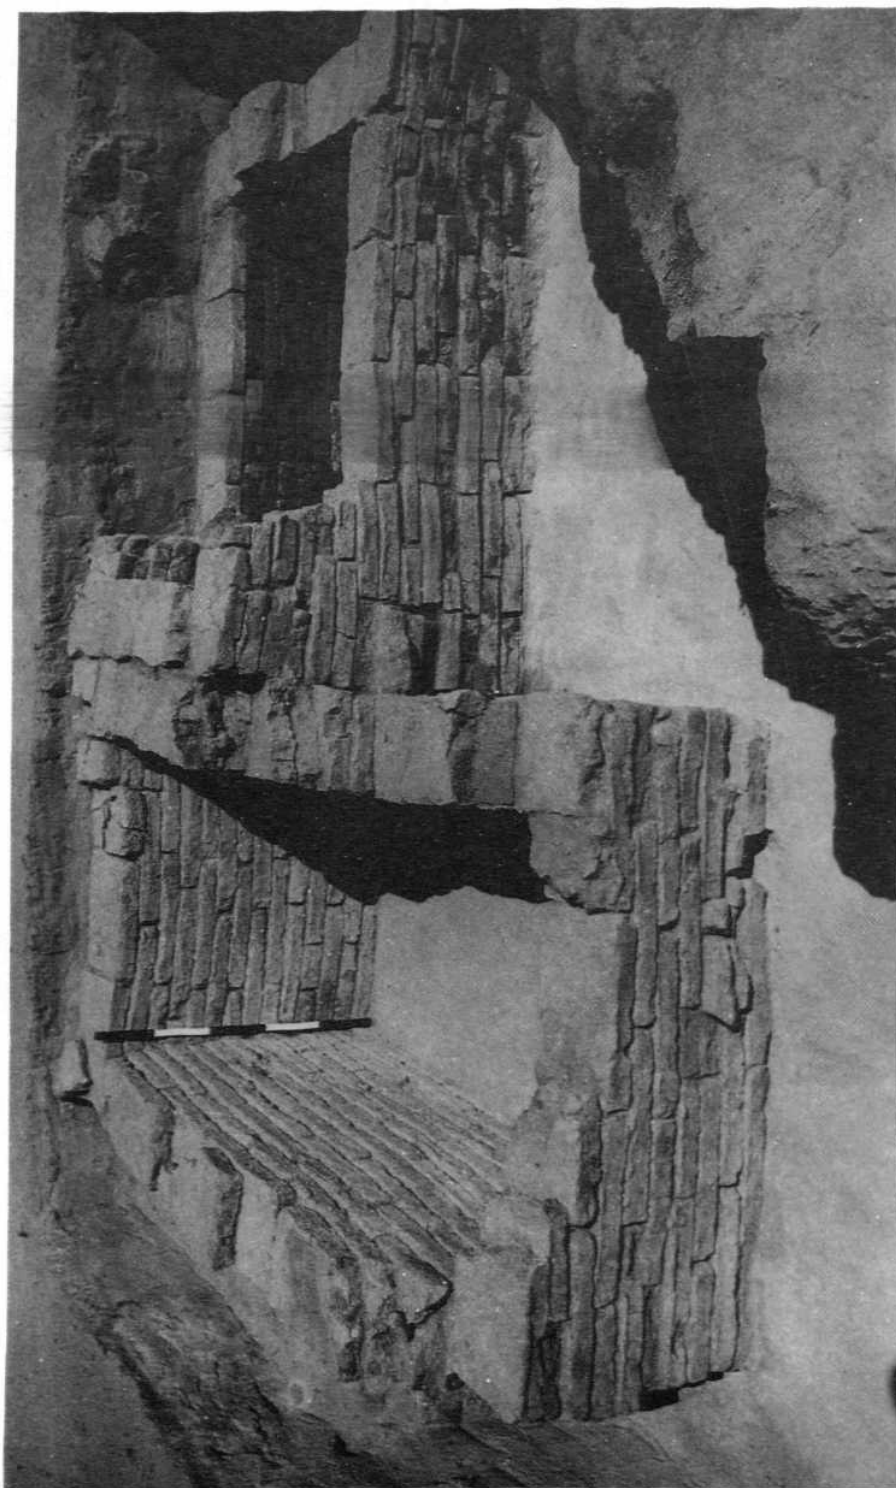
Arikamedu : exposed structures. See p. 86

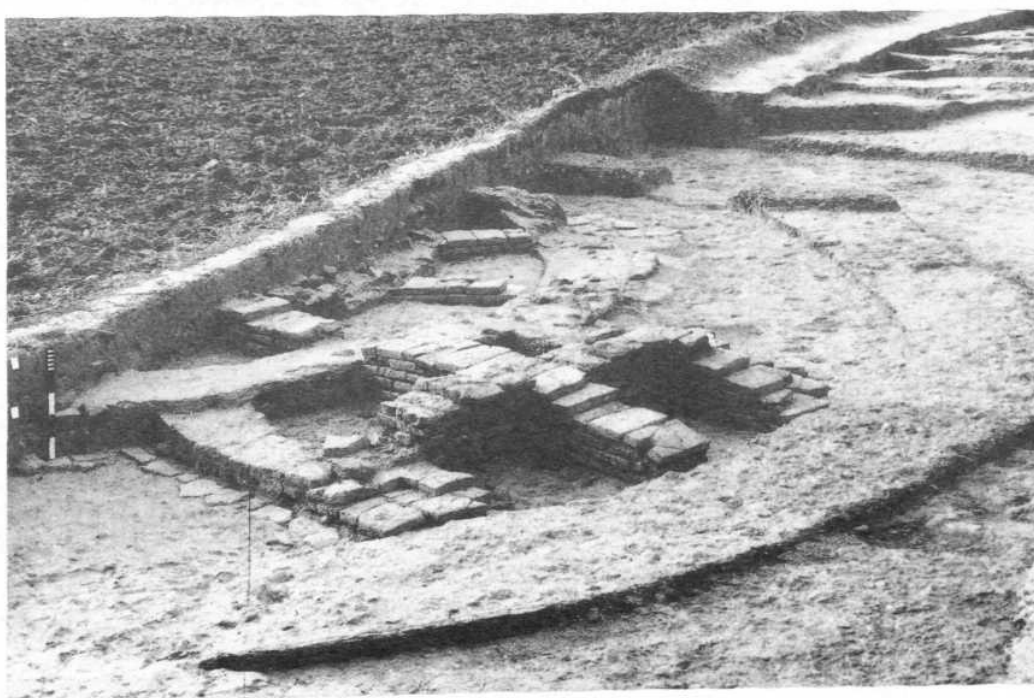
*Sanghol: A, platform with corner portholes for raising cover or canopy, palace complex;
B, part of the excavated stupa. See pp. 90-91*

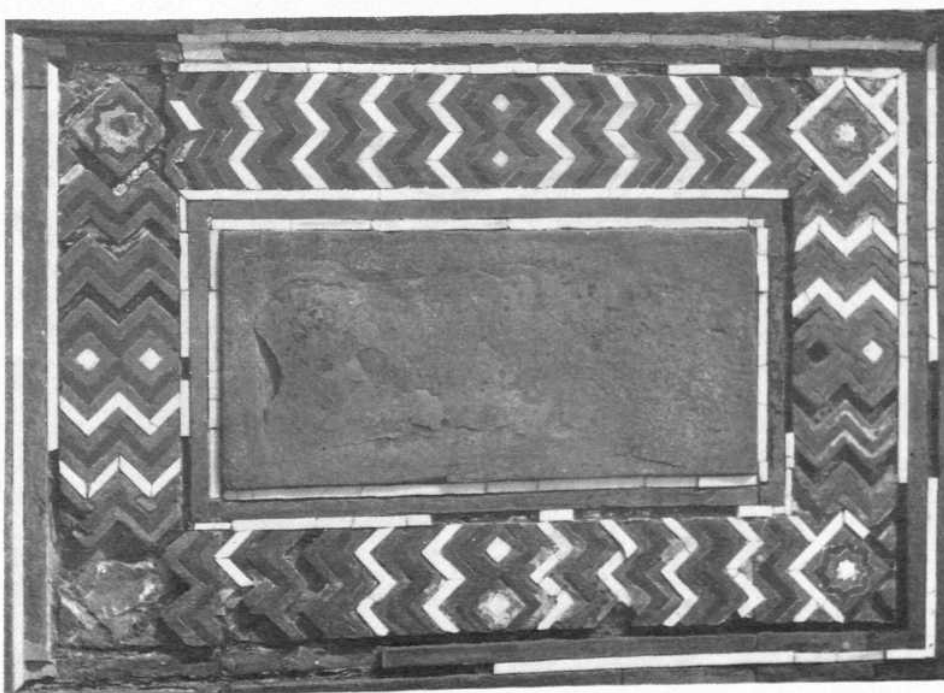
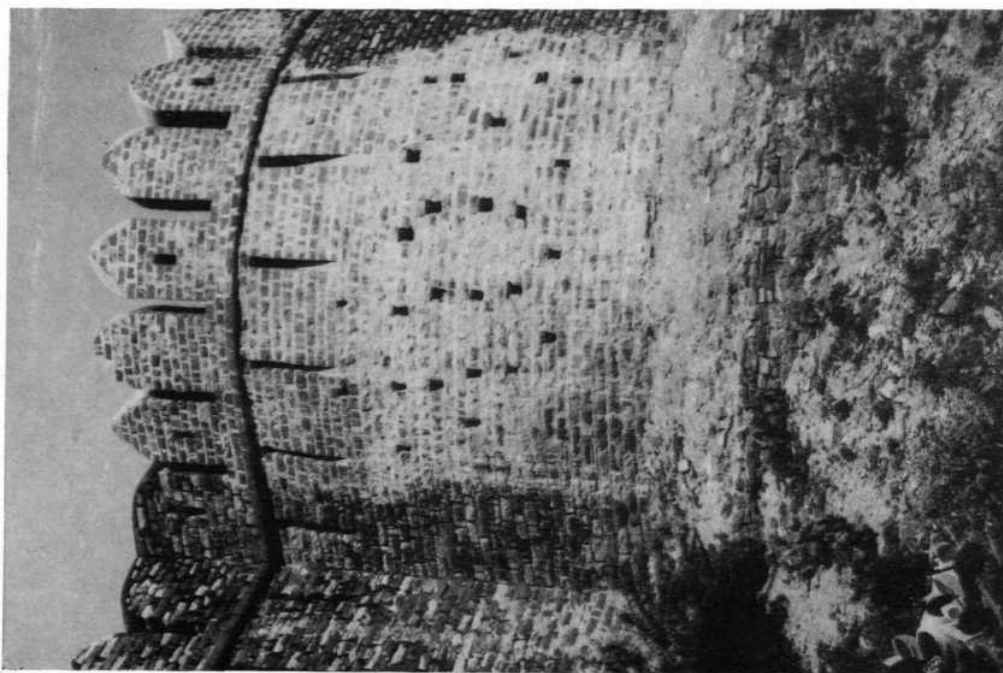
Agra: Taj Mahal, A, before and B, after restoration of missing inlay pieces of main gate. See p. 156

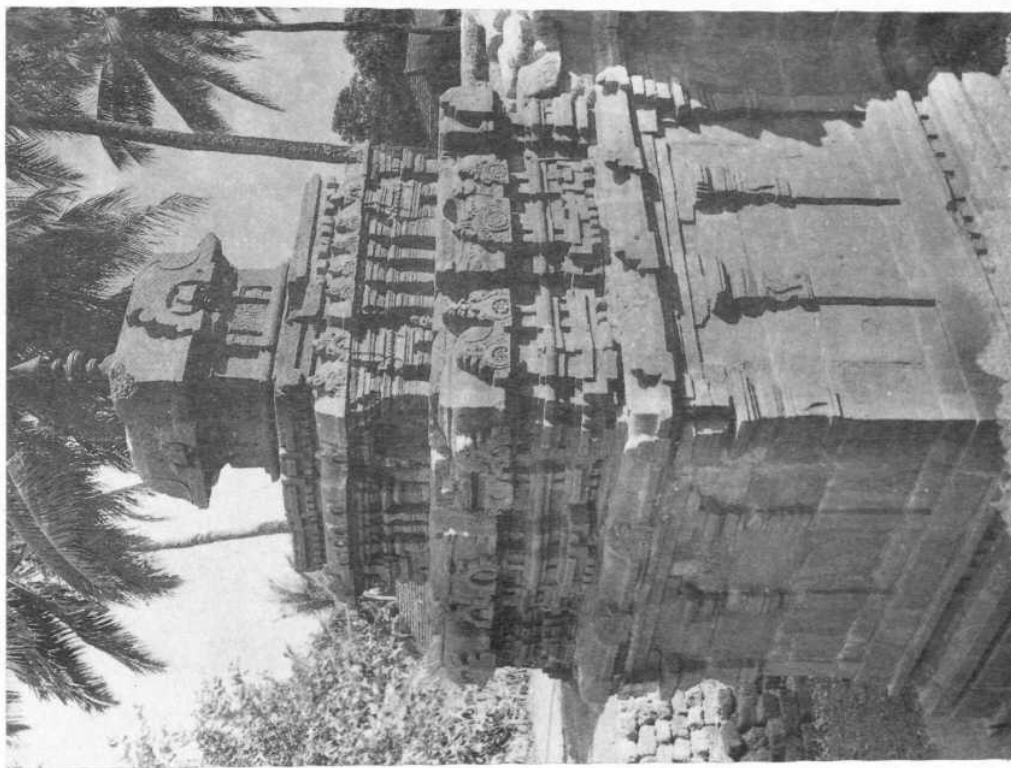
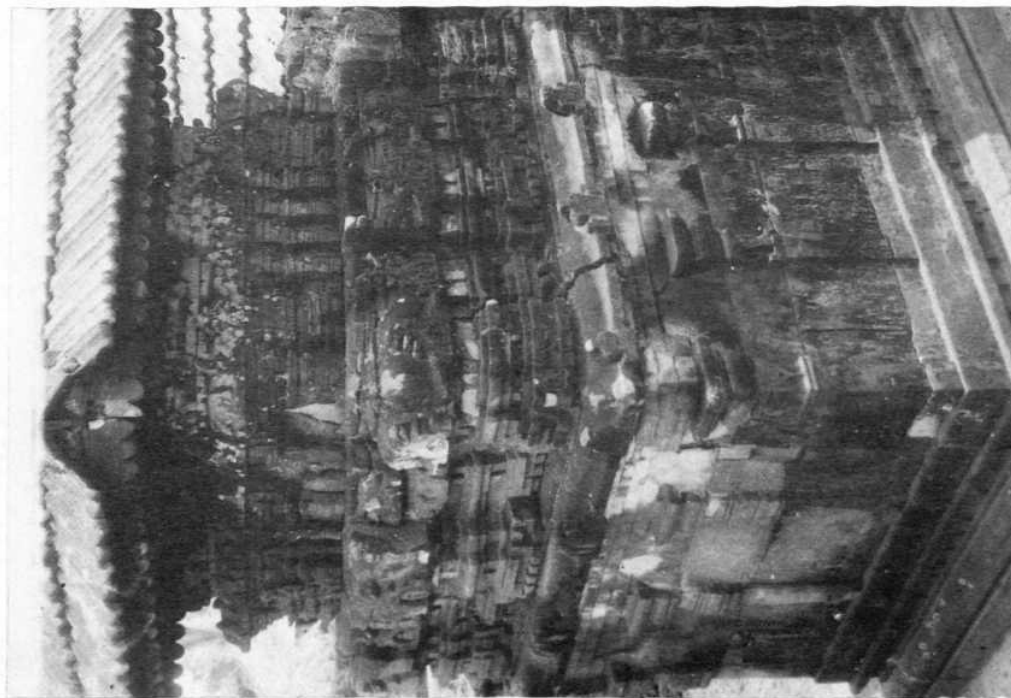
Humcha: Parsvanatha basti, A, before and B, after conservation of the sikhara. See p. 161

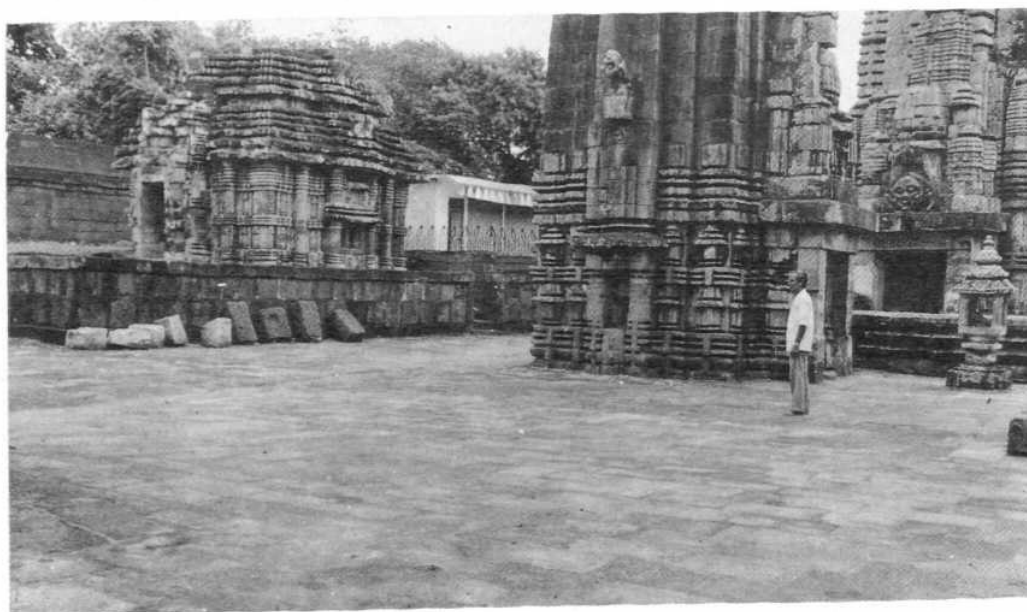
Bhubaneswar : Lingaraja temple, A, before and B, after repairs of the courtyard. See p. 167

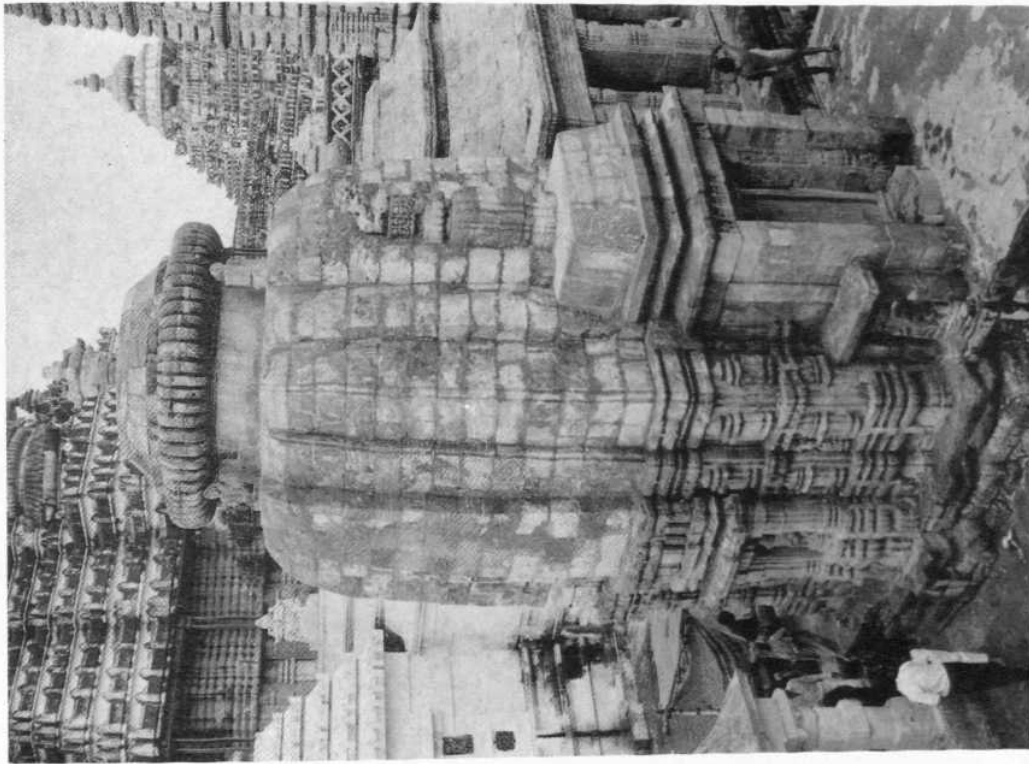
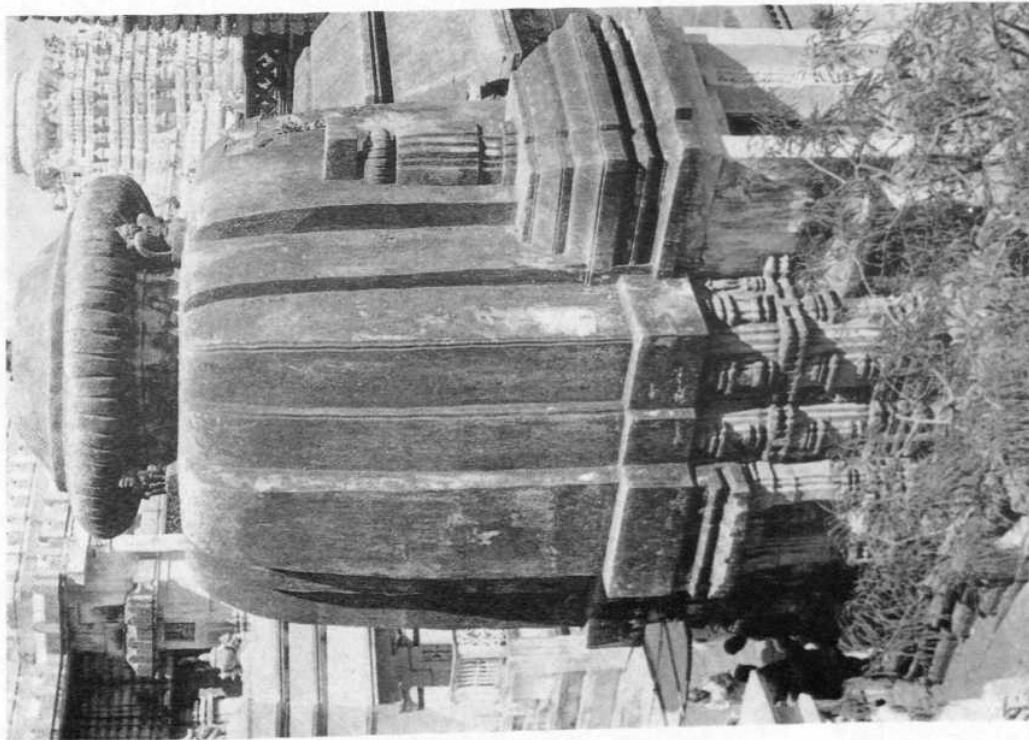
Puri : Jagannatha temple, A, before and B, after deplastering of Ganesa temple. See p. 167

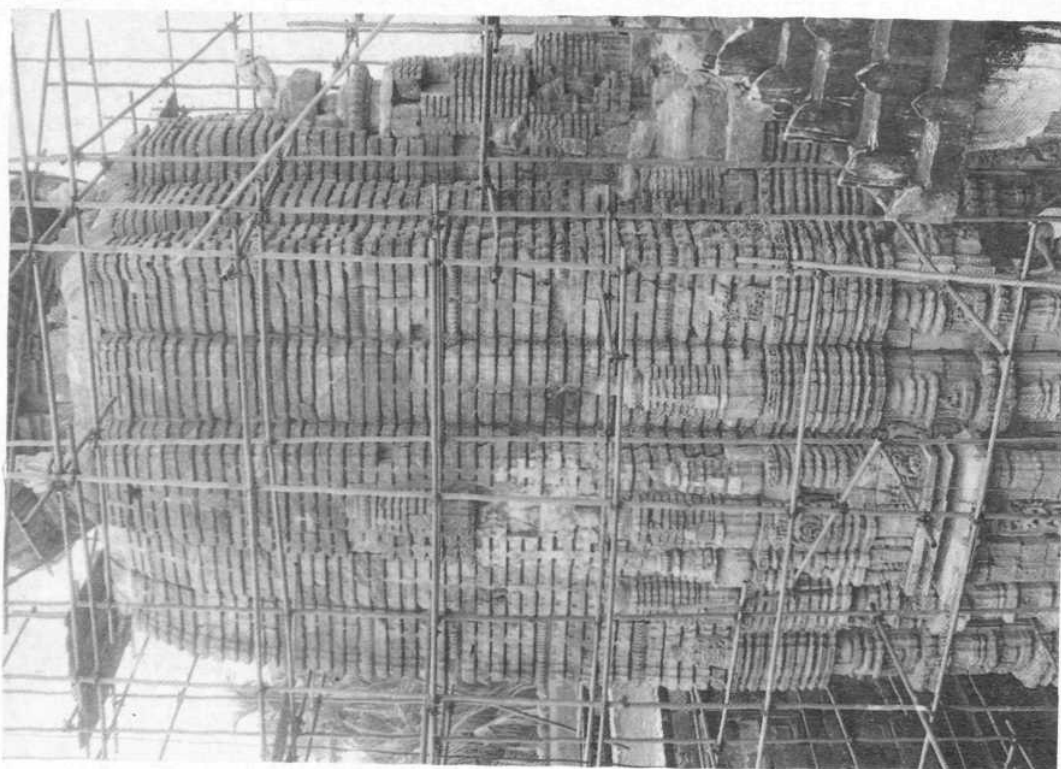
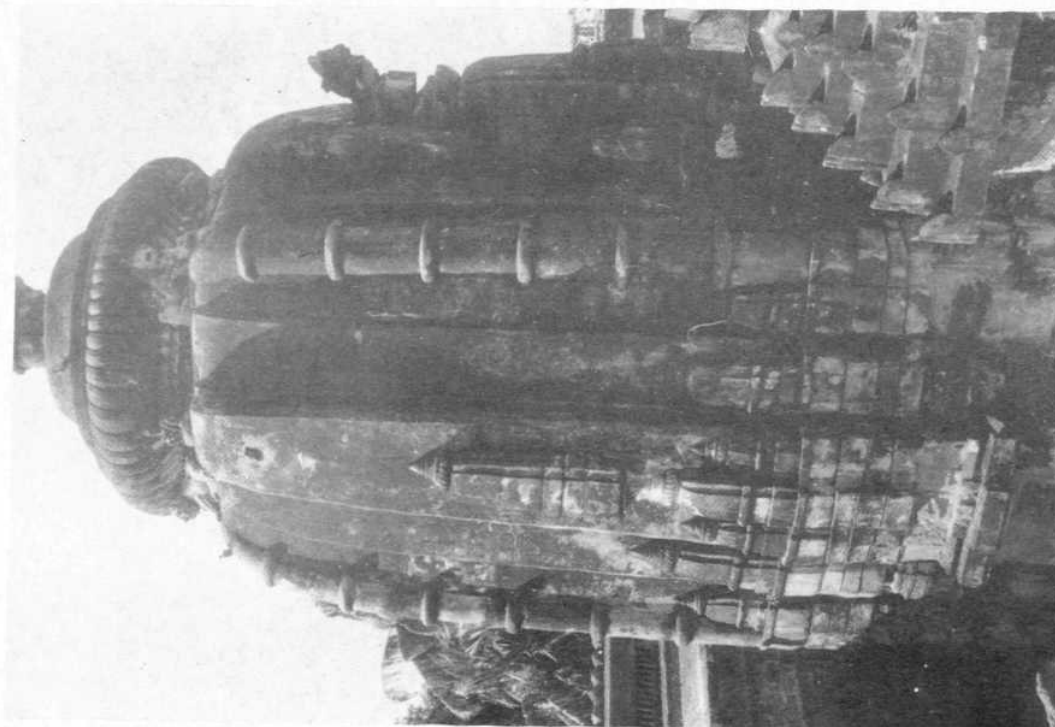
Puri : Jagannatha temple complex, A, before and B, after deplastering of Vimala temple. See p. 167

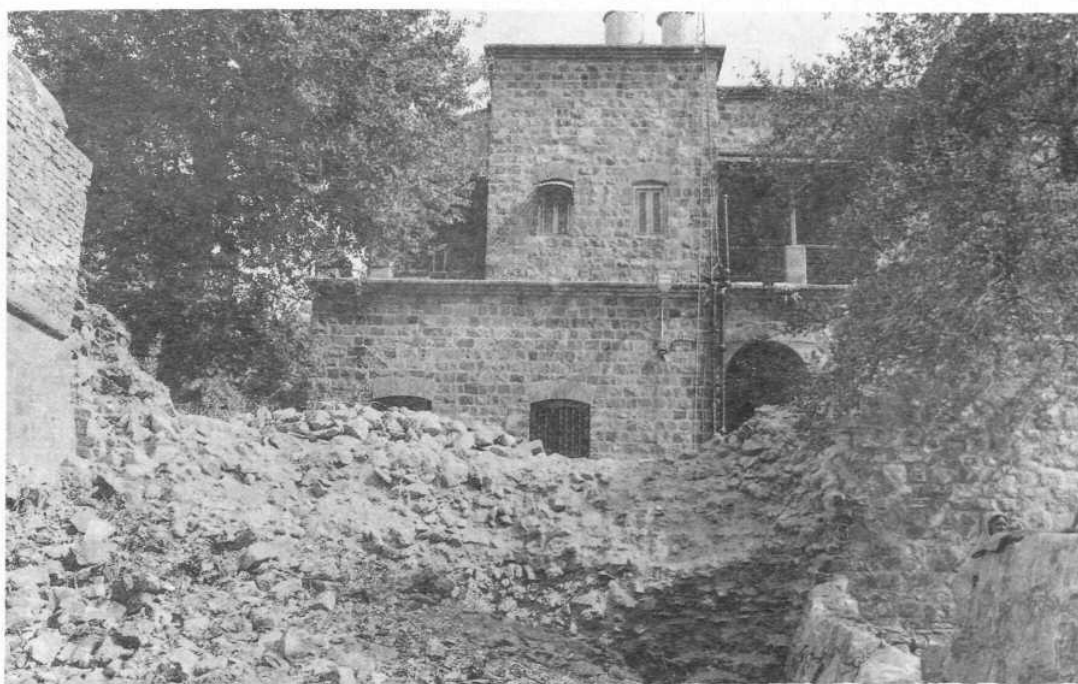
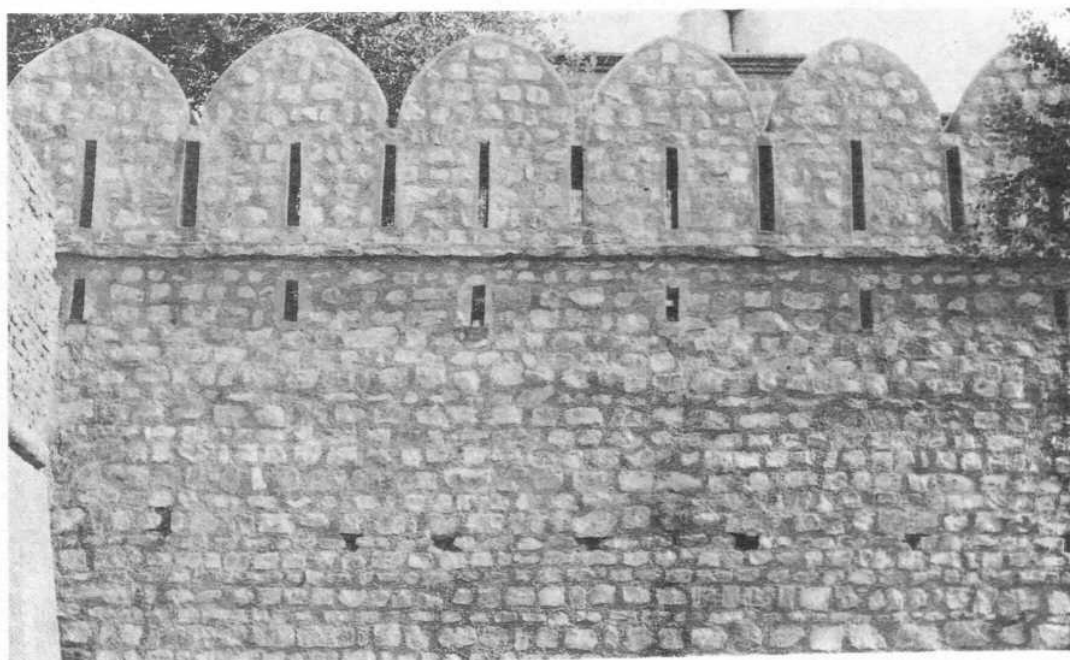
Delhi : Kashmiri Gate, A, before and B, after conservation. See p. 170

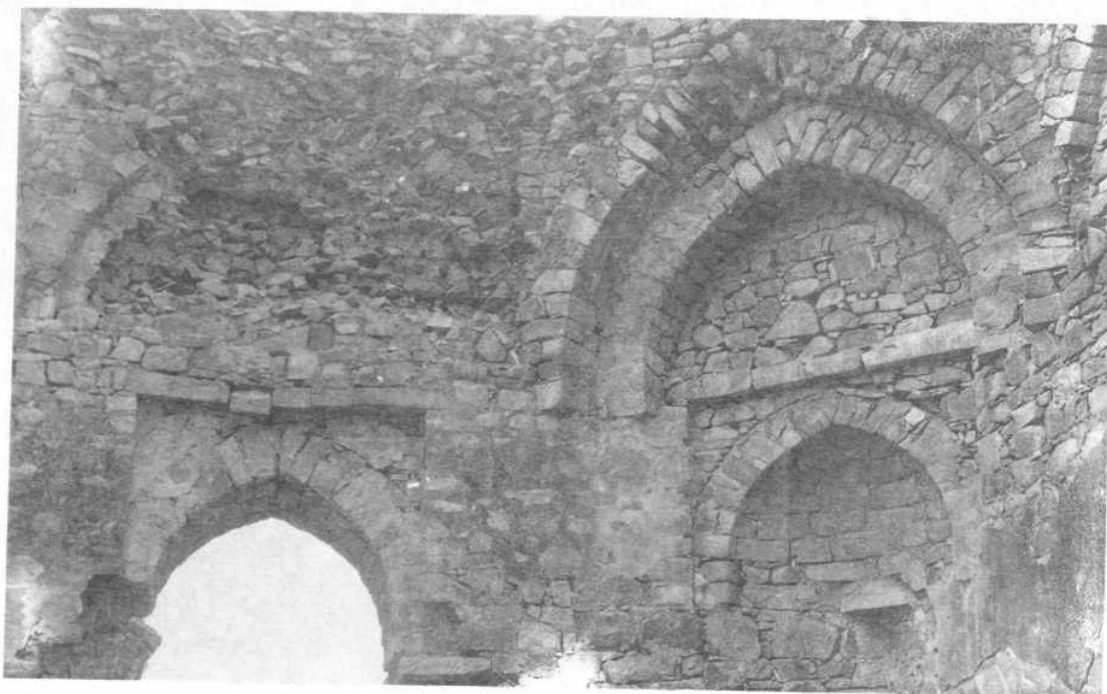
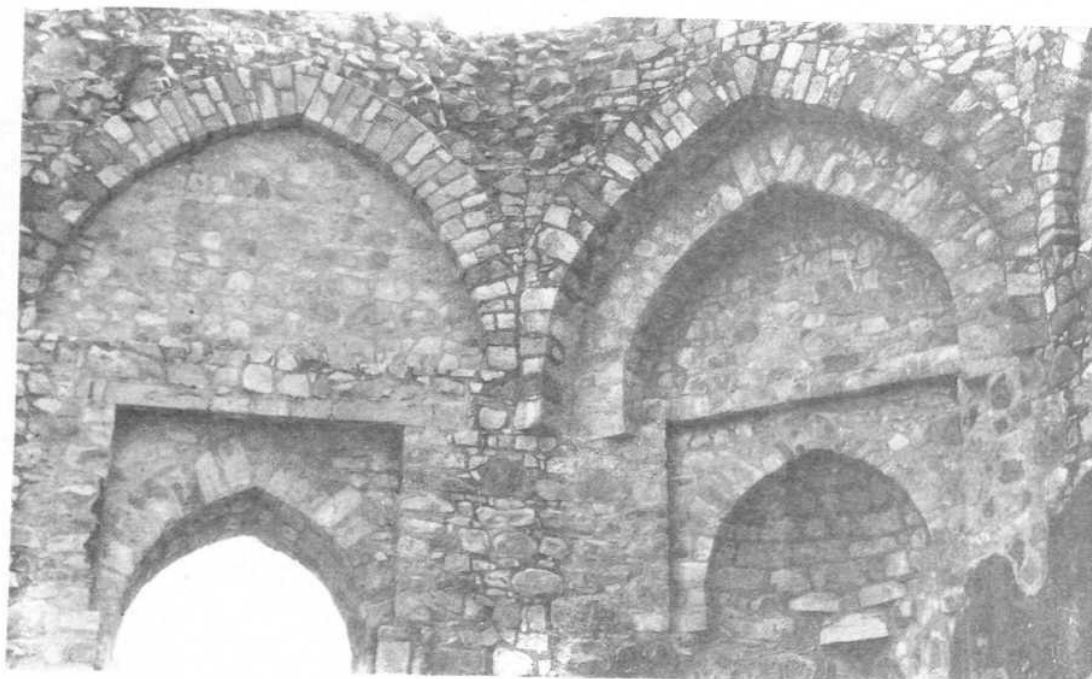
New Delhi: Ghiyathud-Din Balban's tomb, A, before and B, after repairs. See p. 171

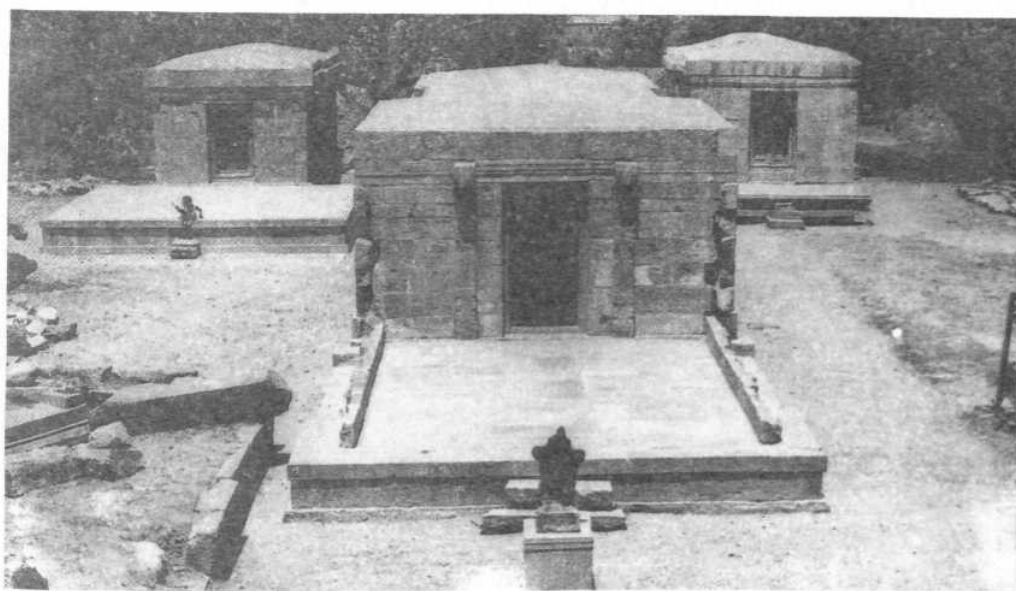
Vayalur : Thiruppulisvara temple, A, before and B, after repairs. See p. 179
