Indian Archaeology

1989-90—A REVIEW

INDIAN ARCHAEOLOGY 1989-90 - A REVIEW

EDITED BY **S. K.
MAHAPATRA**
*Secretary
Department of Culture
&
Director General
Archaeological Survey of India*

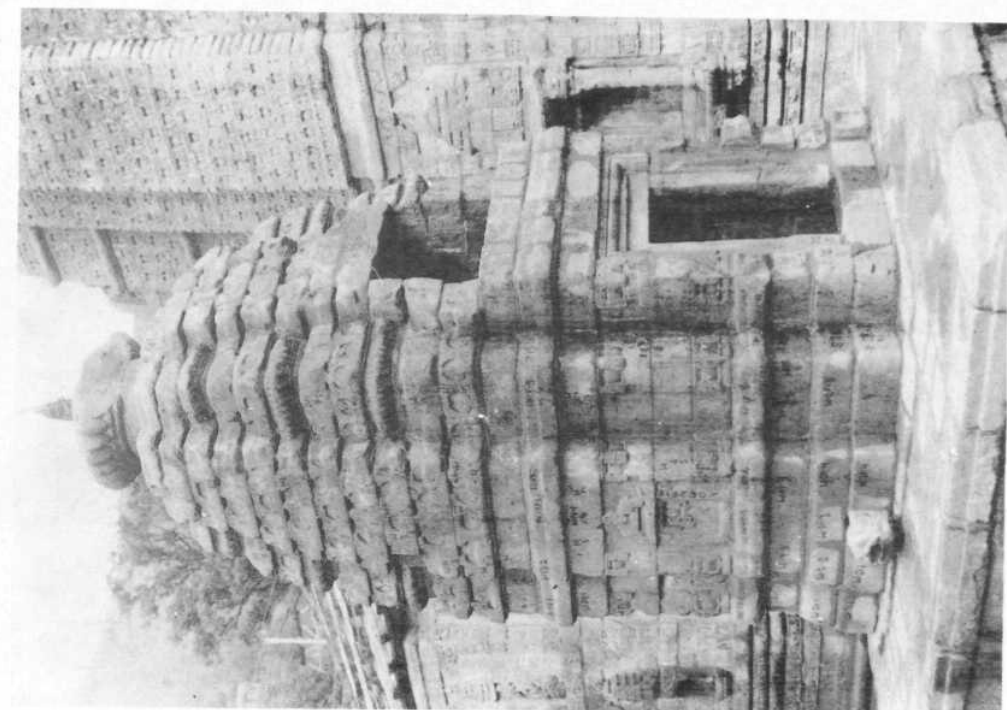
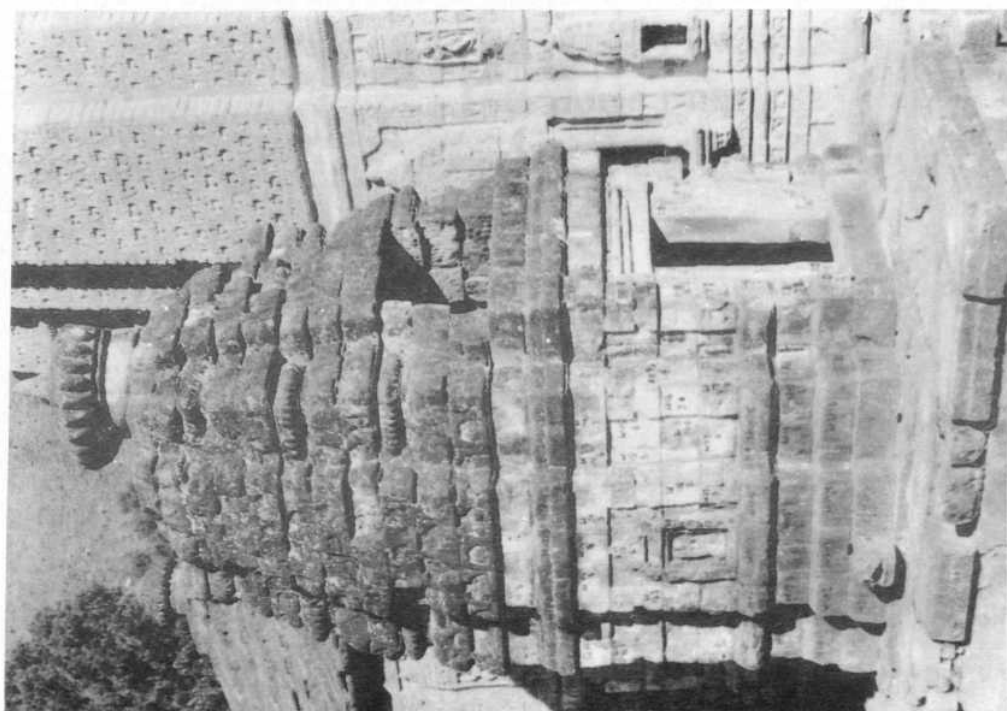
Mandi : Trilokinath temple, A, before and B, after repairs of miniature sikhara temple. See p. 184

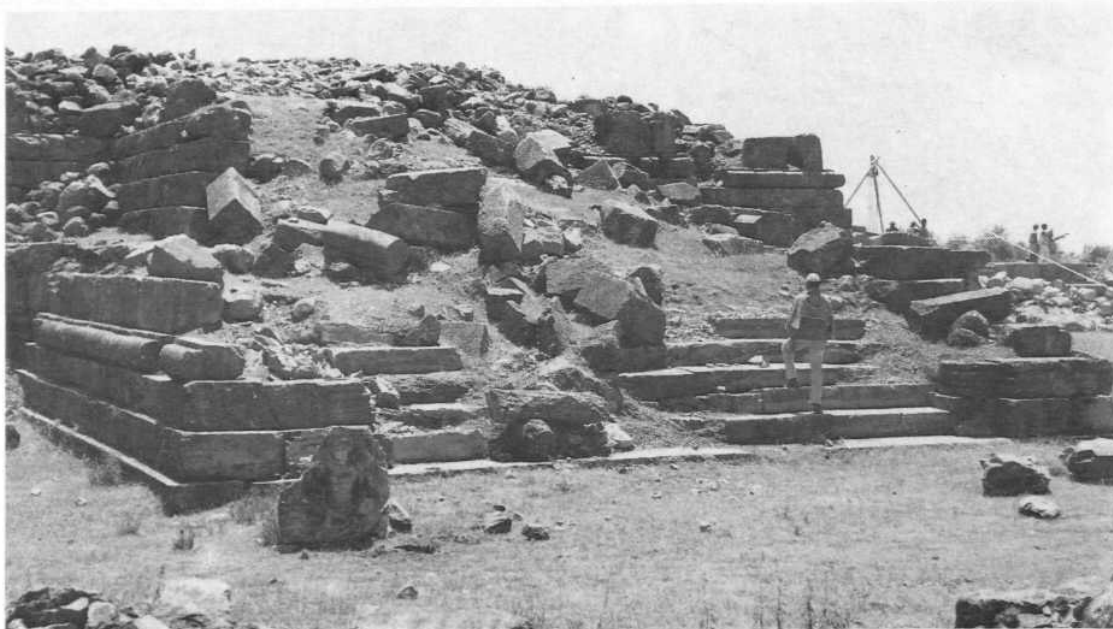
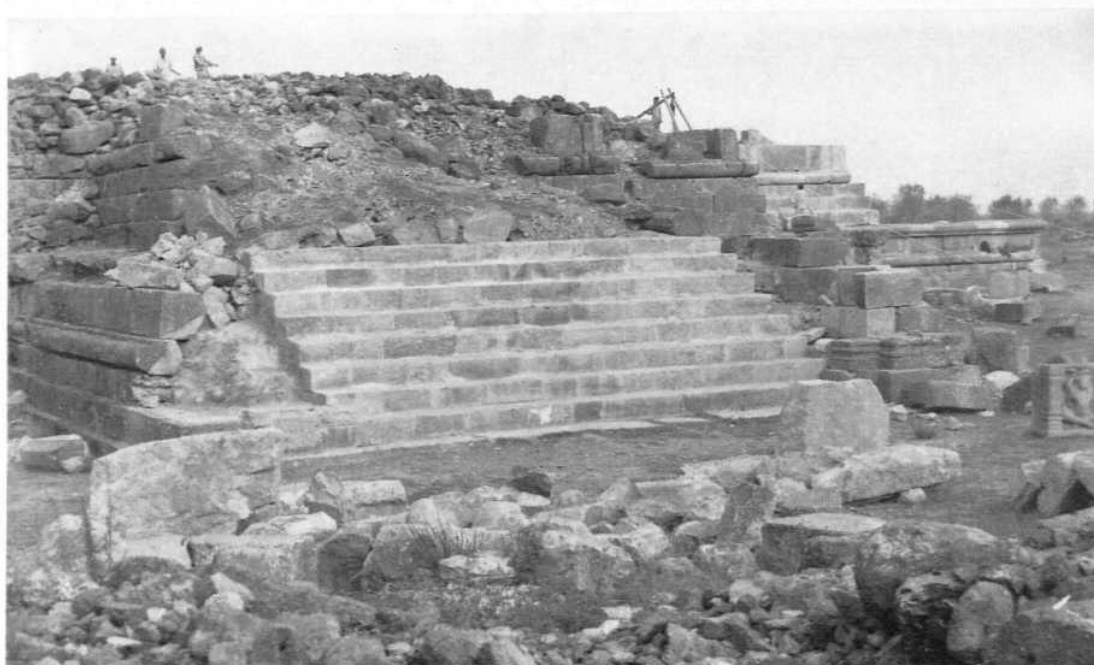
Parihasapura : Stupa, A, before and B, after repairs to the steps. See p. 184

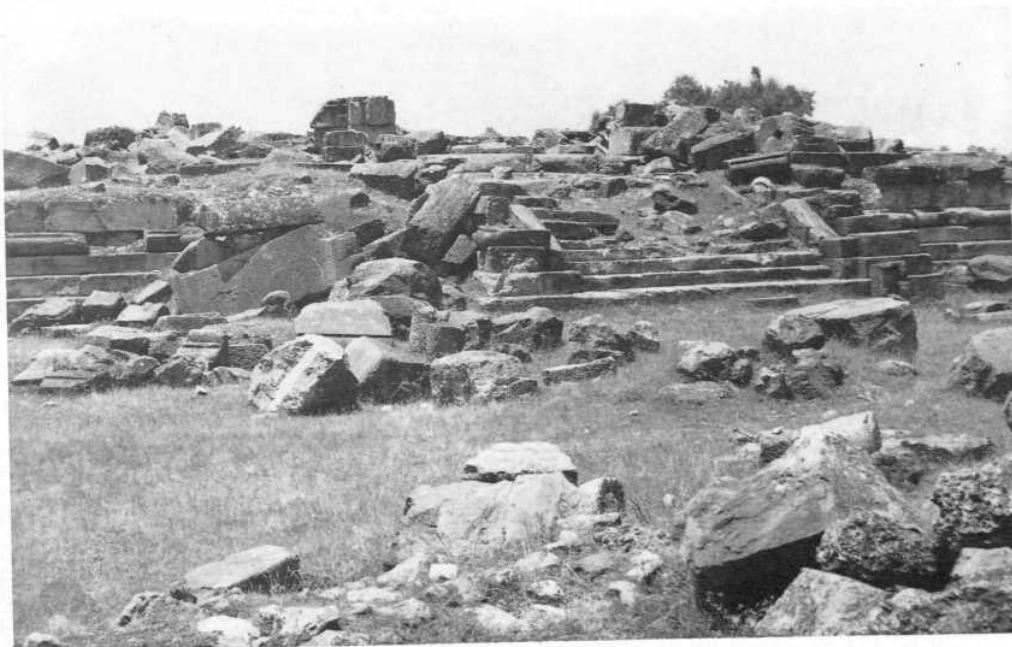
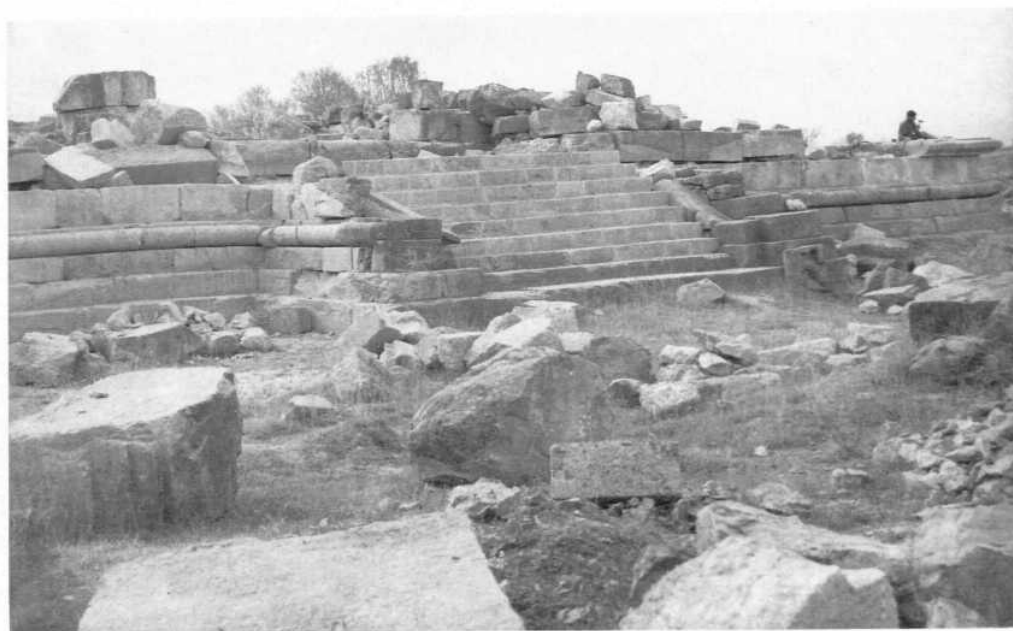
Parihasapura : Chaitya, A, before and B, after repairs. See. p. 185

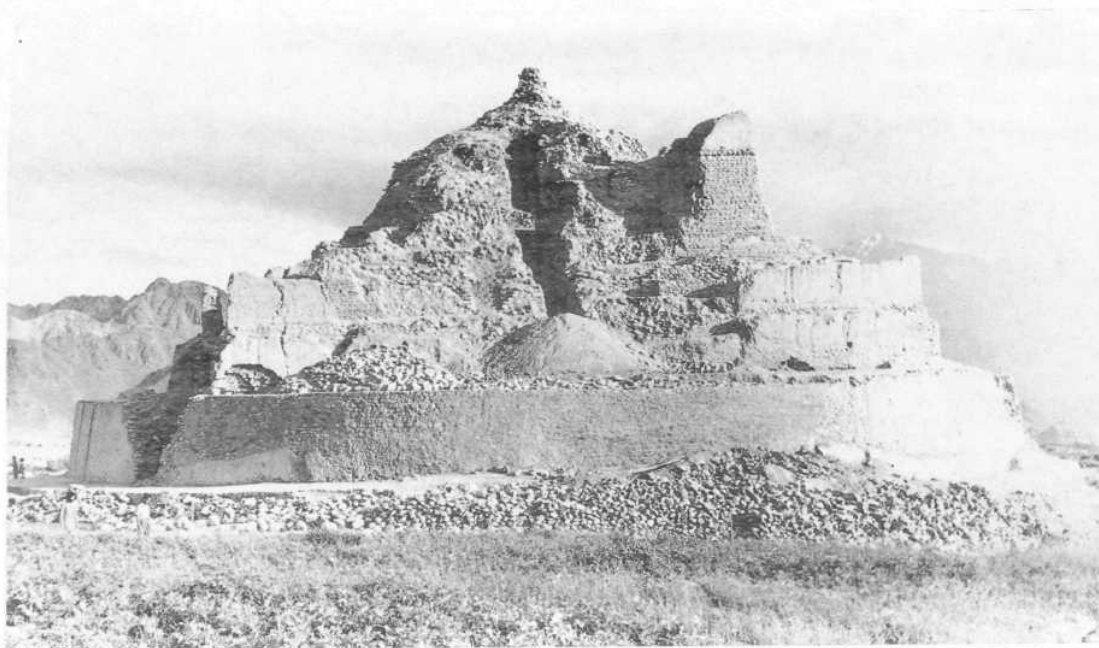
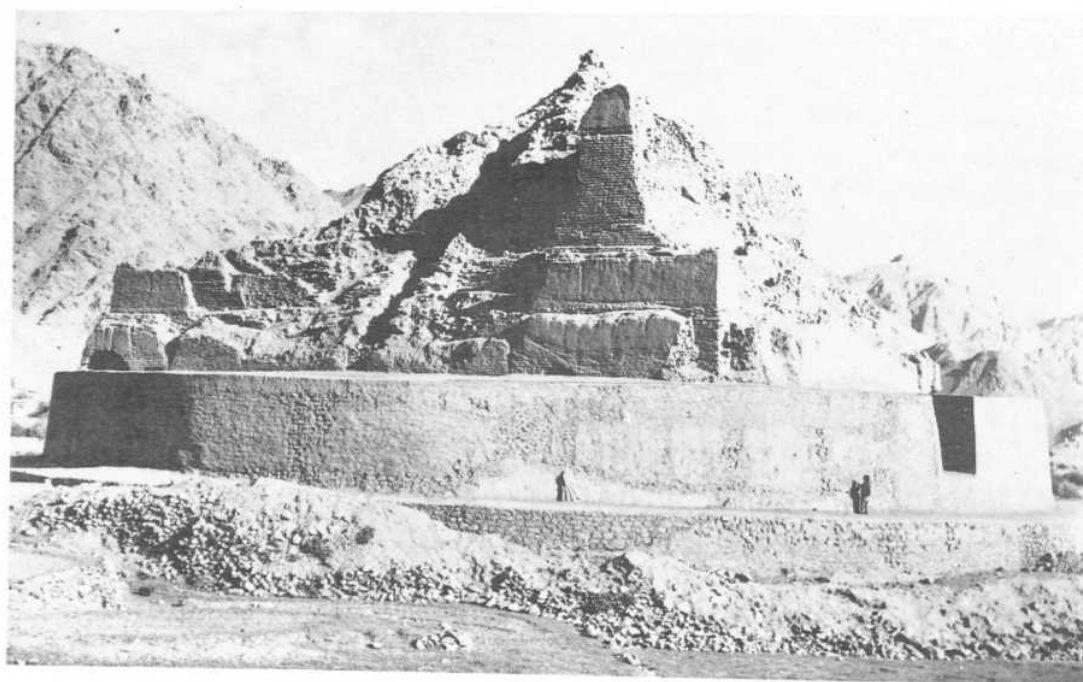
Leh : Tisseru Stupa, A, before and B, after repairs. See p. 185

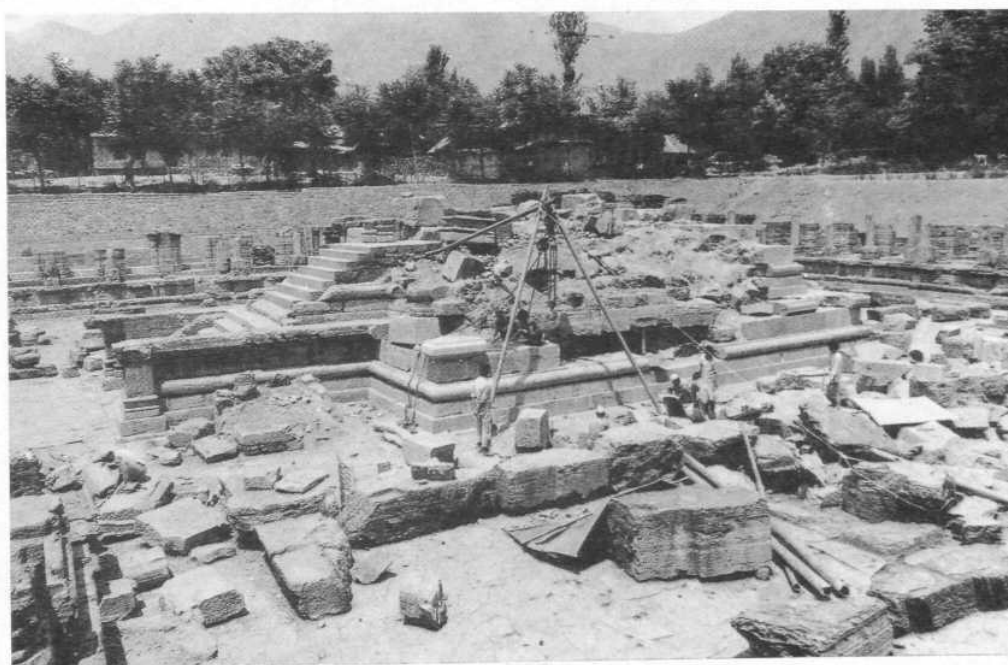
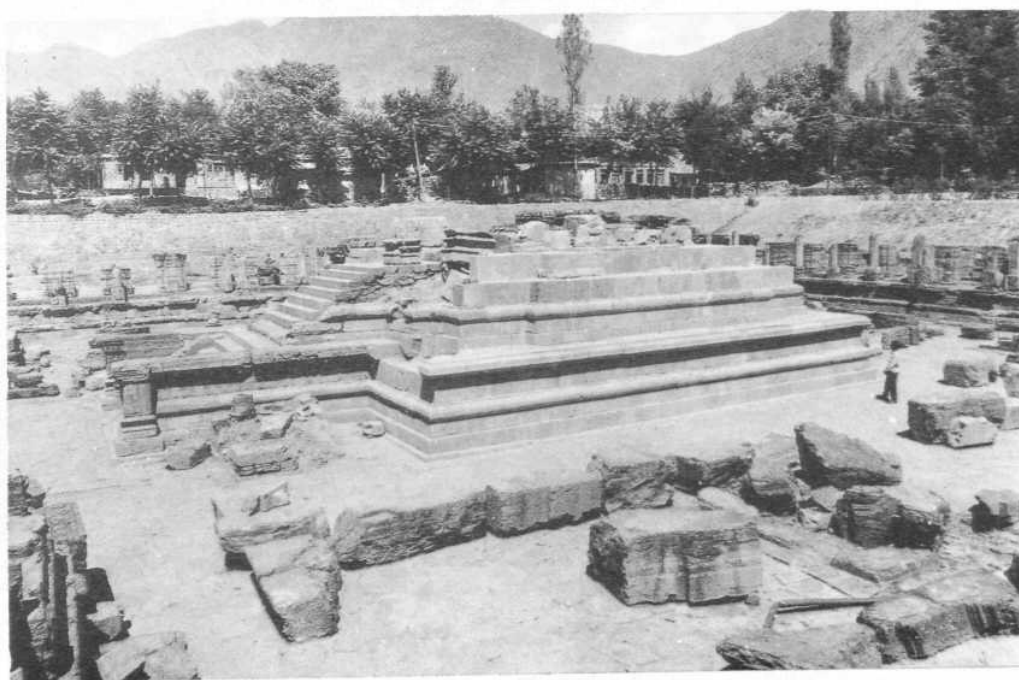
Avantipur : Avantiswami temple, A, before and B, during repairs. See p. 185

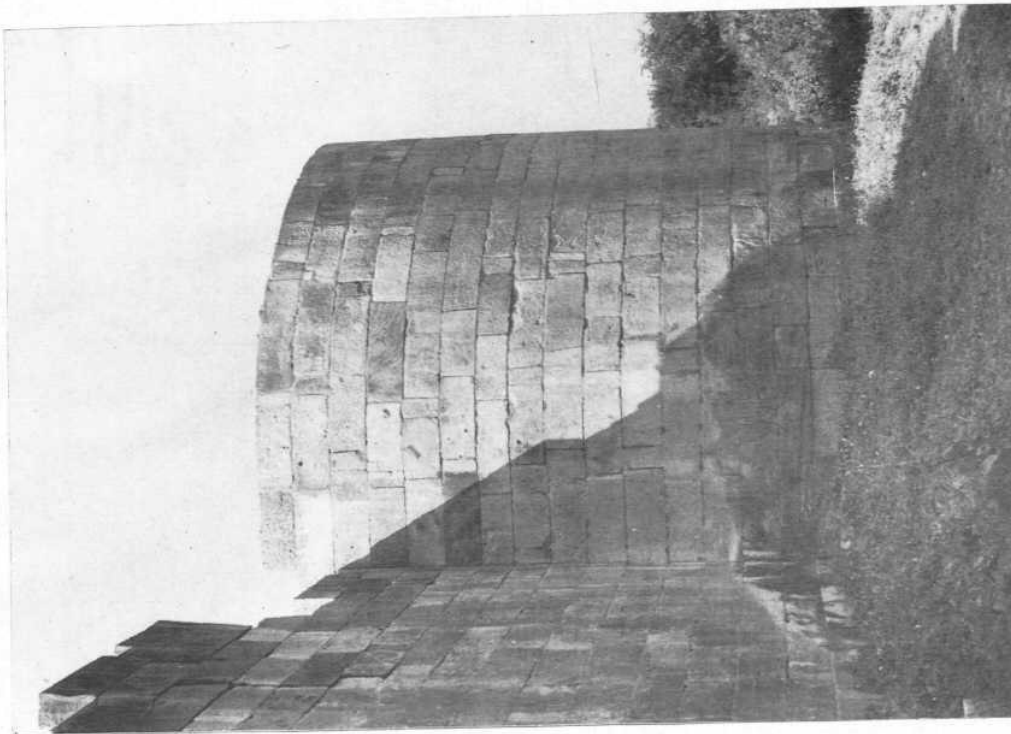
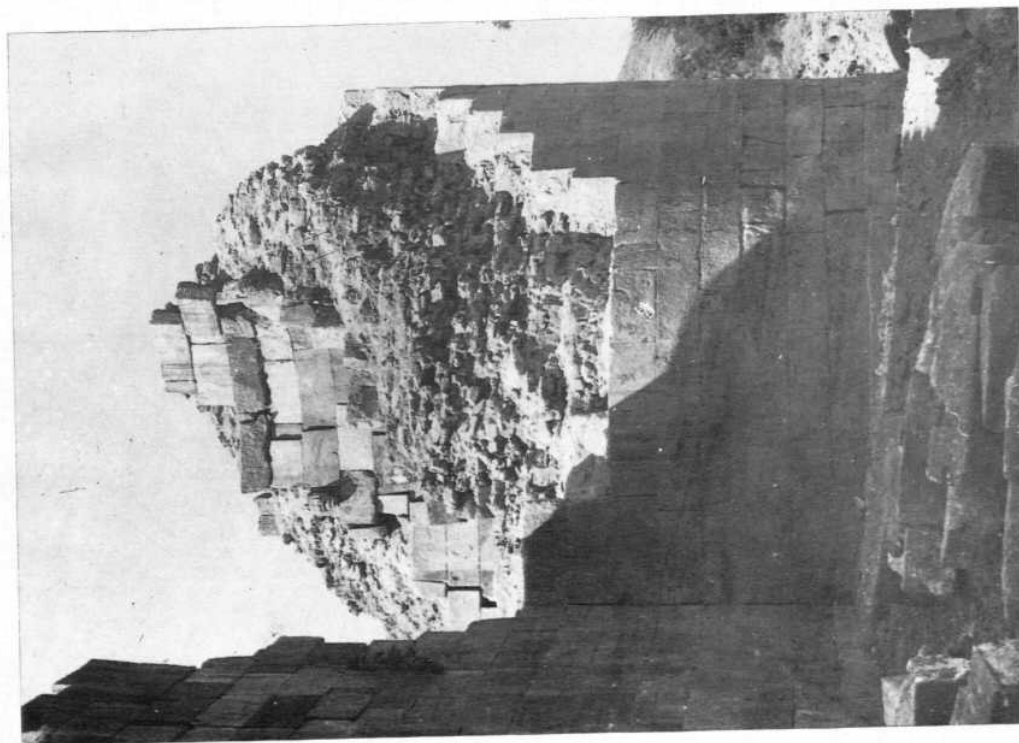
Pavagadh : fort wall, A, before and B, after conservation of north-east portion of wall. See p. 188

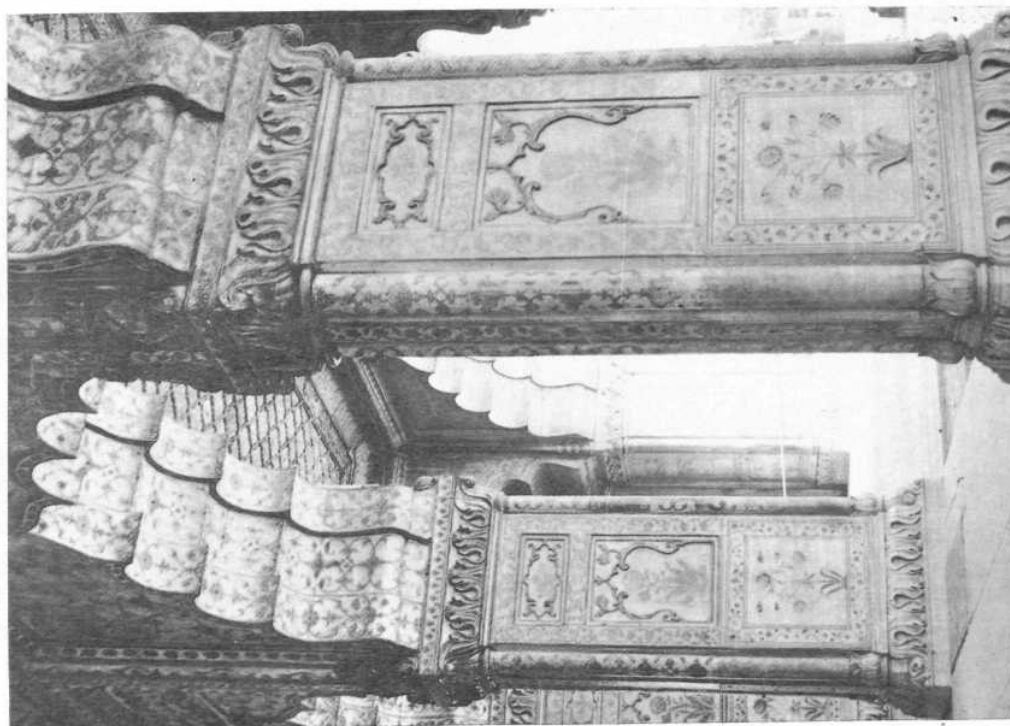
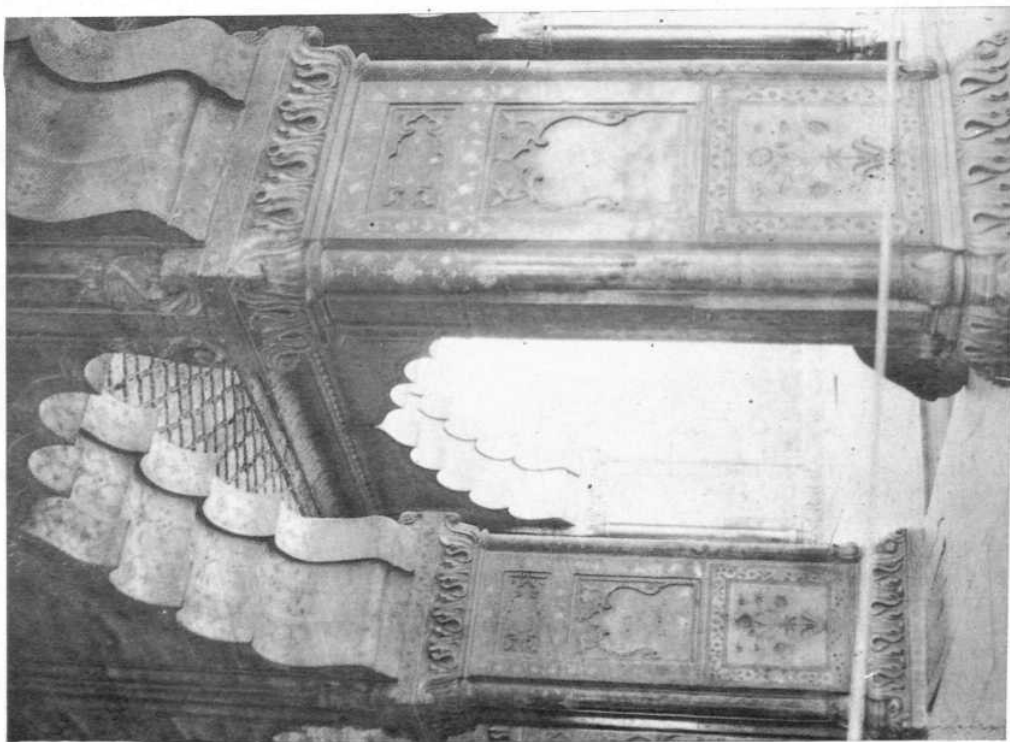
Red Fort, Delhi : A, before and B, after chemical treatment of ornamental designs and inlay works of Diwan-i-Khas. See p. 200
