Indian Archaeology

1992-93—A REVIEW

INDIAN ARCHAEOLOGY 1992-93 — A REVIEW

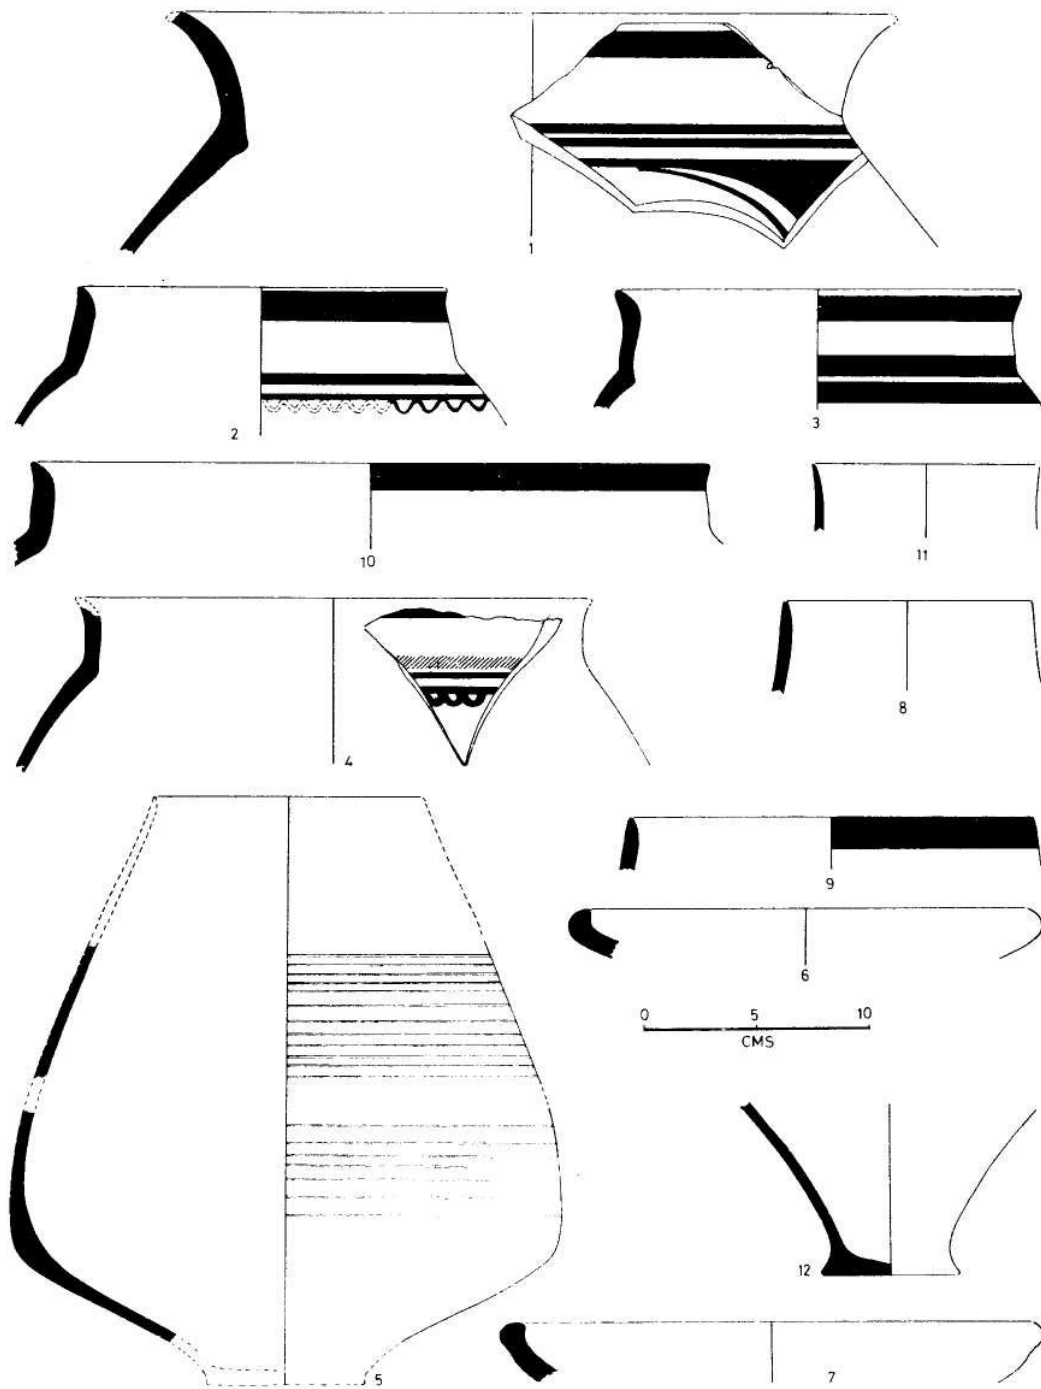
FIG. 2 : Moti Pipli, pottery types

The other group of pottery, predominated by the gritty red ware and red ware represent large and medium pots, small pots with constricted neck and bulbous body (figs. 2,3), bowls, basins, dishes and dish-on-stand, are generally decorated with thick bands and lines of dark chocolate or black colour at the rim, neck and shoulder. Such decorations are done mostly on a cream background to get a bichrome

effect (figs. 2,3,4). Similar type of jars/pots were also found in burnished grey/black ware and burnished red ware (fig. 3). The site yielded only a few sherds of bowl in black and red ware.

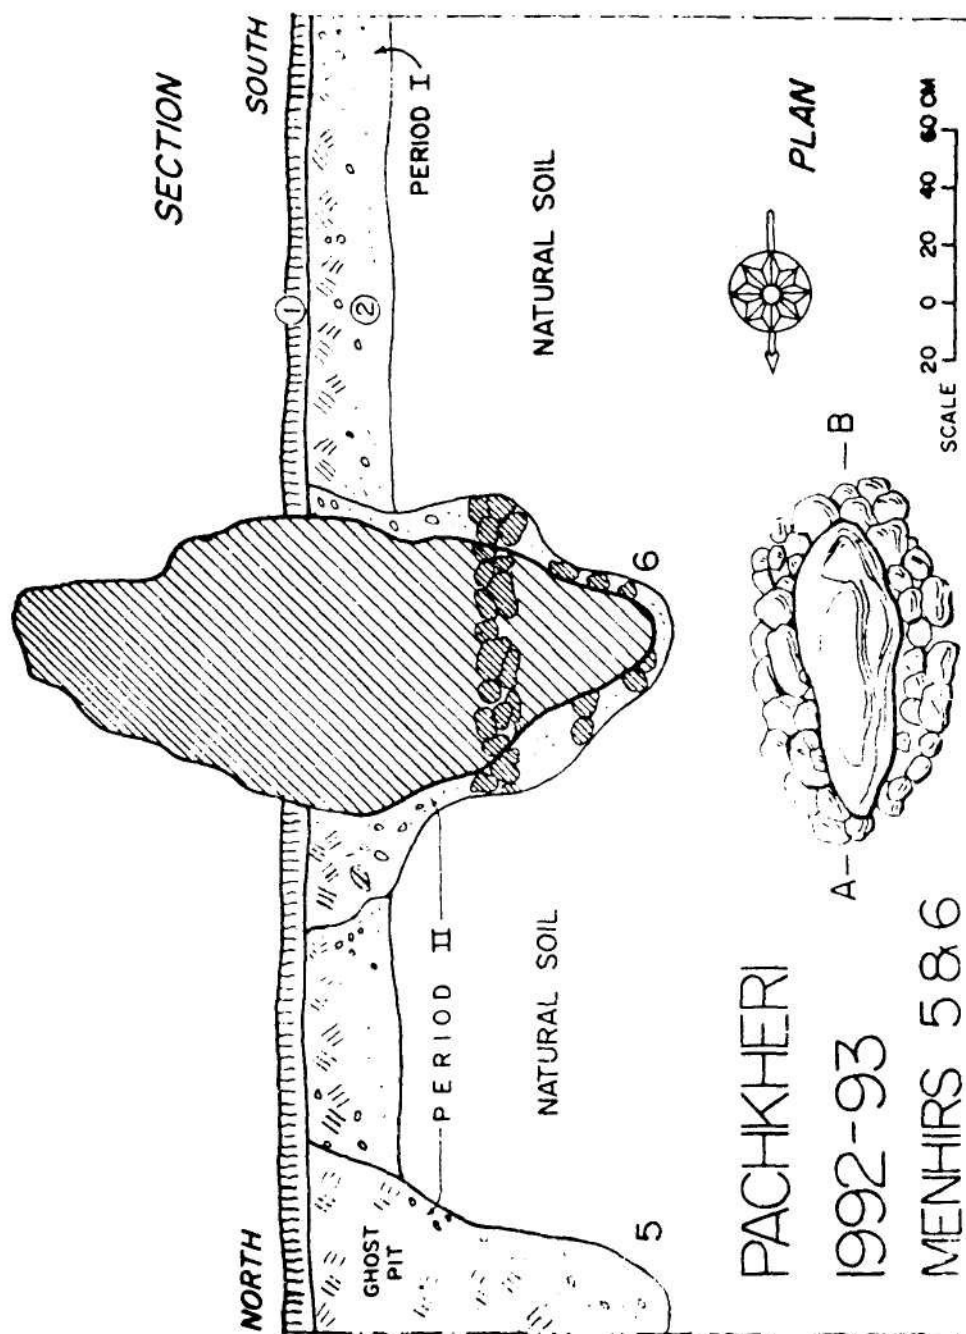
Fig. 14

Damaged from the top, Menhir 6 consisted of a partially dressed conical monolith showing near oval cross section (fig. 14). It measured 220 X 100 X 40 cm. An interesting feature noticed in the pit was the formation of stone-ring of two courses at a depth of 75 cm, devised in order to secure its upright position (pl. XXIB). Below and above this ring the filling was haphazard type of dug out sediments.

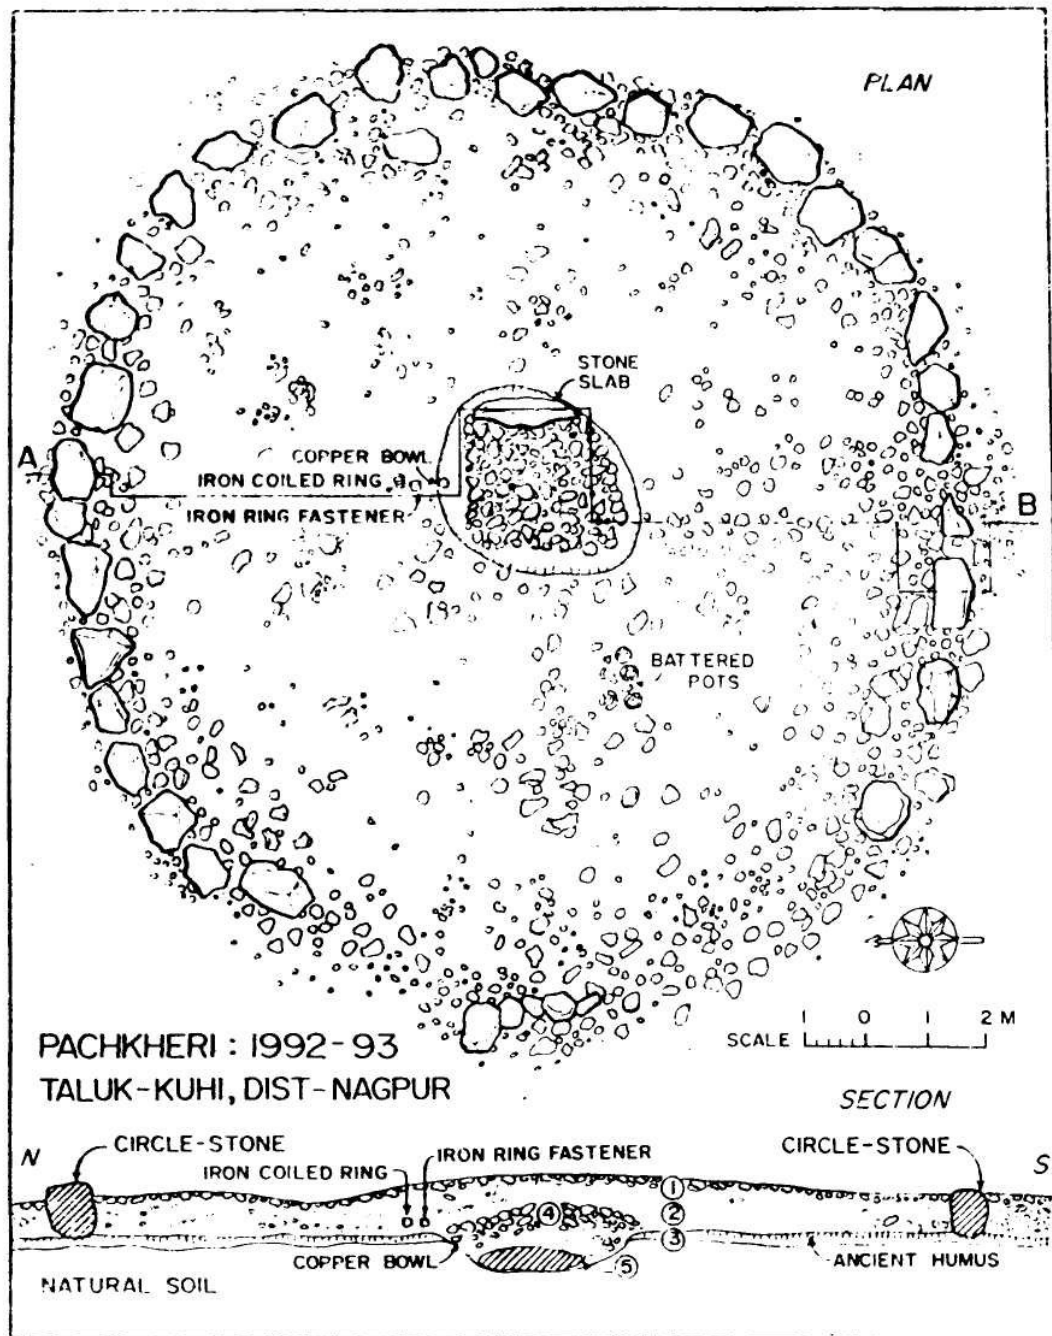
FIG. 15

Pit-circle with cairn (PKD-3) consisted of a circle of undressed Deccan trap boulders with an external diameter of 16m (fig. 15). The circle stones of southwestern side were dislodged while some of the stones in western side were virtually removed in recent days (pl. XXII B). The centre of the circle entombed a near oval pit burial measuring 380x300x80 cm. The upper section of the pit showed a deposit of the gravel mix brownish red soil which formed the contemporary working level (layer 3), while the lower section had natural gravel deposit. Towards the eastern base of the pit a stone slab (170 X 45cm) of Menhir-6 (PKD-2) type was found placed in north-south orientation. No other material of funerary rights was found at the base, however, a battered copper bowl was placed at the upper portion of the northern inner edge of the pit. Further, say 120 cm west of the pit were noticed red ware vases having typical flared or near funnel type rims, in a battered condition immediately above the contemporary working-level. Apparently, the gravegoods were placed at all levels, without any regular order, having evidently been placed simultaneously with the throwing in of the filling earth. The first 55 cm of the pit (layer-5) was filled with fine brown clayey earth brought from elsewhere while its remaining upper portion was piled up to a height of 60 cm with uneven local stone chips (layer 4), forming an hemispherical heap above the contemporary working level (i.e., ancient humus, layer 3).

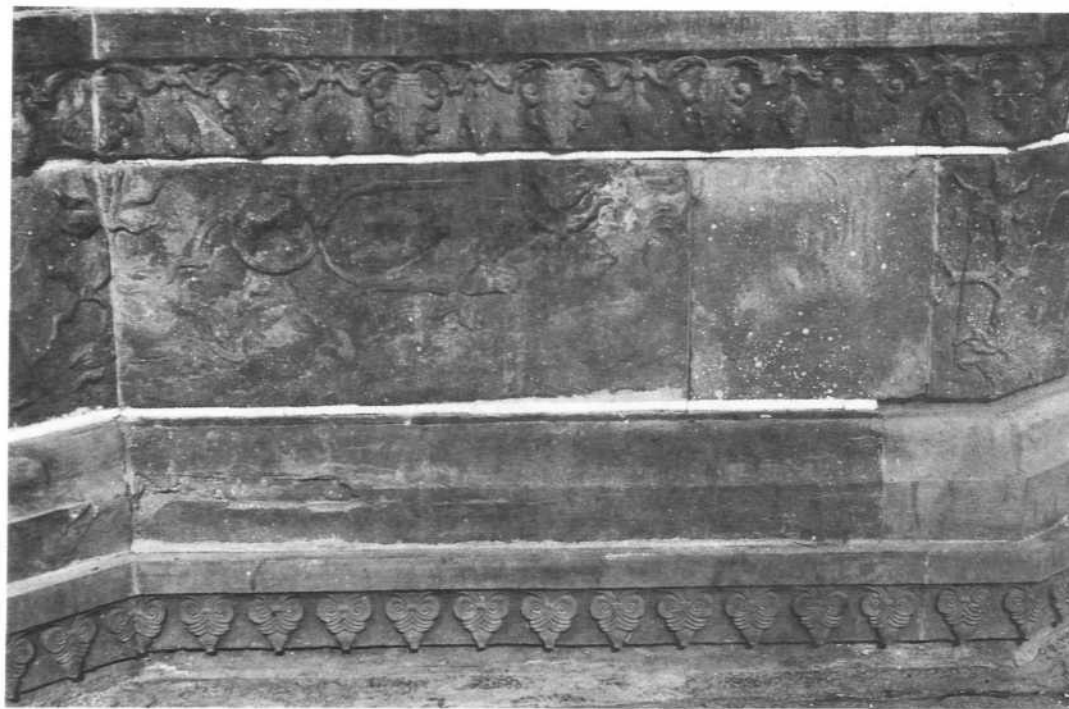
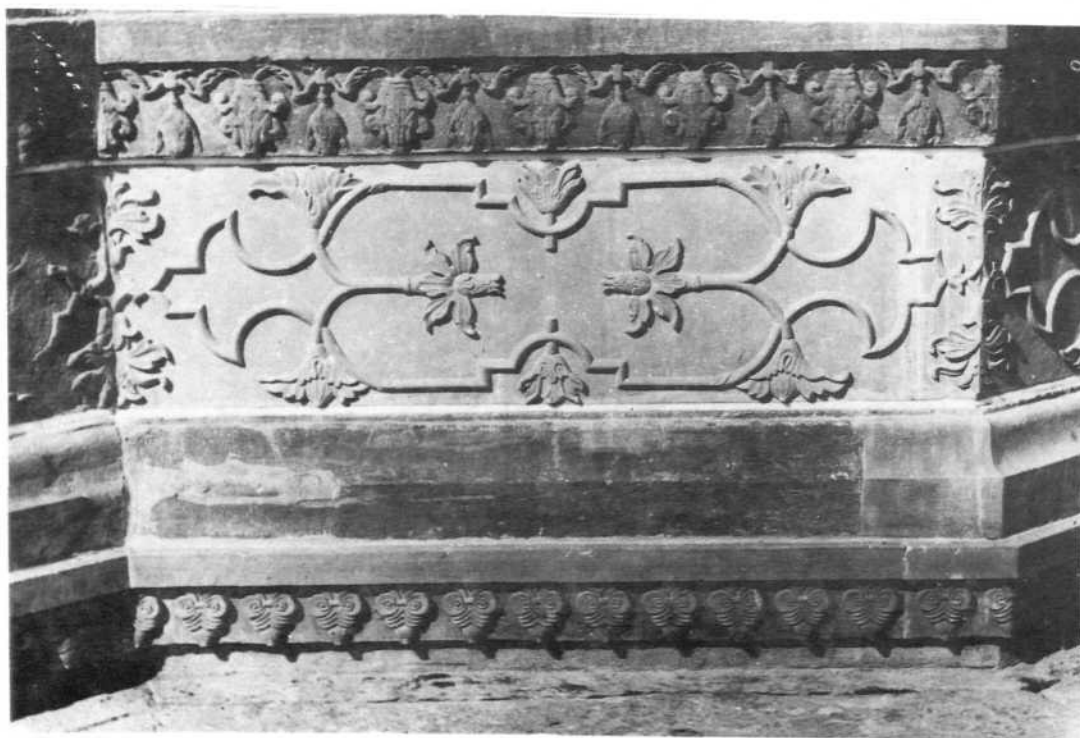
Agra : Taj Mahal, maingate, A, before and B, after conservation of decayed veneering stones and mouldings at plinth level. See p. 147

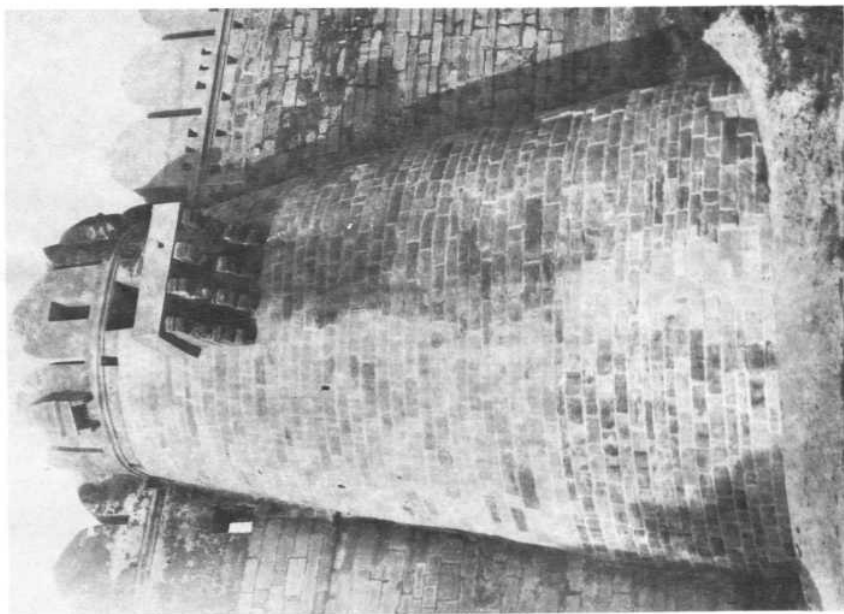
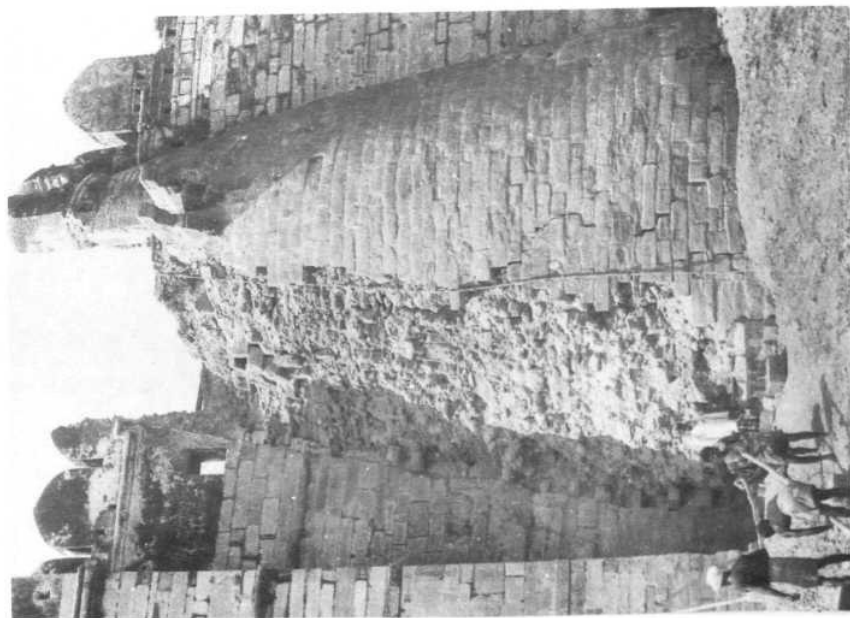
Jaunpur : Fort, A, before and B, after conservation of eastern bastion. See p. 176
