Indian Archaeology

1997-98

INDIAN ARCHAEOLOGY 1997-98 -A REVIEW

PUBLISHED BY THE DIRECTOR GENERAL
ARCHAEOLOGICAL SURVEY OF INDIA
JANPATH, NEW DELHI
2003

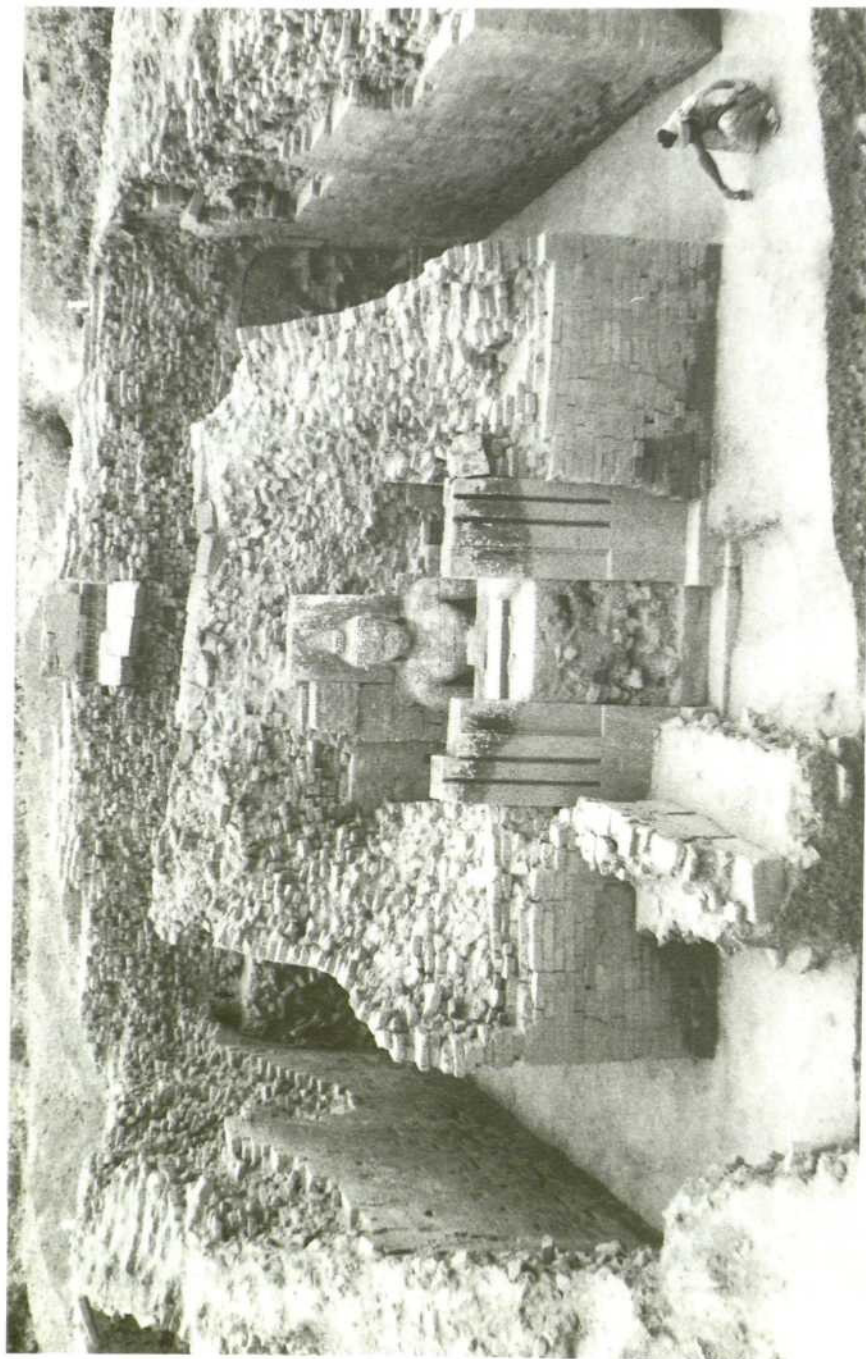
PLATE 101

Udaygiri-2 : sanctum sanctorum with pradakshinapatha

wall was made high to maintain the required level inside the monastery. The outer wall on the east has sixteen small offsets at the base in order to protect outward thrust of the inner filling. Here, the application of offsets increased the thickness of the base by 0.5 m.

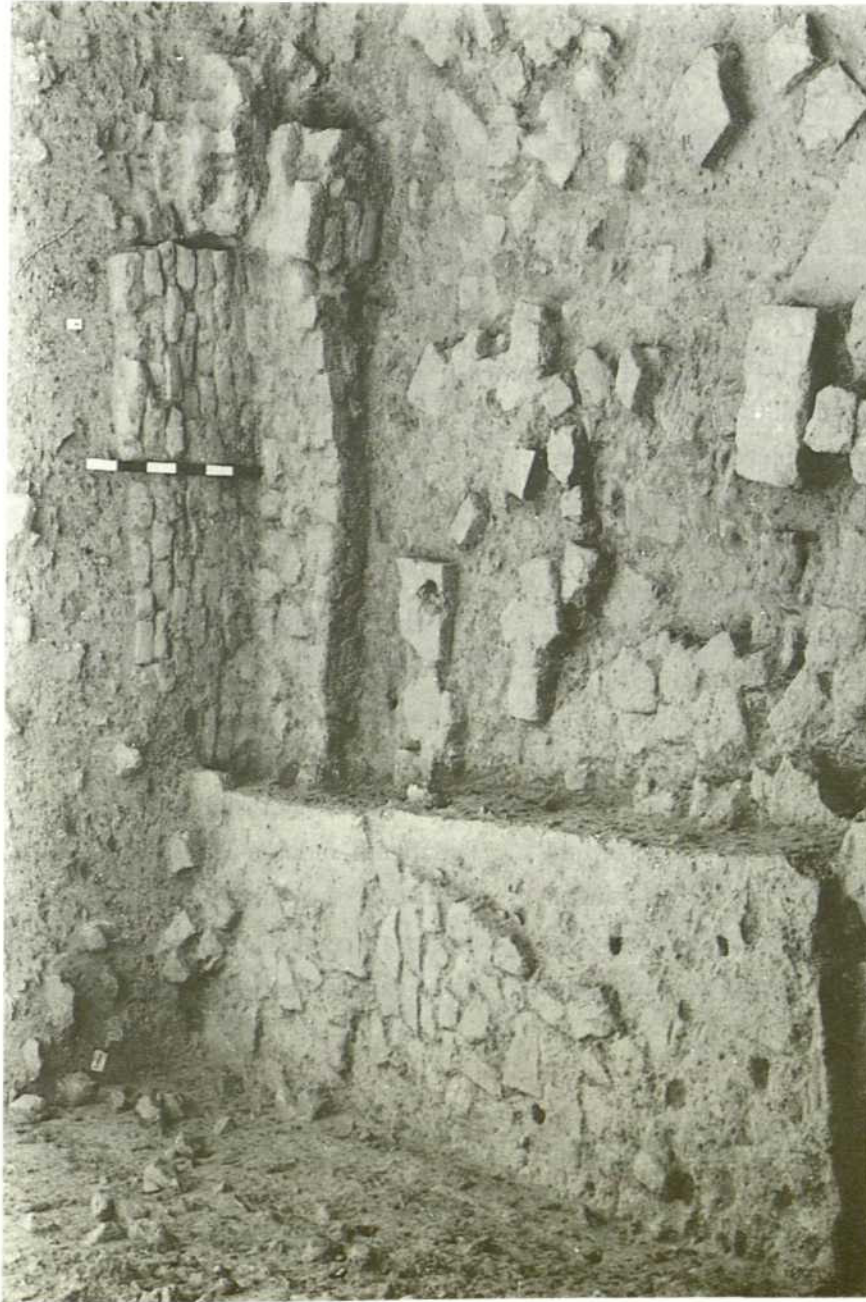
Jhusi : structure of Gupta period

Remains of houses with brick floors were also encountered. It may be pointed out that in the structure pertaining to Kushan period the incidence of complete bricks is higher than in the case of the Gupta period structure (pl. 128).
