# INDIAN ARCHAEOLOGY 1998-99 -A REVIEW

PUBLISHED BY THE DIRECTOR GENERAL  
ARCHAEOLOGICAL SURVEY OF INDIA  
JANPATH, NEW DELHI  
2004

## I. EXPLORATIONS AND EXCAVATIONS

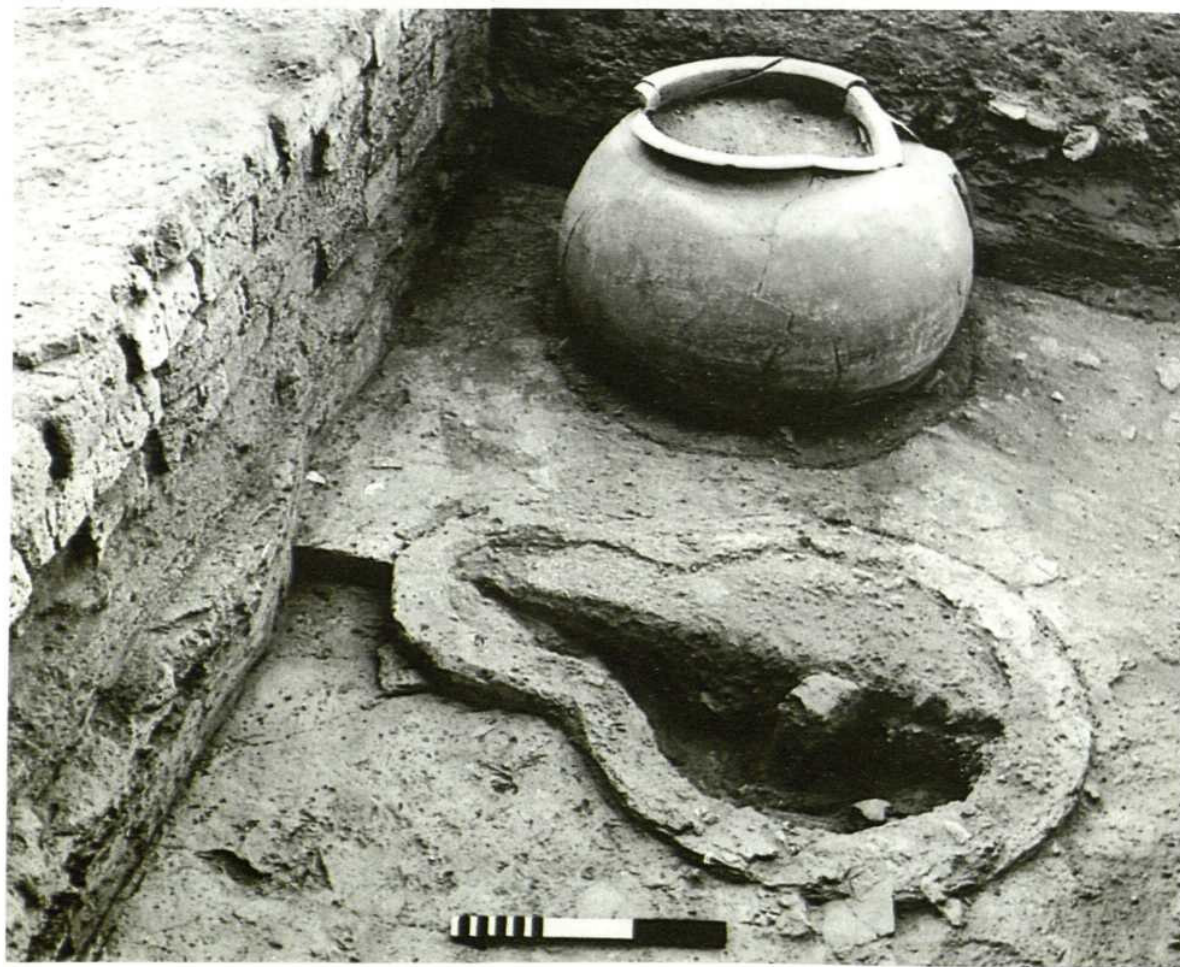
Plate 7

*Rakhigarhi : view of yonipitha type fire-altar; RGR-I, Period-II*

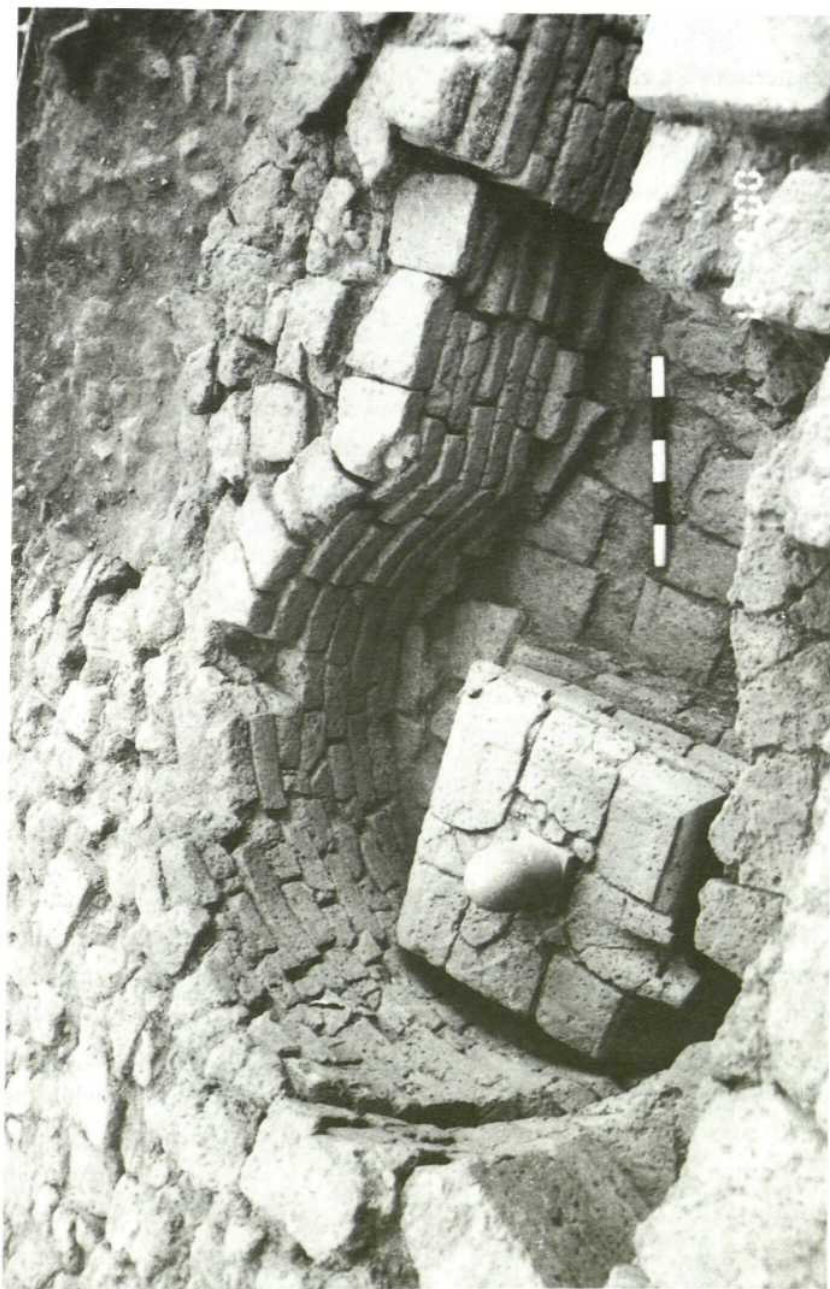
*Mansar : Siva shrine*

Vertically all the shrines were built in the form of lotus buds by adopting the triangles and inverted triangles (equilateral). Method for raising petals that ultimately close into a pointed end making the closed roof of the *sikhara* was adopted. The evidence clearly show that the whole complex was plastered with lime-mortar. At the base of these shrines, on the southern corner of one of the steps, a burnt wooden *yupa* was found, apparently for offering sacrifices to the deities. The triangles, particularly on the outside of the *jangha* portions of the row of shrines, make a human face. Almost each shrine has an approach either from the east or the west, with some having a small *mandapa* and small semicircular or triangular *kunda* for water-storage

near the steps. In one of the shrines, the *linga* has been kept over a square brick pedestal just below the natural rock inclined.

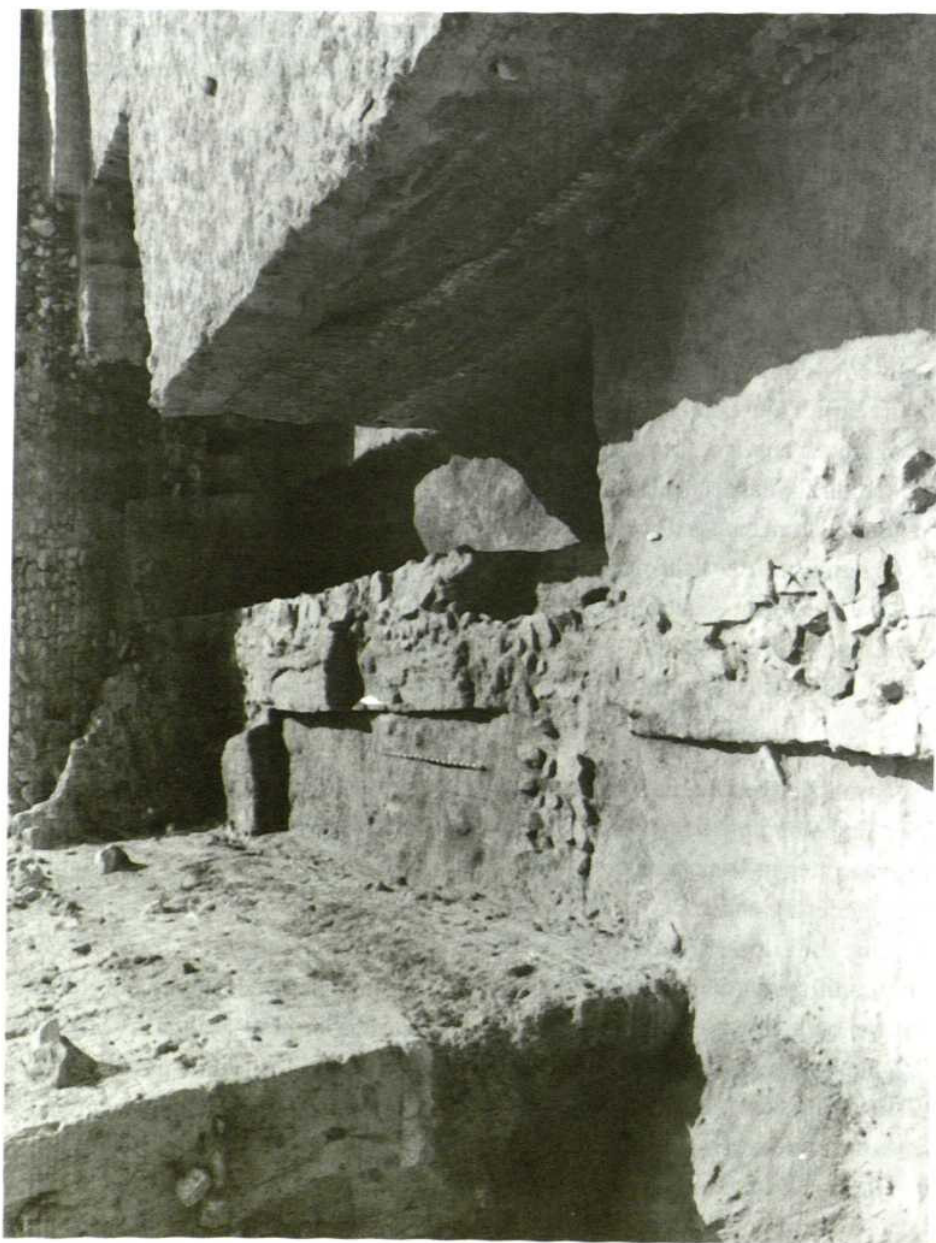
Plate 58

*Balathal : rectangular structure inside the fortified enclosure, phase V, Chalcolithic*

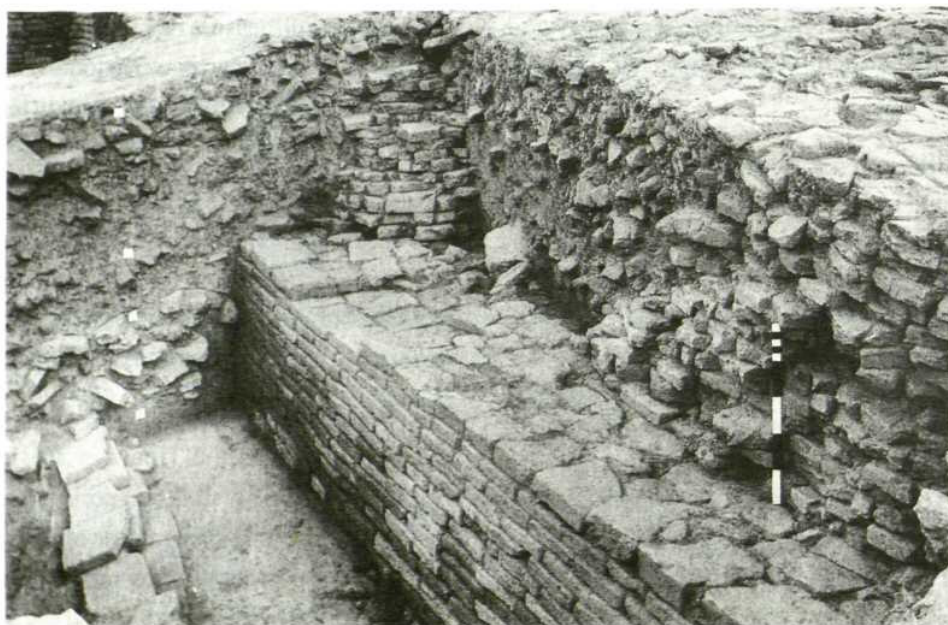
78

*Sravasti : 78, two phases of massive enclosure wall and 79, view of western enclosure wall*

Total fifteen trenches were excavated fully and partly resulting in the discovery of massive enclosure wall (pl.78), three security points and complete entrance-complex leading towards the fortified city of Maheth.

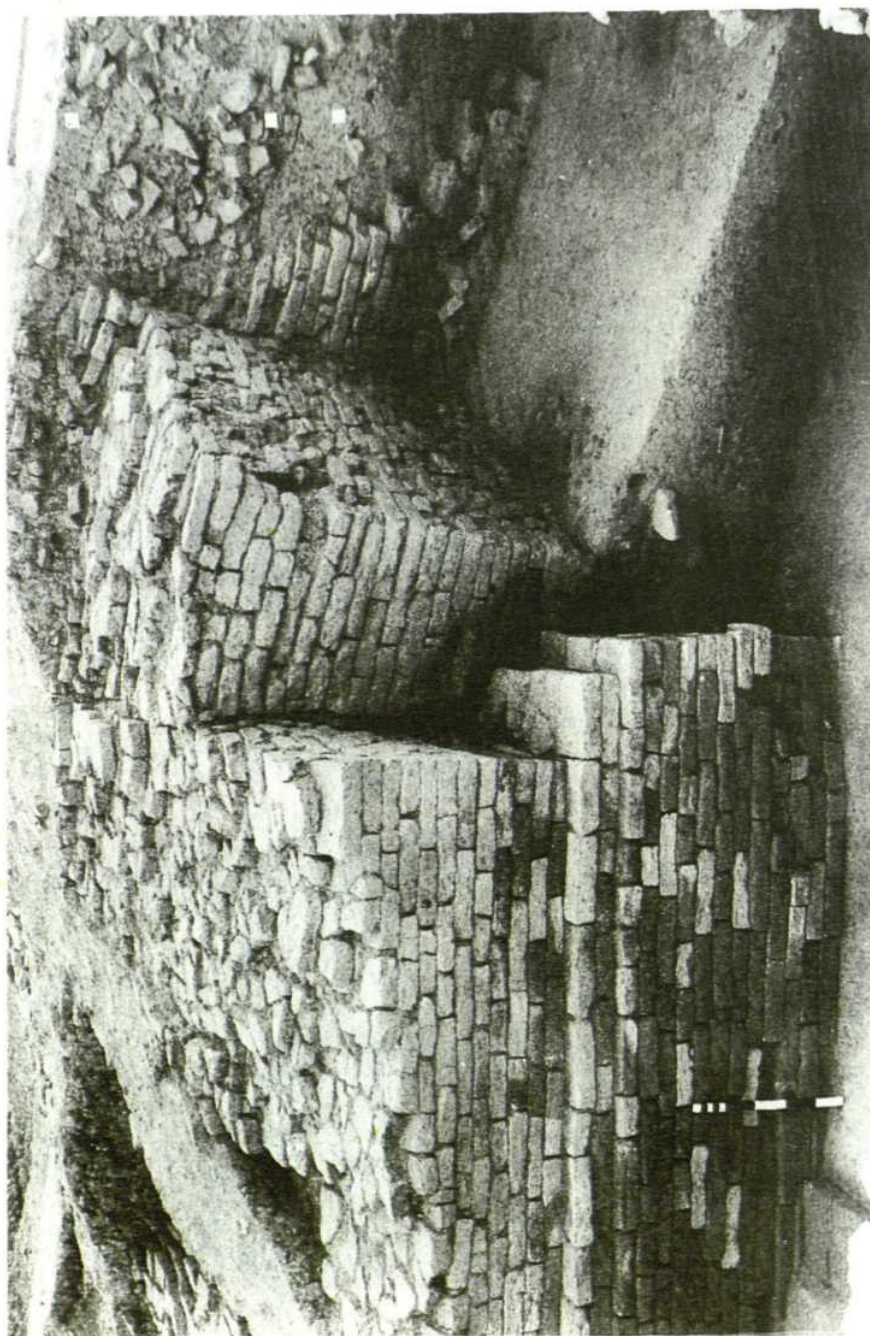
Plate 81

*Shravasti : close view of intermediate security point*

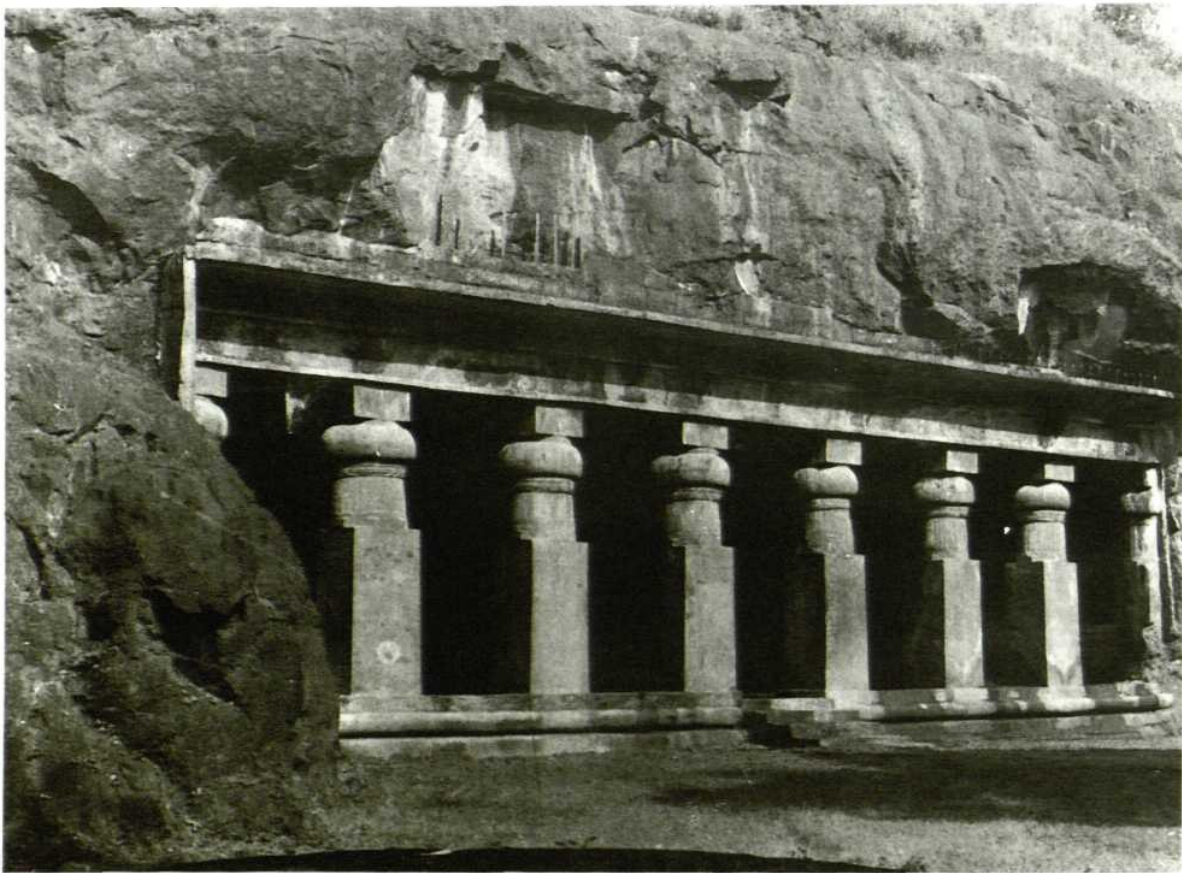
Plate 106

*Elephanta, Raigad : façade, Cave 3, before conservation*

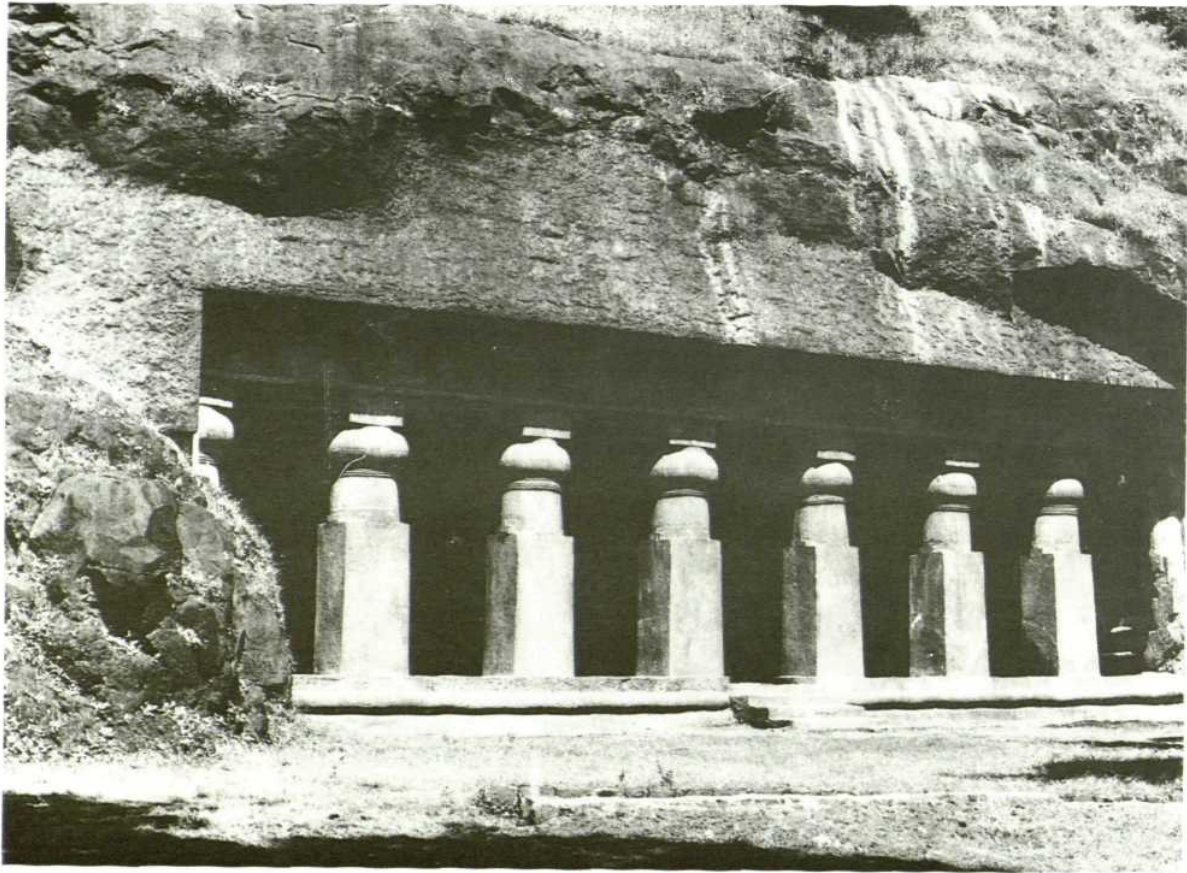
Plate 108

*Elephanta, Raigad : façade, Cave 3, after conservation*

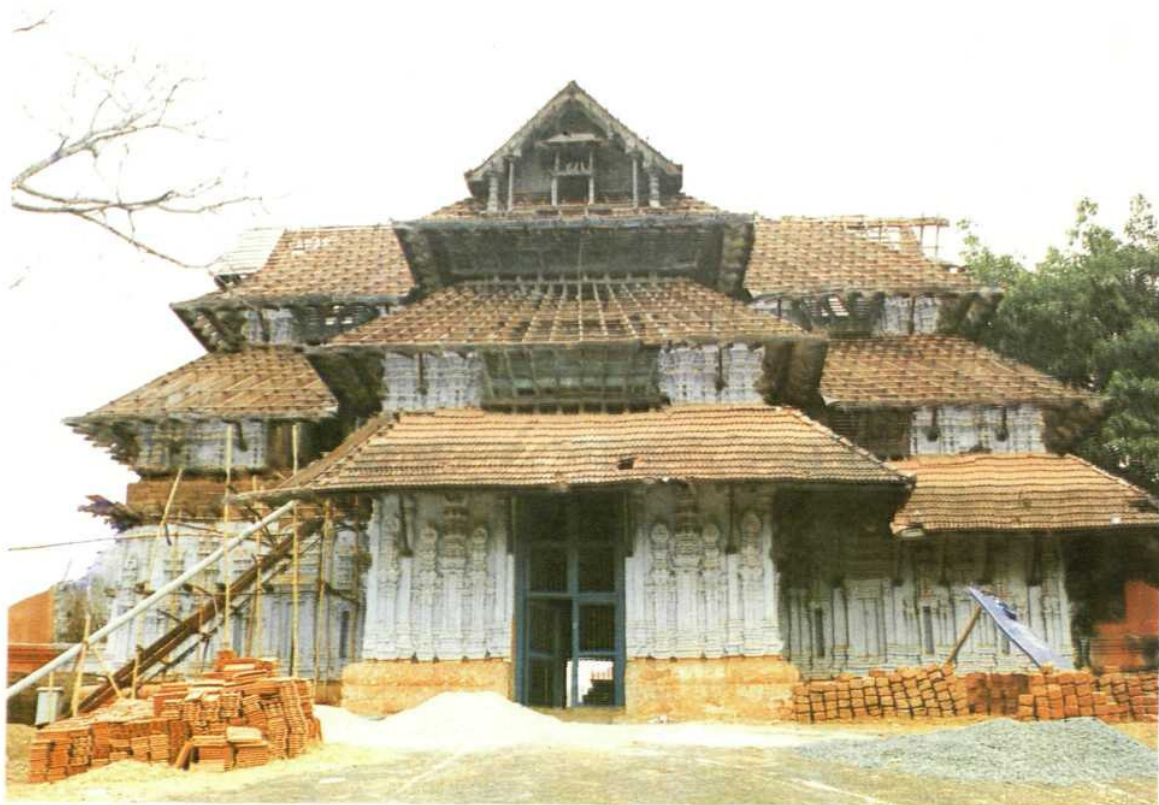
142

*Thenkailasanatha Temple, Thrissur : during conservation of southern gopuram*

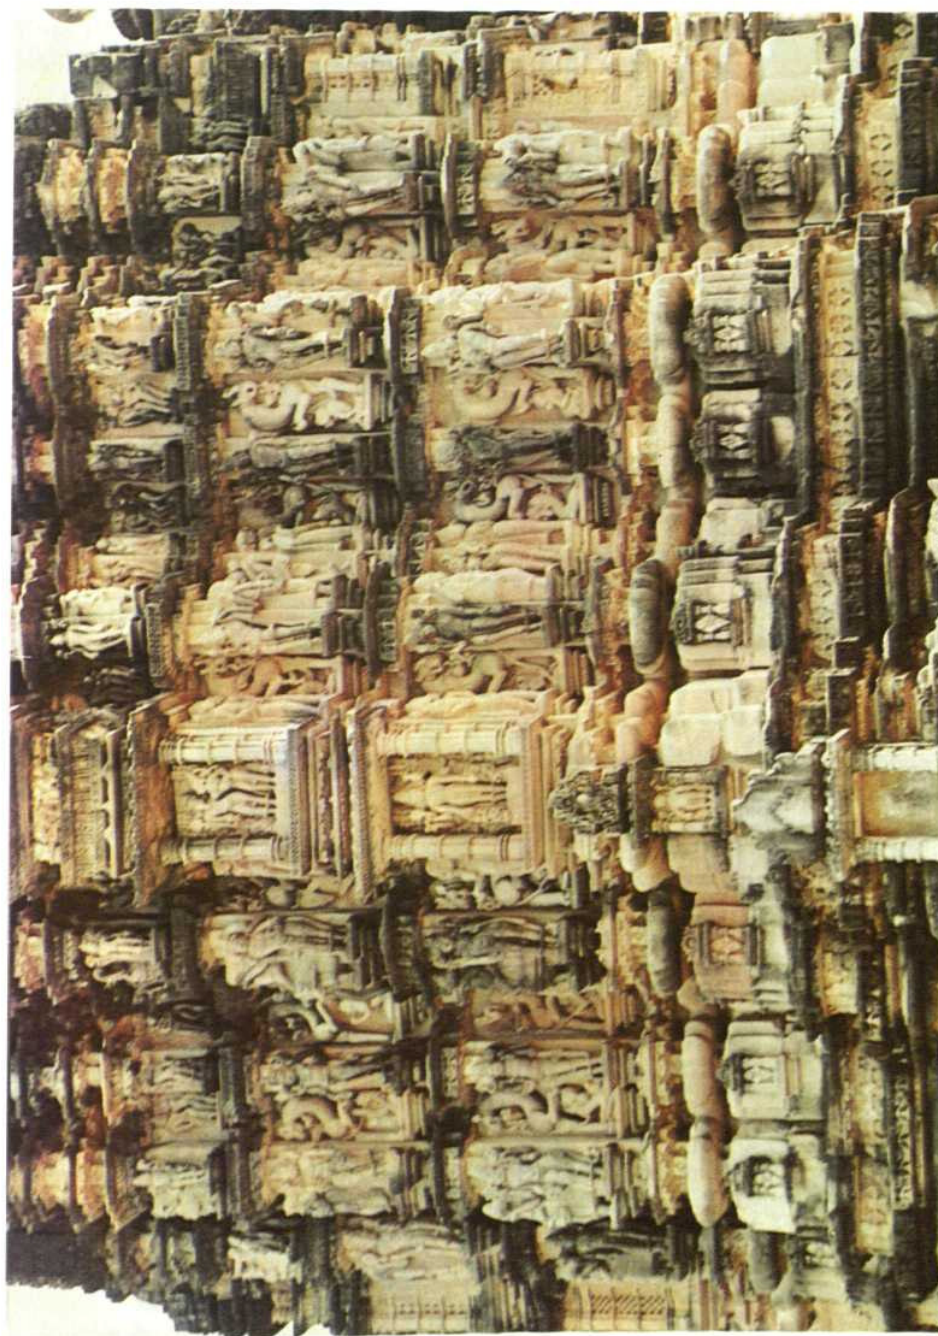
*Devijagadambi Temple, Khajuraho : sanctum façade, affected by cryptogams,  
before chemical treatment*

The mural paintings and relief figures in the Buddhist rock-cut shrines were chemically conserved during the period. The removal of the dust, dirt, mud, nests and cobwebs etc. was carried out from the painted mural surfaces, besides mounting and providing new supports to the detached paintings. Fumigation of cells along with monitoring of micro-climatic conditions inside the caves was done in order to study the optimum condition for insect activity and micro-biological growth. The relief figure of Buddha and Bodhisattva of Cave 2, suffering from recurring problem of excessive ground water seepage and salt

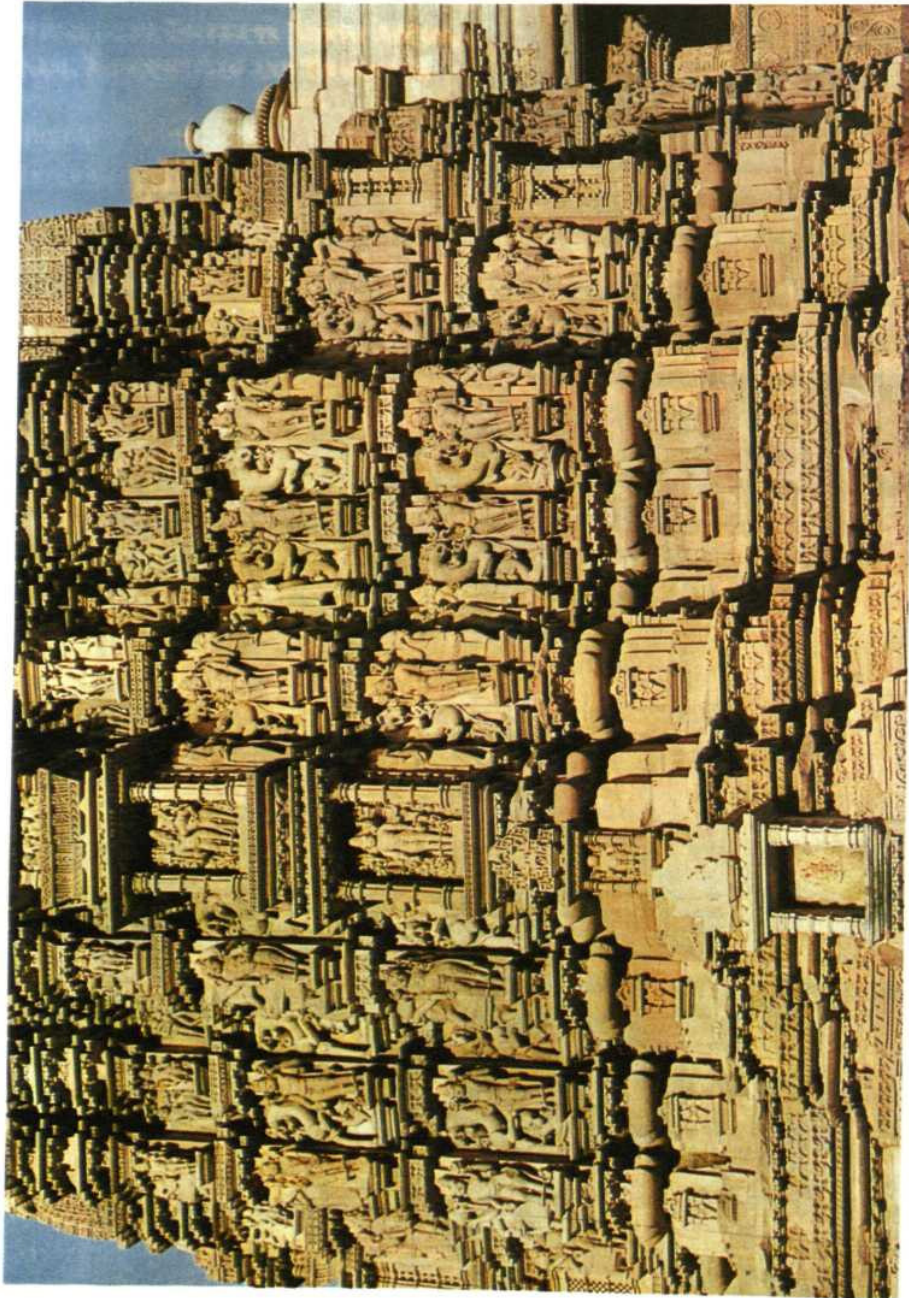
Plate 166

*Devijagadambi Temple, Khajuraho : sanctum façade, after chemical treatment*
